Failure of fluorocarbon copolymer pipes subjected to mechanical strain in an alkaline environment

A failure analysis was carried out on leaking fluorocarbon-based copolymer pipes used in a cleaning and disinfection plant. Pipes conveyed a solution of sodium hydroxide and showed leaking after two months of service. Leaks originated from reddish-colored cuts located on the bending curves of the external surface of the pipes. Experimental findings and literature review pointed out that a combined effect of chemical degradation and mechanical strain (similar to stress corrosion cracking) triggered the failure. This type of degradation developed in high pH hydroxide solution due to dehydrofluorination of the exposed surface, starting material embrittlement and formation of crazes and microcracks. An applied mechanical deformation accelerated the crack opening and the solvent diffusion, up to the consequent pipe leaking and failure.

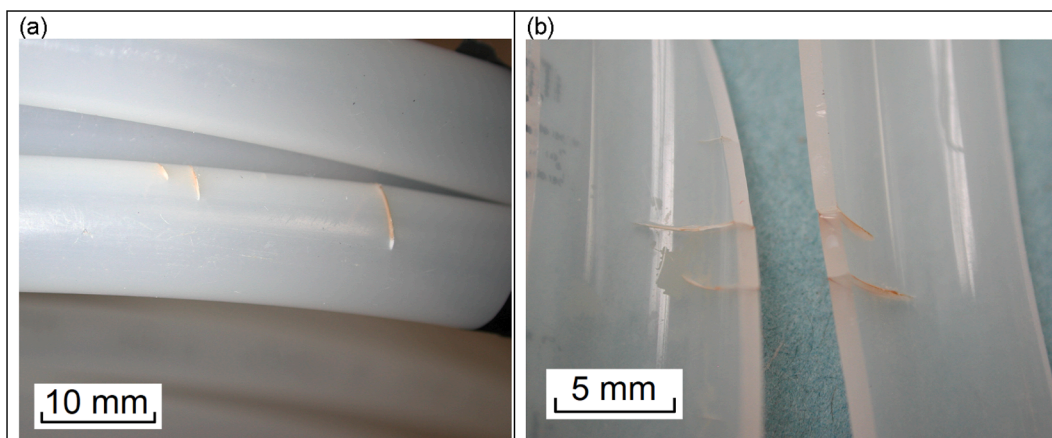
Evident cuts in the location of the leaking points are visible Fig. 1. These cuts are located on the pipe bends and pass through the entire wall thickness. The surface of the cuts is red-colored; in many cases, reddish stains can also be noticed in the internal surface of

Fig. 1. Cuts on the pipe surface: (a) external view and (b) internal and section view.

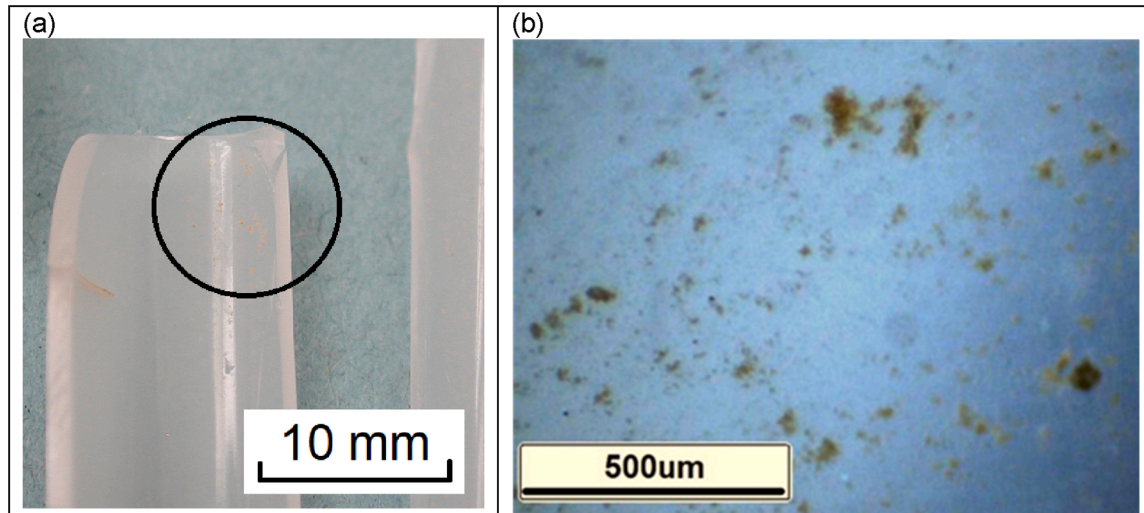
Fig. 2. Reddish stain seen at (a) visual examination; (b) optical microscopy.

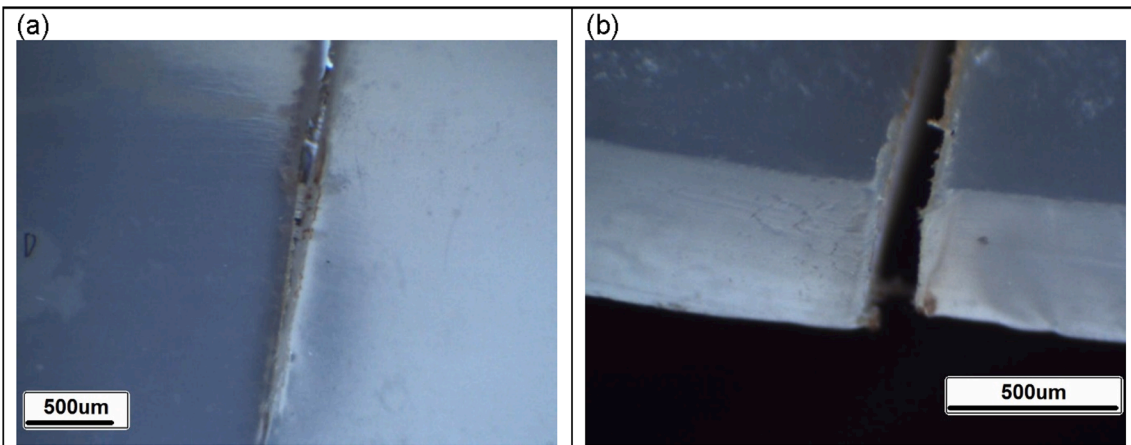
the pipe Fig. 2. Details of two different cuts, as seen at OM examination, are shown in Fig. 3. The cut edges appear rough and jagged; a network of material partially interconnecting the opposing walls of the cut can be seen. Fig. 4a and Fig. 4b shows several rough, whitened and scratched location, as well as areas with an irregular surface on the inner wall of the pipes. The white, parallel scratches are perpendicular with respect to the pipe axis [circumferential cracks]. Samples subjected to artificial ageing in alkaline solution are shown in Fig. 5. Samples immersed in 30% wt. NaOH does not show any noticeable change in their color after 42 days. On the other hand, those immersed in 60% wt. NaOH became reddish after 28 days, and dark red after increasing immersion times.

Fig. 3. Details of two different cuts at optical microscopy.

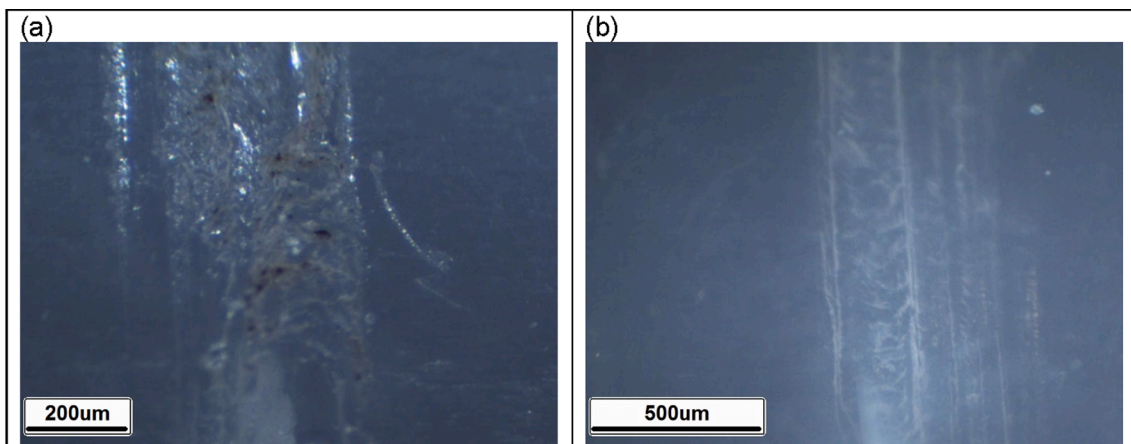
Fig. 4. Optical microscopy of inner pipe wall: – (a) scratched area and (b) parallel, white scratches.

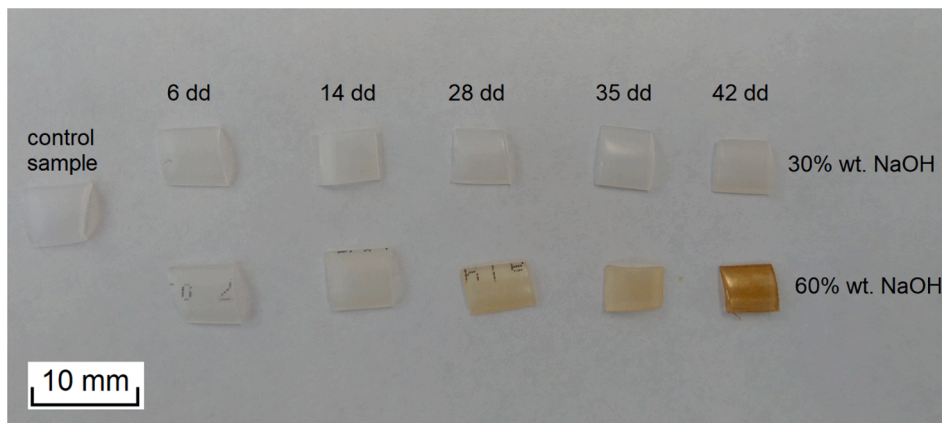
Fig. 5. Sample subjected to artificial ageing in: 30% wt. NaOH (upper line); 60% wt. NaOH (bottom line).

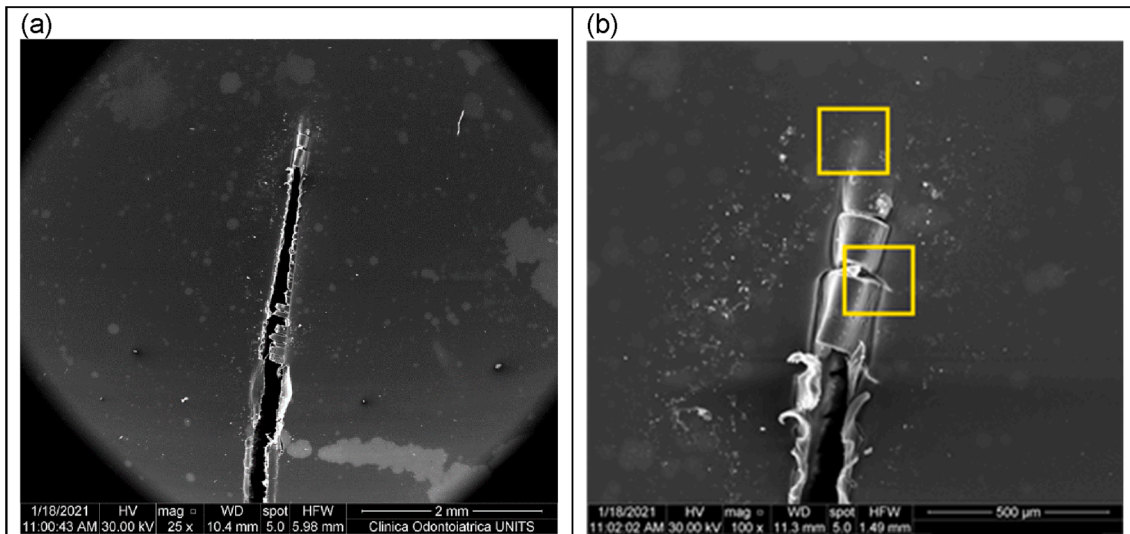
SEM images of the final part of a cut [apex, or crack edge] are shown in Fig. 6a. It is possible to notice a network of material partially interconnecting the opposing walls of the crack, as already noticed in OM images. The details of the opening edge are shown in Fig. 6b. At higher magnification [Fig. 7] indented fracture edges and discontinuous plastic deformation around the crack tip are noticeable. Fig. 8 shows a detail of the central zone of the cut, where the progressive tearing of the interconnecting material can be seen. Similar features, already seen in OM images [Fig. 3] and in other SEM images [Fig. 6], are usually observed in crazing and environmental crazing mechanisms in several polymeric materials [17–19]. Around damaged areas, crystalline deposits can be spotted. At higher magnification, these deposits appear to be octahedral crystals Fig. 9. After EDX analysis, they were identified as crystals of sodium fluoride [NaF]. SEM of samples subjected to artificial ageing did not show any appreciable difference with respect to control samples. No difference in the fluoride to carbon ratio was registered by EDX between aged and control samples.

Fig. 6. SEM images of (a) one cut; and (b) the crack tip (apex of the cut). Highlighted areas (squares) are shown at higher magnification in Fig. 7.

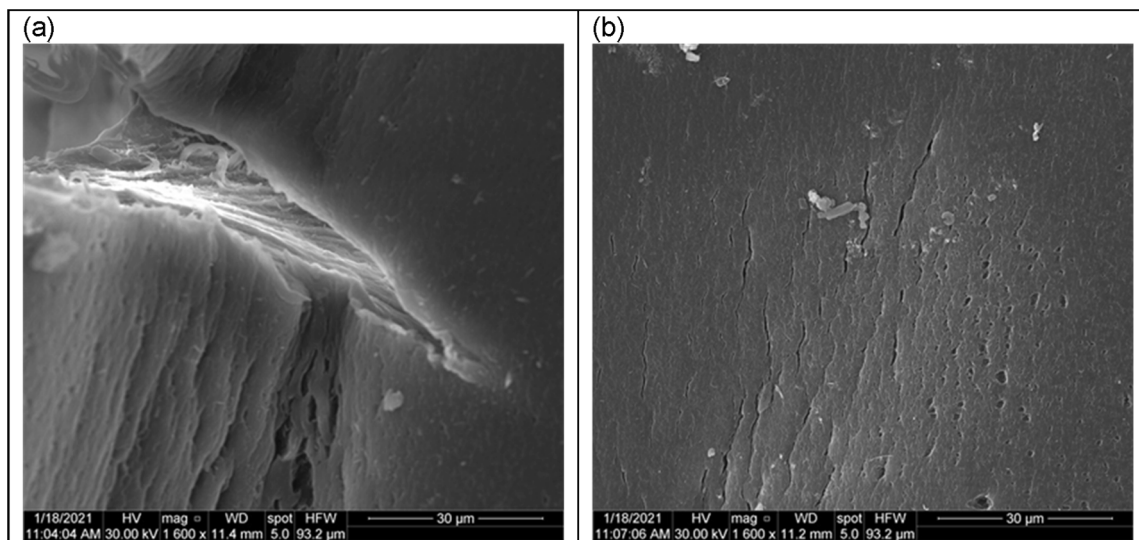
Fig. 7. SEM images: (a) higher magnification detail of fracture surface from Fig. 6; (b) higher magnification detail of crazes close to the crack tip from Fig. 6.

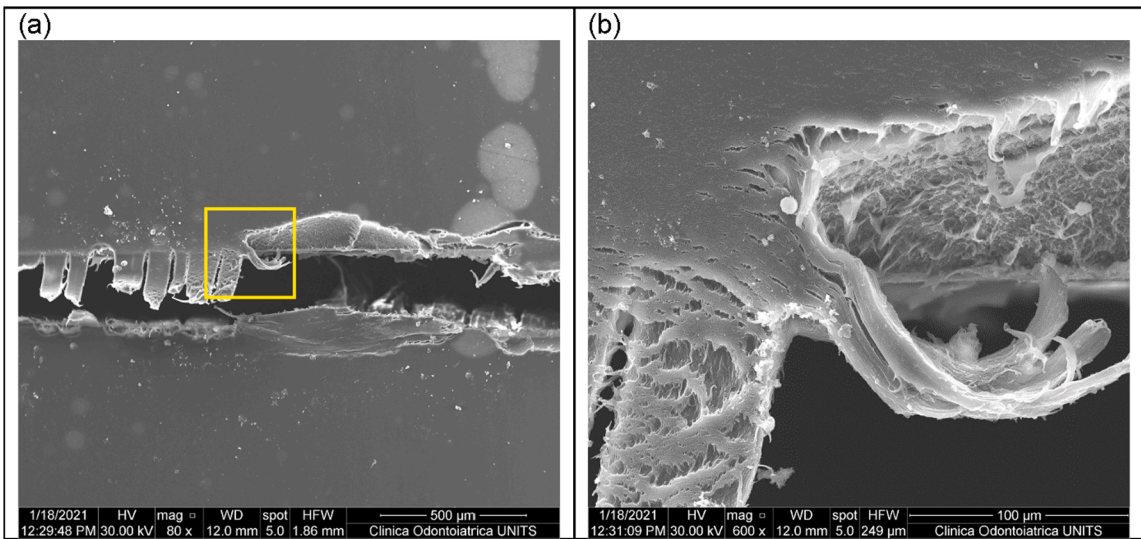
Fig. 8. SEM images the progressive tearing of the material interconnecting the cut surfaces. Highlighted area (square) in (a) is shown in (b).

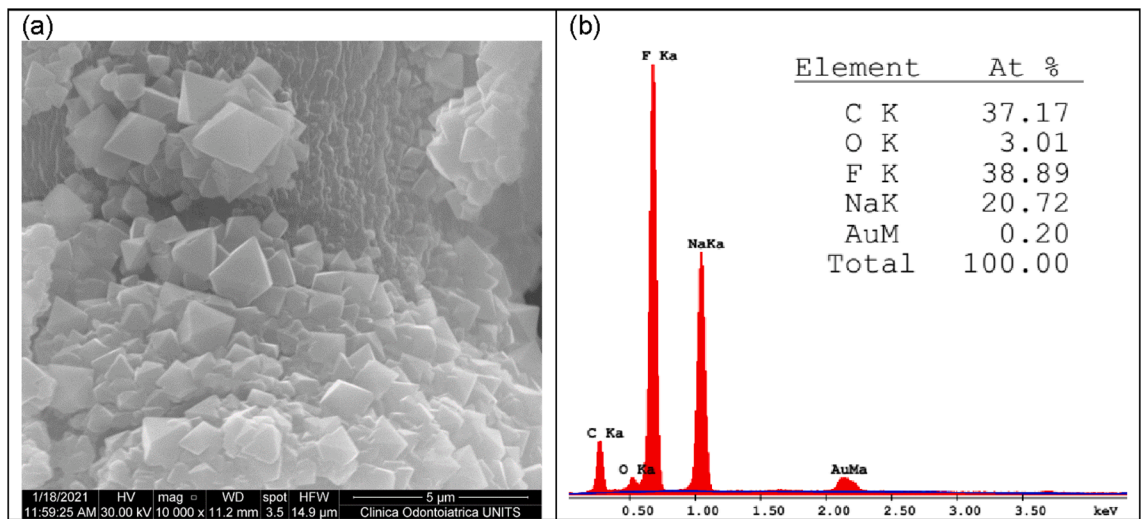
Fig. 9. (a) SEM images of crystalline deposits found around damaged areas; (b) EDX spectrum of crystalline deposits.

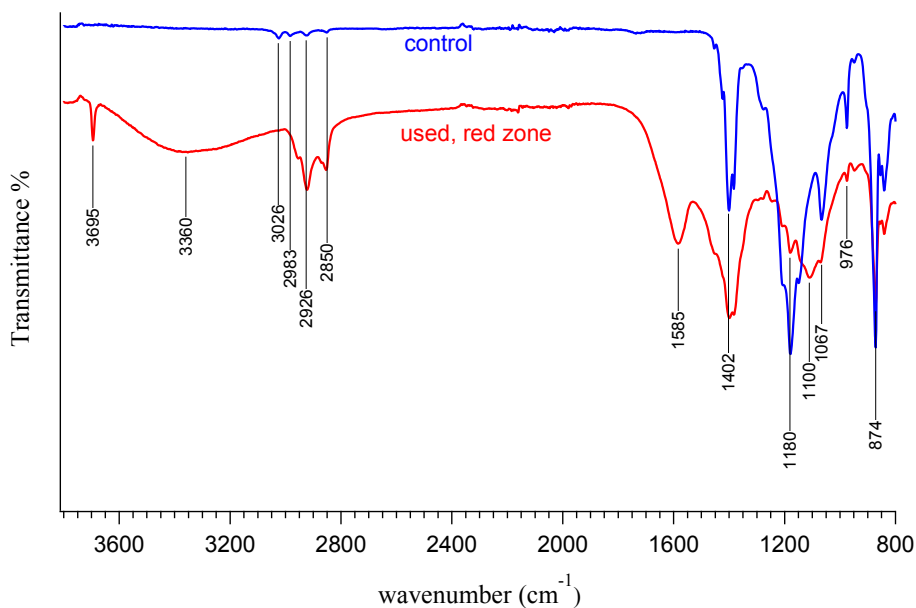
After comparing FTIR spectra acquired on control samples to those acquired on brown/reddish areas [close to the leaking cuts of failed pipes] [Fig. 11], it is possible to notice in the latter the rising of a sharp peak at 3693 cm^{-1} [Na–OH stretch], a broad band centered at 3360 cm^{-1} [OH stretch] [20] and another band at 1585 cm^{-1} . This latter band is usually attributed to COO^- stretch [chain breakdown/scission] or to COO^-/Na^+ stretch [saponification] [24,25]. Nevertheless, in this specific case, likewise to FT-IR data reported for fluorinated polymers subjected to alkaline degradation, the rise of this band can be related to the formation of a $-\text{C}=\text{C}-\text{C}=\text{C}-\text{C}=\text{C}-$ conjugated double bond system [6,16]. Moreover, the intensity of CH and CH/CH_2 vibrations [3000–2800 cm^{-1}] in the failed pipes spectra rises with respect to that related to CF_2 vibrations [1200–1050 cm^{-1}], pointing out a loss of CF_2 groups in the polymer chain [defluorination]. More in detail, the 2926 cm^{-1} and 2850 cm^{-1} bands [asymmetric and symmetric CH_2 stretch] become more intense than the 3026–2958 cm^{-1} band [CH stretch]. This also points out an increase in the intensity of vibrational bands related to CH_2 groups alongside the polymer chain. FTIR spectra acquired on samples subjected to simulated ageing

Fig. 11. FTIR spectra of internal surfaces of new pipe (blue curve) and brown/reddish area of used pipe (red curve). (For interpretation of the references to color in this figure legend, the reader is referred to the web version of this article.)

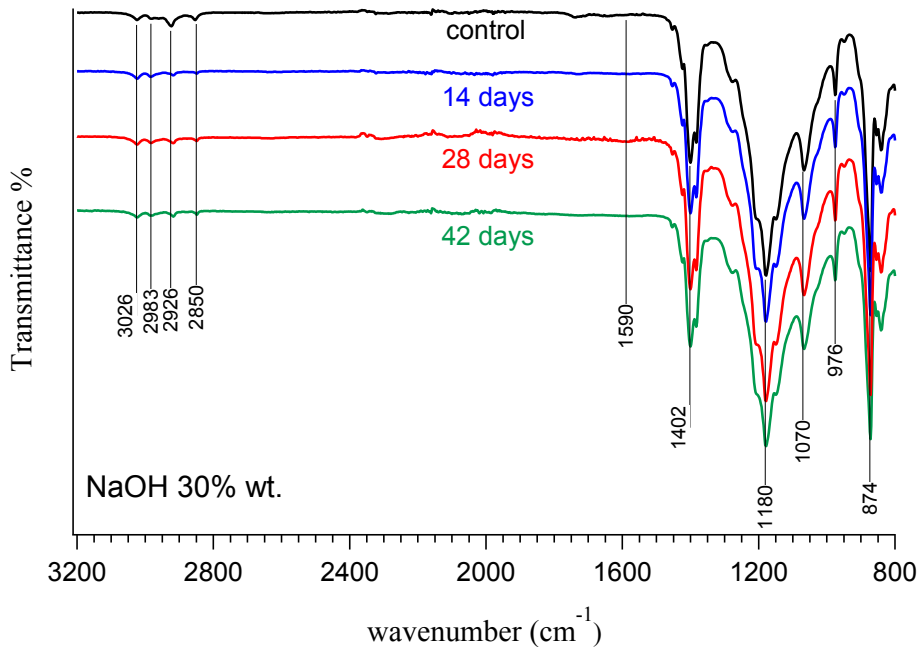
[Fig. 12 and Fig. 13] show no substantial difference for samples immersed in NaOH 30% wt. respect to control ones [even after 42 days]. No clear vibrational band related to oxidation or degradation is noticeable. On the other hand, samples immersed in NaOH 60% wt. show a clear increase in the IR band centered at 1590 cm^{-1} , which, as already discussed above, can be attributed to COO^-/Na^+

Fig. 12. FTIR spectra of artificially aged samples, after immersion in NaOH 30% wt. for different times.

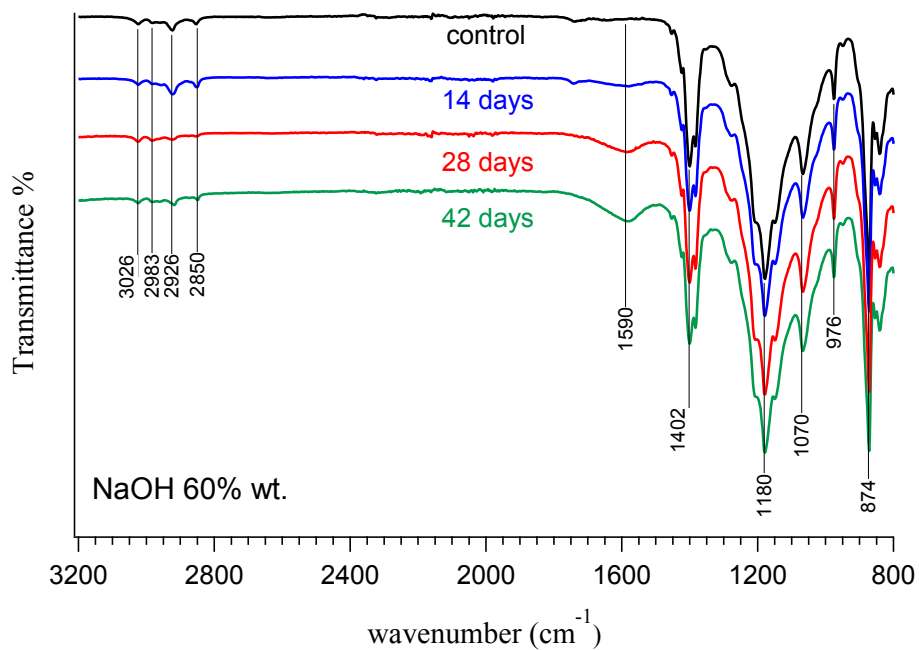
stretch [saponification] or to —C=C—C=C— conjugated double bond system. No change in the CH_2/CF_2 intensity ratio is observed in both cases, so defluorination is not apparently taking place, contrary to the behavior previously seen on the failed pipe sections spectra. This difference can be ascribed to the limited penetration depth of chemical attack in absence of an applied mechanical strain. If this depth is limited to the first layers, it could be speculated that the ATR FT-IR probes [on average] a deeper, non-degraded material volume [with diamond window, and assuming a PVDF refractive index of 1.426 [26], the instrument probing depth should be between 10 and 50 μm in the 3000–500 cm^{-1} region [27]].

Fig. 13. FTIR spectra of artificially aged samples, after immersion in NaOH 60% wt. for different times.

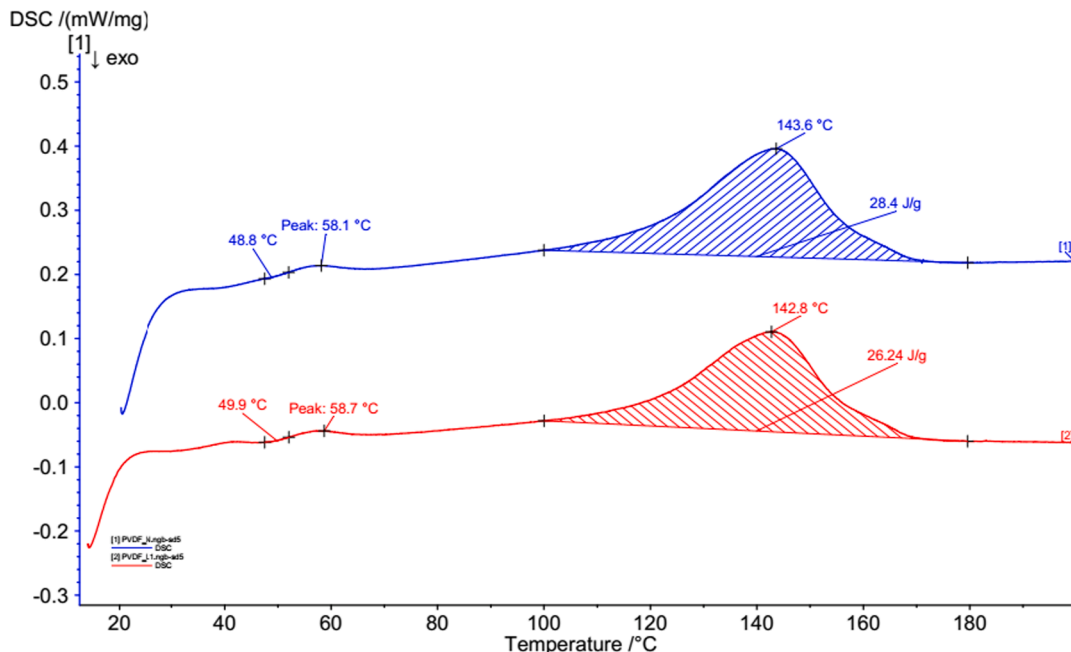
Thermograms of new pipe and used pipe samples are depicted in Fig. 14. The melting peaks of new and used samples are comparable and fit well the value reported in the technical datasheet [143 °C]. The melting enthalpy of the used sample [26.2 J/g] is slightly lower than that of the control one [28.4 J/g]. No significant difference between the crystallinity of control and used samples is therefore expected. Both melting enthalpy values are about 50% with respect to the melting enthalpy reported for PVDF homopolymer [22,23,28]; it is worth remembering that this material is a commercial copolymer, and its crystallinity value is not reported.

Fig. 14. DSC heating traces of samples obtained from new pipe (blue curve) and used pipe (red curve). (For interpretation of the references to color in this figure legend, the reader is referred to the web version of this article.)
