Ant-Nest Corrosion in Copper Pipes Triggered by Ethylene Vinyl Acetate-Based Adhesive

ABSTRACT

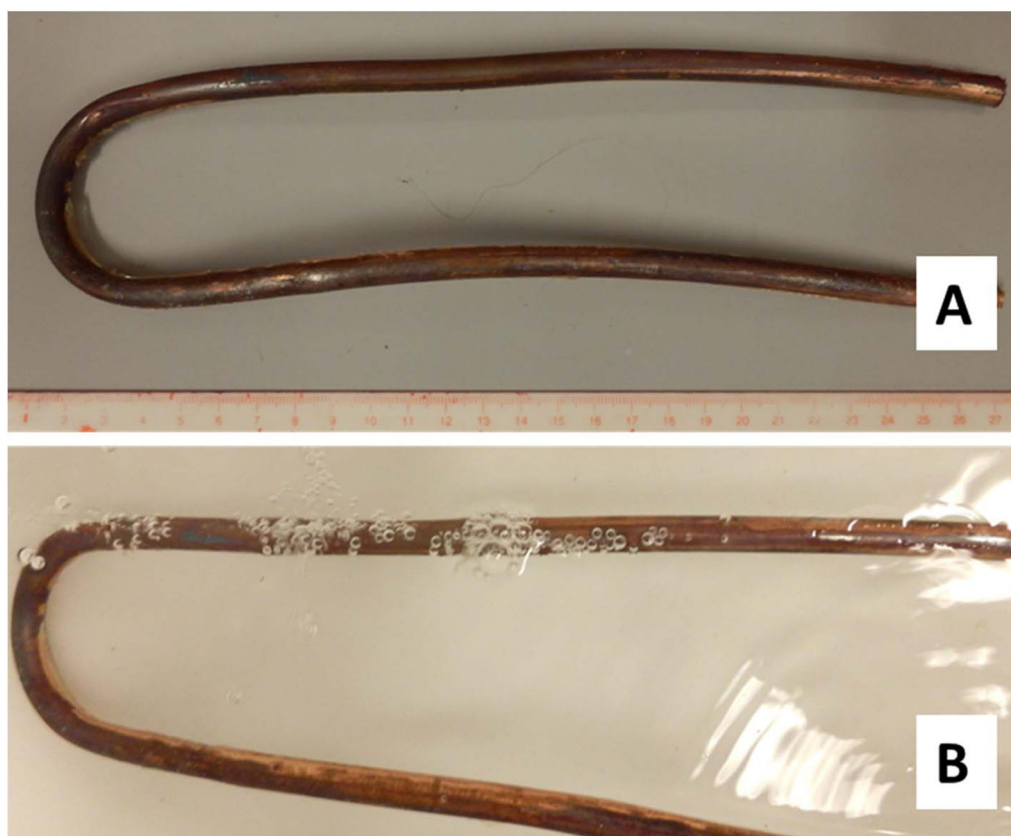
FIGURE 1 | Failed pipe section as cut (A) and the same failed pipe section during the pressure test (B). The exact location of leakage due to microscopic holes (not visible in A) is pinpointed by the air bubbles in B. [Color figure can be viewed at [wileyonlinelibrary.com](https://onlinelibrary.wiley.com)]

The picture of a representative failed section of the pipe is depicted in Figure 1. Figure 1A shows the failed pipe section after being cut, while Figure 1B displays the same sample during the pressure test. In Figure 1A, the microscopic holes are imperceptible to the naked eye. On the other hand, in Figure 1B, the presence of air bubbles during the pressure test

pinpoints the exact location of leakage. These bubbles highlight the previously unseen microscopic holes, emphasizing the importance of the pressure test in identifying the leakage location. The tube surfaces display characteristic copper patinas, exhibiting both dark-blueish and dark-red variants, as illustrated in Figure 2A,B. These patinas are typically composed of various copper compounds [5, 22]. Usually, among these, copper (II) oxide (CuO or tenorite) appears dark in color, and copper basic carbonate, a mixture of $\text{Cu}_2(\text{OH})_2\text{CO}_3$ (malachite) and $\text{Cu}_3(\text{OH})_2(\text{CO}_3)_2$ (azurite) appear green to blue. Additionally, copper (I) oxide (Cu₂O or cuprite) contributes to dark red to bright-red hues. Bright blue deposit could be identified as azurite or as copper (II) acetate ($\text{Cu}(\text{COOH})_2$), adding further complexity to the corrosion products observed. Raman spectroscopy conducted on the pipe surface (Figure 3A,B) unveiled distinctive Cu (I) oxide signals, including characteristic shifts at 148 and 220 cm^{-1} [23–27]. The detection of Cu (II) oxide signals (Figure 3C), represented by a peak at 296 cm^{-1} [23, 24, 27–29]) was sporadic and limited to certain dark areas, and only after laser-induced overheating. No characteristic signals of carbonates/hydroxides were discerned on the patina [29]. It is

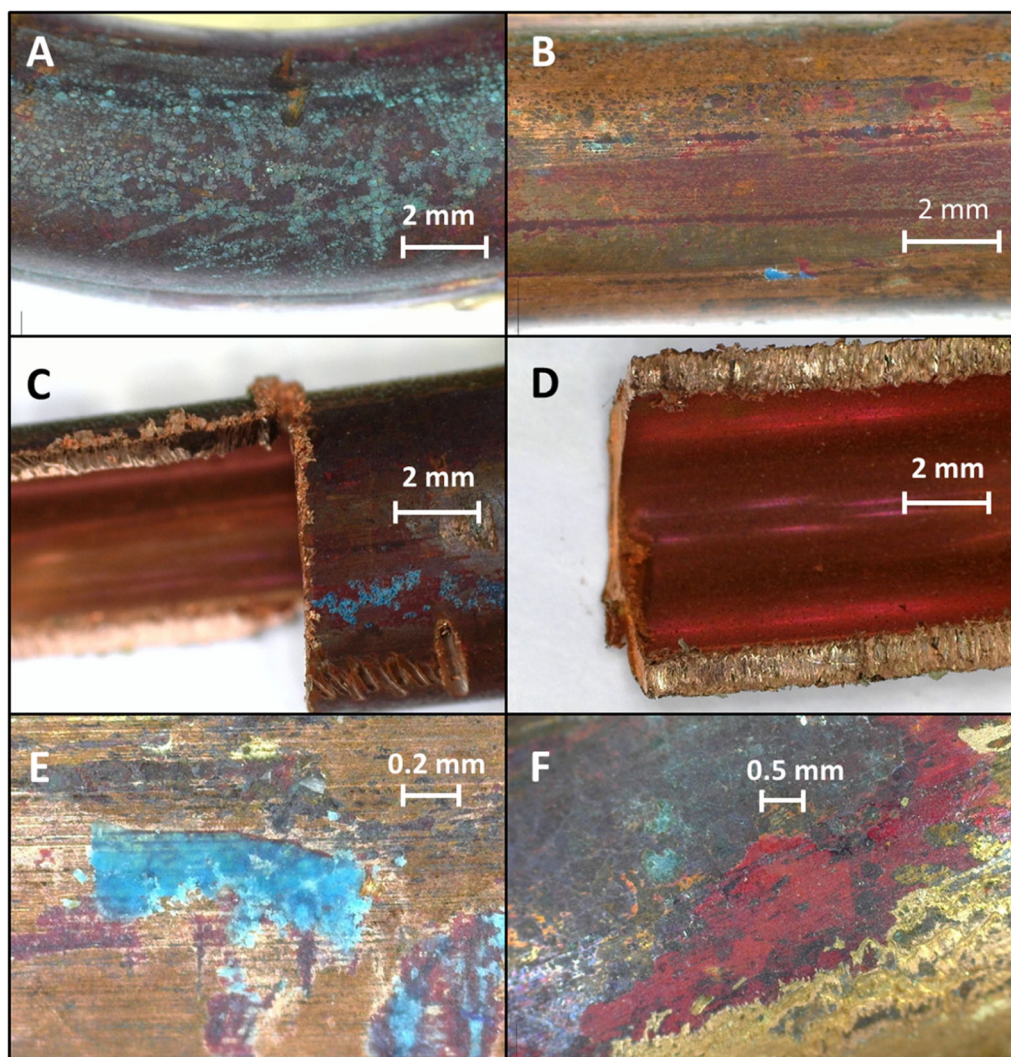
FIGURE 2 | Low magnification micrographs of samples: (A) example of dark/blueish patina; (B) example of dark red patina; (C) area next to sample cutting: dark patina and bright blue deposits on the outside, copper with no patina on the inside; (D) inner surface of the tube, no deposits or evident patina; (E) details of a bright blue deposit; (F) details of a bright red deposit next to a dark patina. [Color figure can be viewed at [wileyonlinelibrary.com](https://onlinelibrary.wiley.com)]

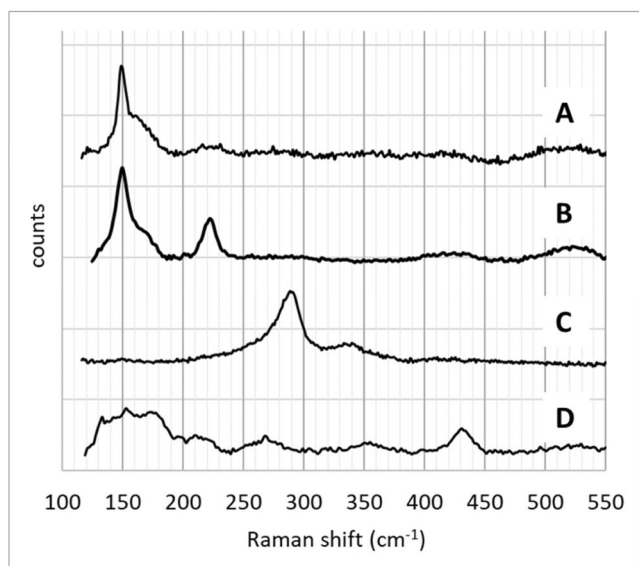
FIGURE 3 | Raman spectra of (A) dark patina; (B) red spot; (C) overheated dark spot; (D) blue spot.

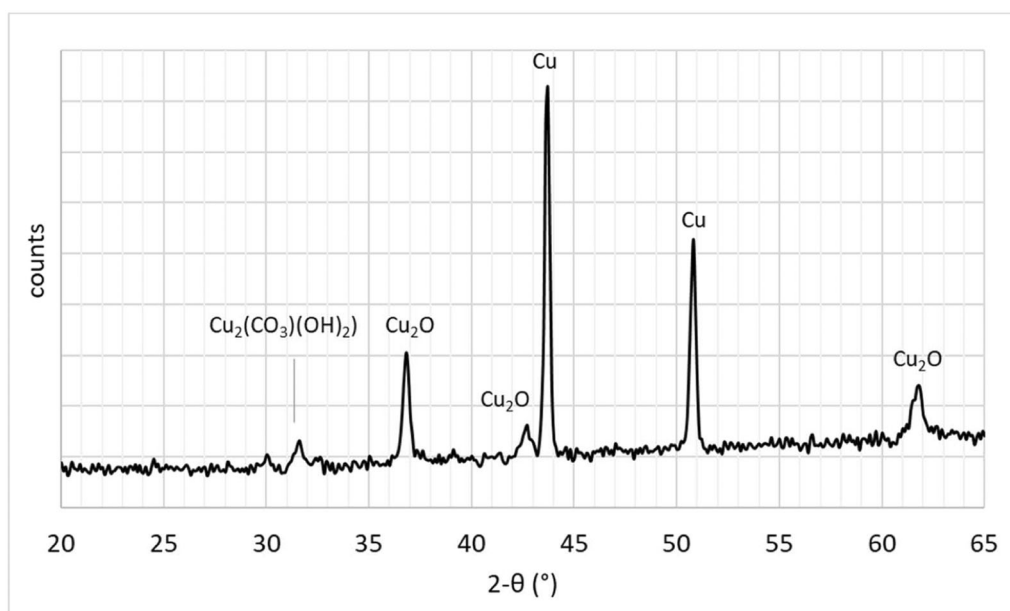
recognized that Cu (I) oxide thin films, formed adjacent to the metal surface, may exhibit dark or brown-black tones, differing from the typical red hue of bulk cuprite mineral [30]. XRD analysis (Figure 4) confirmed the presence of a cuprite layer on the outer pipe surface, with a minor diffraction signal attributed to malachite [26, 27, 31]. Furthermore, Raman spectroscopy conducted on selected blue regions (Figure 3D) exhibited signals consistent with malachite, characterized by a Raman shift at 430 cm^{-1} [31–33]. Interestingly, the inner surfaces of the tubes, as depicted in Figure 2C,D, appear unpatinated. Upon closer examination, Figure 2E,F provides detailed views of bright blue and bright red deposits. Further analysis with a portable optical microscope in Figure 5 revealed the presence of pits along the lateral edges, particularly in areas immediately

FIGURE 4 | X-ray diffractogram of the pipe's external patina.

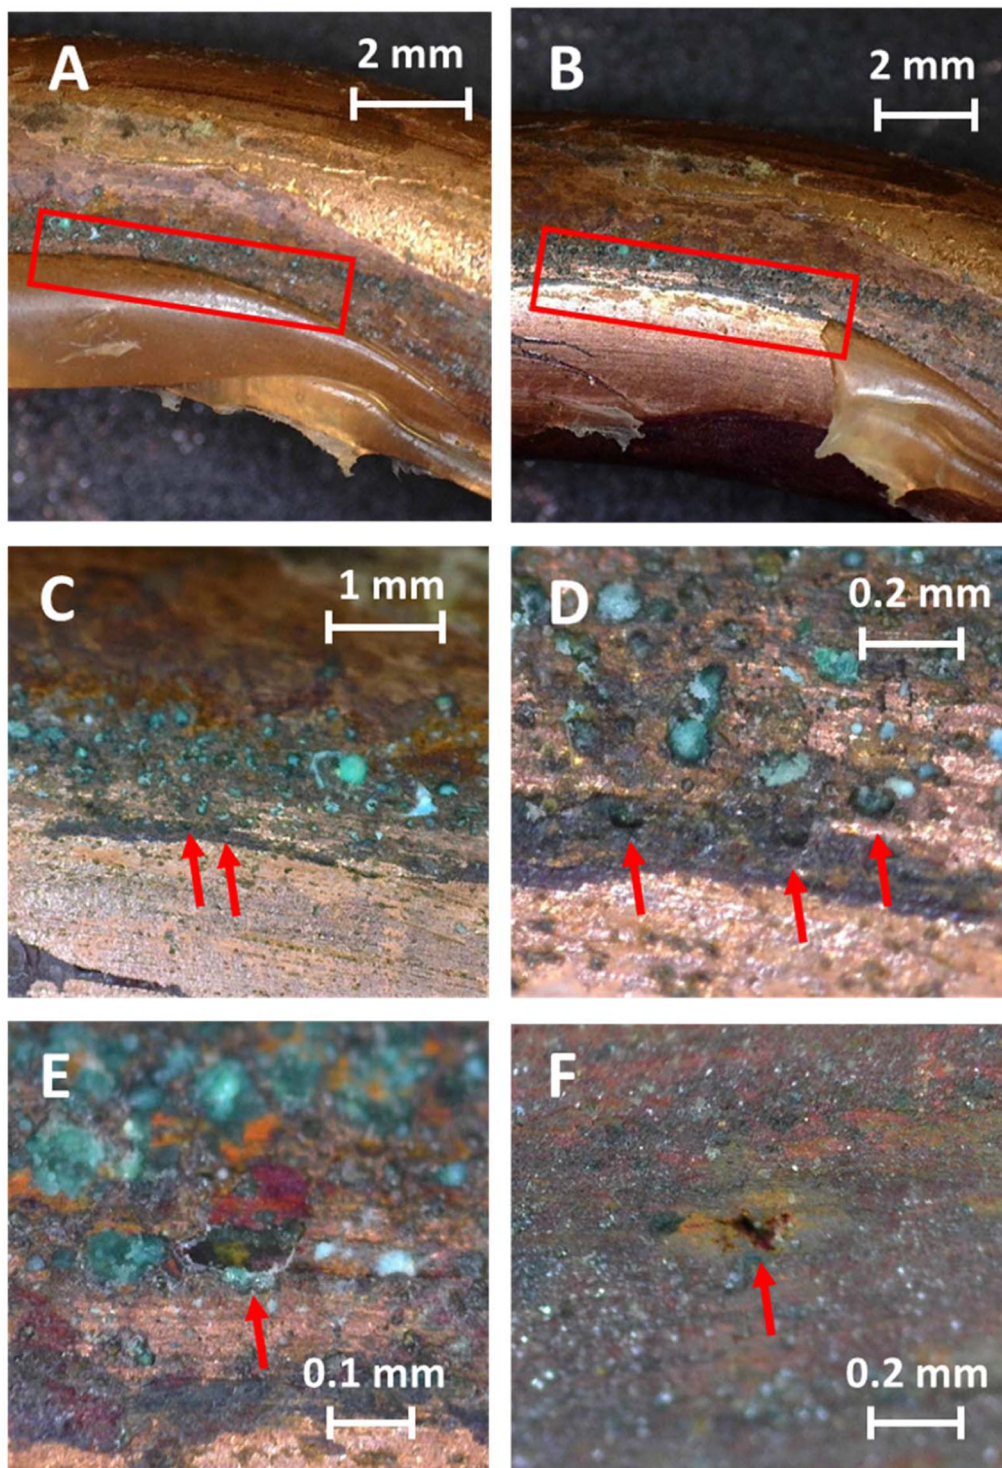
adjacent to the hot melt adhesive. Figure 5A captures an area adjacent to the adhesive before removal, while Figure 5B shows the same area post-adhesive removal. Magnified views in Figure 5C–F shows numerous pits (highlighted by red arrows), indicative of localized corrosion phenomena. Intense blue and bright red corrosion products are observed both inside and adjacent to most pits. In Figure 6A,C, two representative images of the cross-section of the tube are depicted, while the longitudinal sections are shown in Figure 6B,D. Evidently, the presence of pits originating from the outer surface of the tube is observable, manifesting as microscopic tunnels randomly traversing the tube wall, extending longitudinally. Subsequently, these tunnels breach the inner surface of the tube (Figure 6D), resulting in perforation and gas leakage. Similar phenomena are observed in the cross-sectional views. Notably, the interconnected nature of multiple galleries is apparent in Figure 6C, where smaller cavities converge into larger tunnels (Figure 7).

FIGURE 5 | Low magnification micrographs of samples: (A) area next to the hot adhesive, prior to adhesive removal; (B) same area, after adhesive removal. (C) and (D): magnification of the area highlighted in (B), several pits can be noticed. (E) details of one pit: blue and bright red corrosion products can be spotted. (F) details of another pit, no corrosion products. [Color figure can be viewed at [wileyonlinelibrary.com](https://onlinelibrary.wiley.com/doi/10.1002/maco.202414539)]

The pressure test on the examined pipes revealed numerous leaks from the side adjacent to the hot melt adhesive; this area shows numerous pits not visible to the naked eye filled with bright blue and red deposits, identified as copper basic carbonate and copper

This failure underscores the critical yet unexpected role of adhesive selection in copper pipe corrosion. The refrigerator pipes were assembled manually using hot melt glue; the premature leaking affects units bonded with a specific type of adhesive containing ethylene vinyl acetate, while units assembled with another adhesive of similar performance but different chemical formulations seem unaffected. Despite the seemingly innocuous substitution of a conventional polyethylene-based adhesive with one containing ethylene vinyl acetate, the consequences were significant. The latter adhesive unexpectedly triggered a relatively rapid corrosion event and finally the failure due to the leaking of the condenser circuit within the refrigeration system. It is worth noting that the typical timeframe for an ant-nest corrosion failure is on the order of several months, rather than years as reported in this case. In this specific instance, although the failure occurred before the forecasted time of appliance operation, it can be speculated that the arrival of atmospheric humidity on the pipe surface may have been hindered or delayed by the PU foam encapsulation. Additionally, it can also be hypothesized that the concentration of acetic acid resulting from the melting of the hot melt adhesive is lower than in typical reported cases. A recommended preventive measure for addressing this specific failure is to replace the adhesive containing EVA with an alternative adhesive, such as the one based solely on polyolefin.

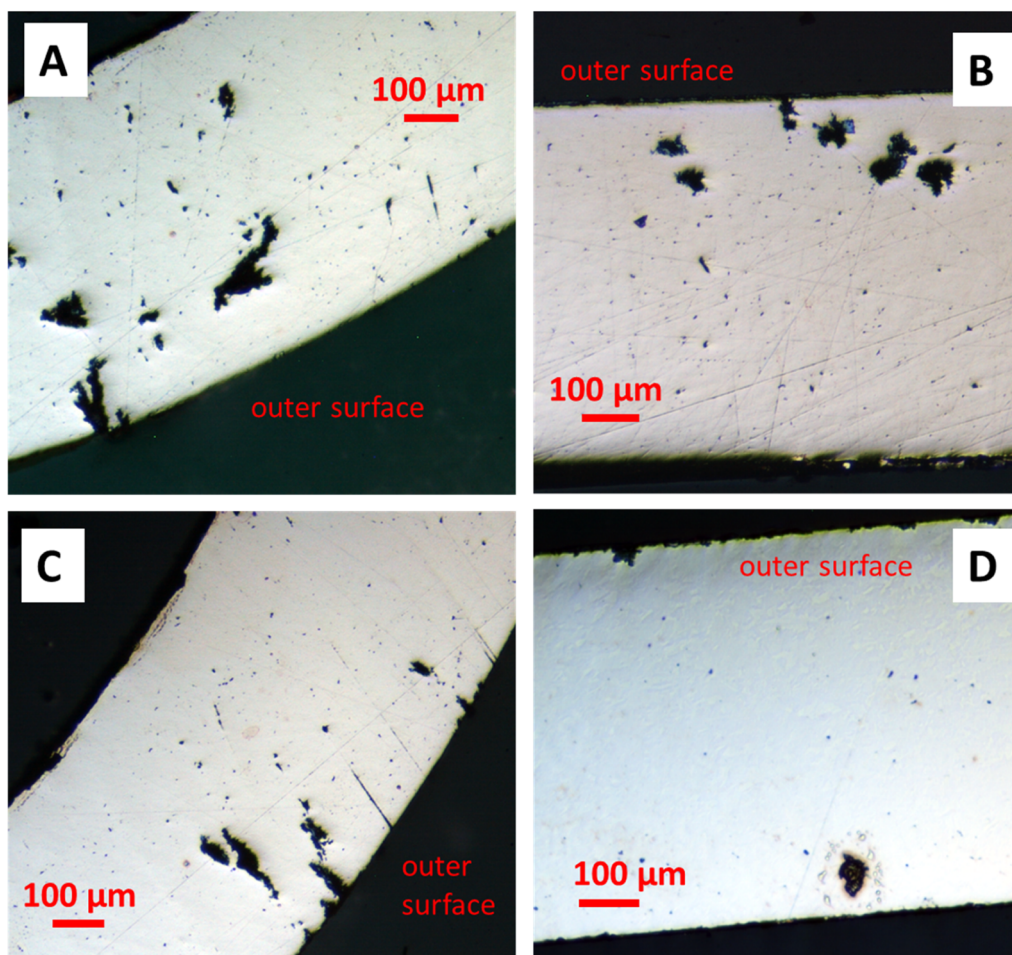
FIGURE 6 | Metallographic micrographs of samples: cross sections (A, C); longitudinal sections (B, D). [Color figure can be viewed at wileyonlinelibrary.com]

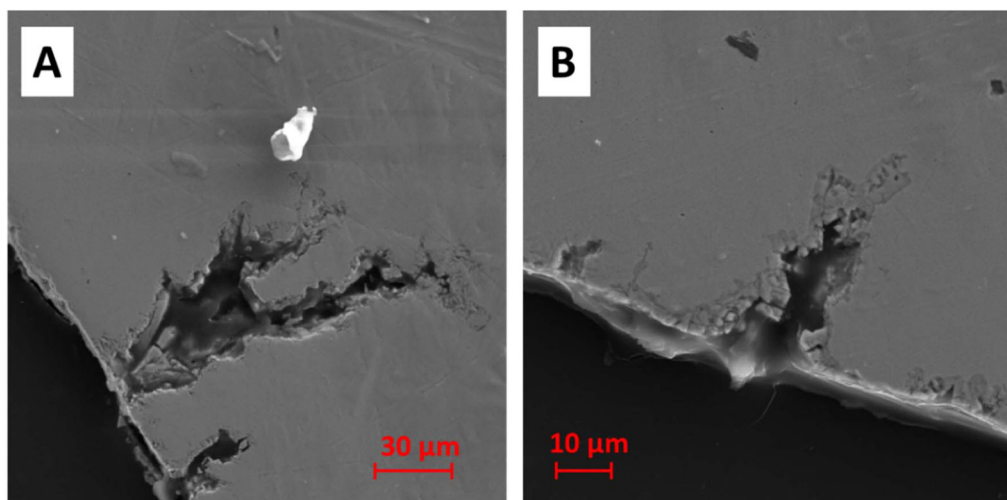
FIGURE 7 | SEM images: details of pits originating from the outer surface of the cross-sections of the tubes. [Color figure can be viewed at wileyonlinelibrary.com]

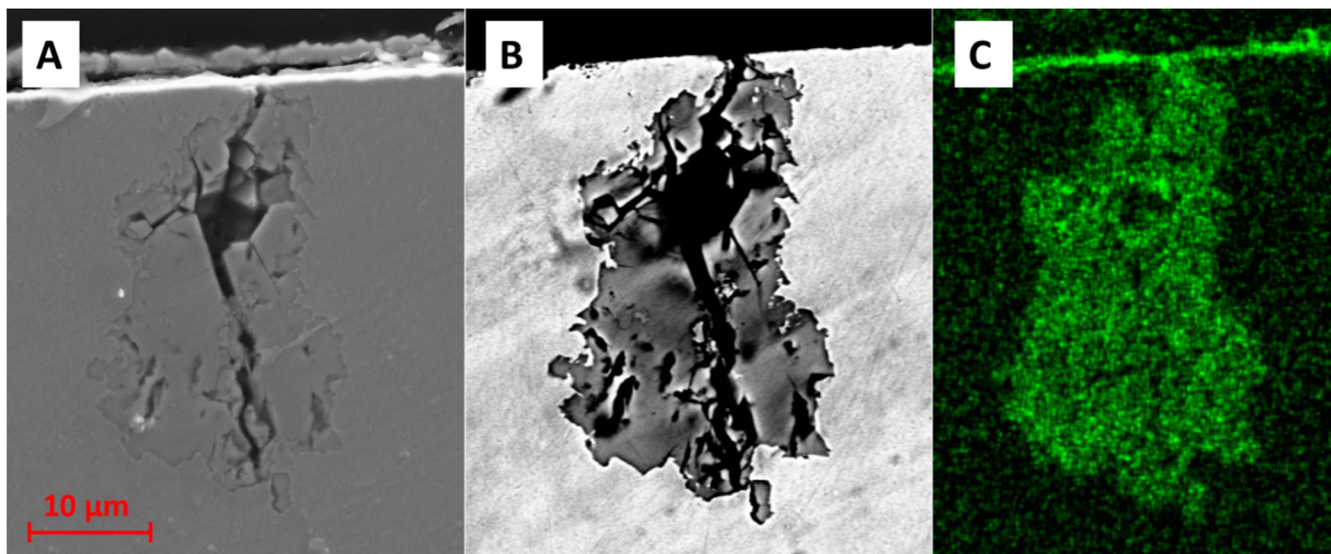
distribution of oxygen within the pits. These oxygen-rich areas correspond to regions where corrosion products, such as oxides or hydroxides, develop. Therefore, the EDX map of oxygen distribution serves as a complementary technique to the BSE imaging, providing additional confirmation of the presence of corrosion products in the darker regions of the image. This combined approach helps to validate the interpretation of the BSE image and provides further insights into

FIGURE 8 | Details of a pit originating from the outer surface of the longitudinal section of the tubes. (A) SEM image acquired with secondary electrons (topographic contrast); (B) SEM image acquired with backscattered electrons (atomic number contrast); (C) EDX map of oxygen distribution superimposed onto the SEM image. [Color figure can be viewed at [wileyonlinelibrary.com](https://onlinelibrary.wiley.com)]

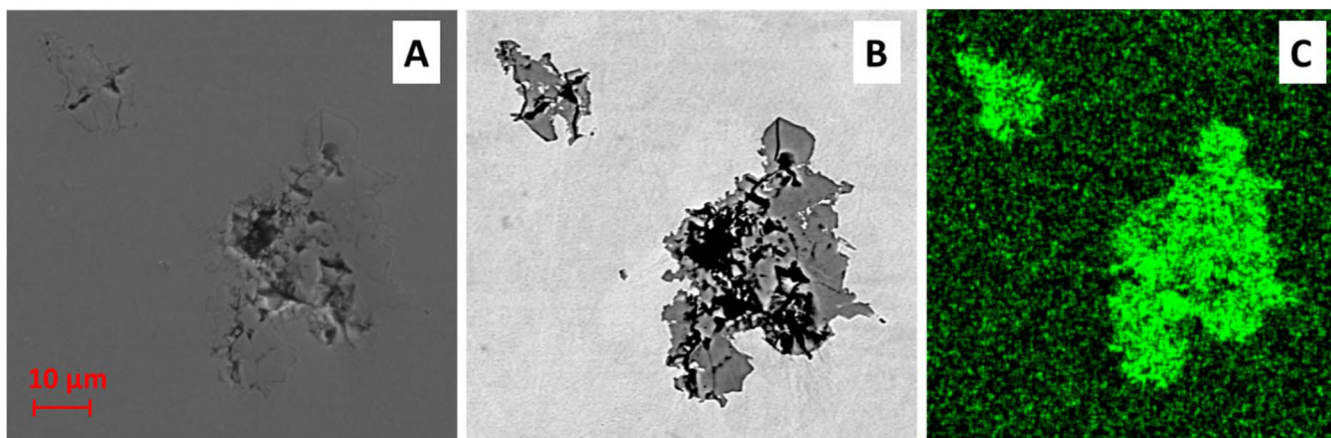
Figures 8 and 9 illustrate the details of two pits developing perpendicular to the longitudinal section of the tubes. These pits, visible in both SEM images acquired with SEs (A) and BSEs (B), exhibit contrasting topographic and atomic number characteristics, respectively. The brighter regions in the BSE image (B) indicate areas with higher atomic number elements, such as metallic copper. BSE in SEM imaging provide contrast related to atomic number because higher atomic number elements tend to scatter electrons more effectively than lower atomic number elements. As a result, regions with higher atomic number elements appear brighter in BSE images. Copper has a higher atomic number than other elements typically found in corrosion products, such as oxides. Therefore, areas containing copper will appear brighter in BSE images due to the higher atomic number contrast, while areas with corrosion products will appear darker because they typically have a lower average atomic number compared to the original metal. Additionally, an EDX map of oxygen distribution superimposed onto the SEM image highlights the

FIGURE 9 | Details of two pits developing perpendicularly to the longitudinal section of the tubes. (A) SEM image acquired with secondary electrons (topographic contrast); (B) SEM image acquired with backscattered electrons (atomic number contrast); (C) EDX map of oxygen distribution superimposed to SEM image. These oxygen-rich areas correspond to regions where corrosion products (oxides or hydroxides) have formed. [Color figure can be viewed at [wileyonlinelibrary.com](https://onlinelibrary.wiley.com)]

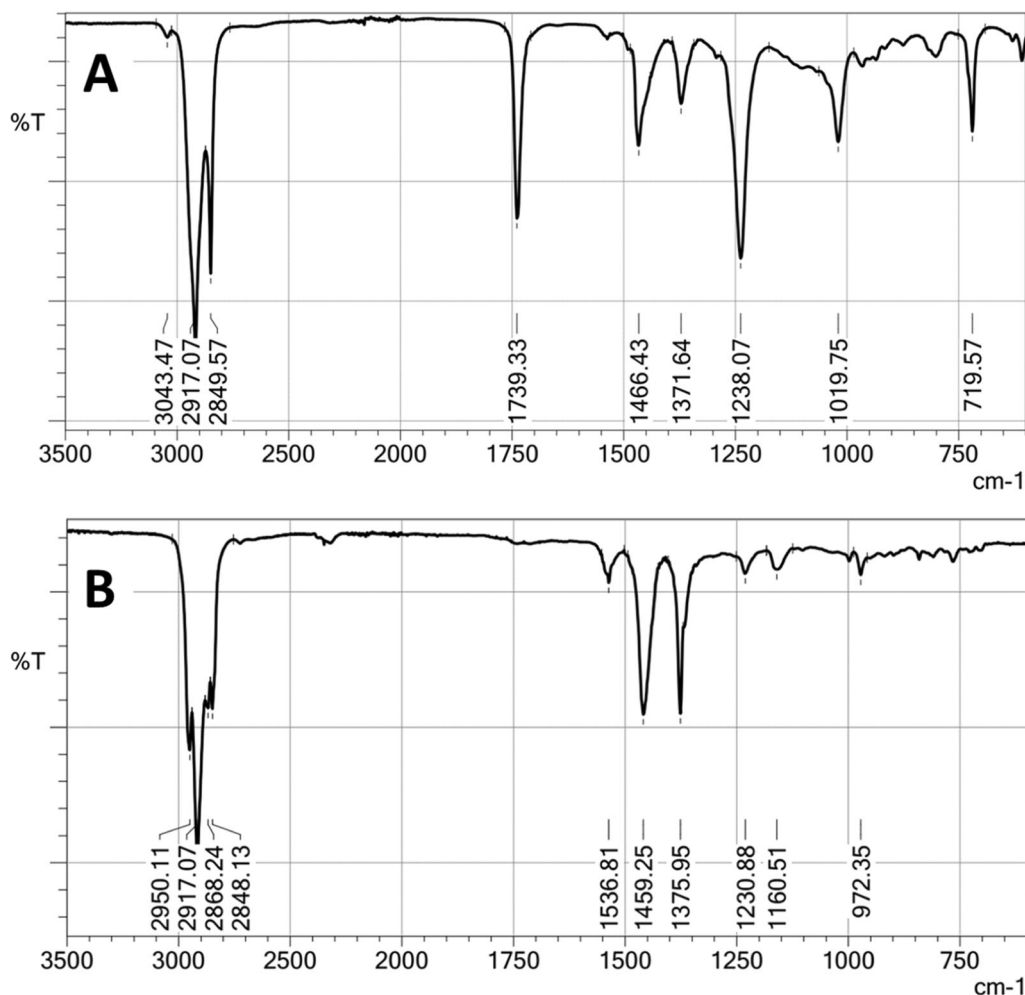
In Figure 10A, the FT-IR spectrum of the thermoplastic adhesive “A” is shown. The spectrum exhibits characteristic vibrational bands associated with the functional groups present in ethylene-vinyl acetate (EVA) [34–37]. Aliphatic and vinyl C-H stretching are observed at 2850, 2917, and 2950 cm^{-1} . Carbonyl

(C=O) stretching can be noticed at 1739 cm^{-1} ; methylene (CH_2) bending at 1466 cm^{-1} ; methyl bending (CH_3) at 1371 cm^{-1} ; vinyl acetate (C=O) and ester (C–O–C) stretching at 1238 and 1020 cm^{-1} ; vinyl ($\text{CH}_2=\text{CH}$) bending at 719 cm^{-1} . Also, the Shimadzu FTIR database [38] identified the adhesive “A”

spectrum as EVA. In Figure 10B, the FT-IR spectrum of the thermoplastic adhesive “B” is shown. The spectrum exhibits most of the characteristic vibrational bands associated with the functional groups present in polypropylene (PP) and polyethylene (PE) [34, 35, 39, 40]. Aliphatic stretching are observed

in the $2850\text{--}2950\text{ cm}^{-1}$ range; methylene (CH_2) bending at 1459 cm^{-1} ; methyl bending (CH_3) at 1375 cm^{-1} ; C–H stretch in methyl groups at 1231 cm^{-1} ; CH_2 rocking at 972 cm^{-1} . The Shimadzu FTIR database [38] identified the adhesive “B” spectrum as a polyolefin (PP/PE)-based polymer, with the presence of minor additives (that can be related to other minor vibrational bands, such that visible at 1537 cm^{-1}). Peaks related to EVA are not recorded in adhesive “B.”

FIGURE 10 | FT-IR spectra of the thermoplastic adhesive “A” and “B.”
