Vibration Analysis and Characterization of Damaged Structural Glass Elements

An original experimental program was carried out in August 2021. For the present study, the attention was focused on two original panels (from the set of 39 elements) that are currently part of the Crypt of Excavations suspension path (Fig. 13.4a).

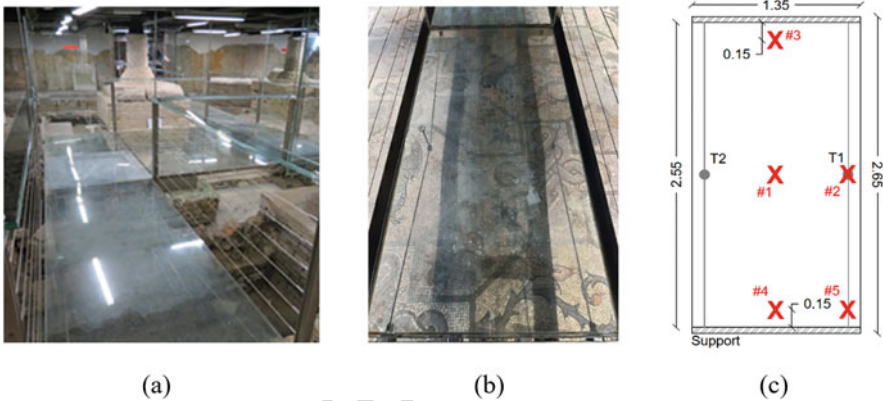
Fig. 13.4 Case-study LG slab: (a) walkway (Crypt) and (b) reference LGU module, with (c) dimensions in m

The reference LG panel has a total dimension of 1.35×2.65 m (Figs. 13.4b, c). The slab consists of a triple section composed of fully tempered (FT) glass layers (3×12 mm the thickness) and interposed PVB foils (0.76 mm thick). An additional protective layer made of annealed (AN) glass (6 mm in thickness) is also positioned on the LG top surface (Fig. 13.5). The mechanical interaction between LG and the top AN layer was ensured by contact only.

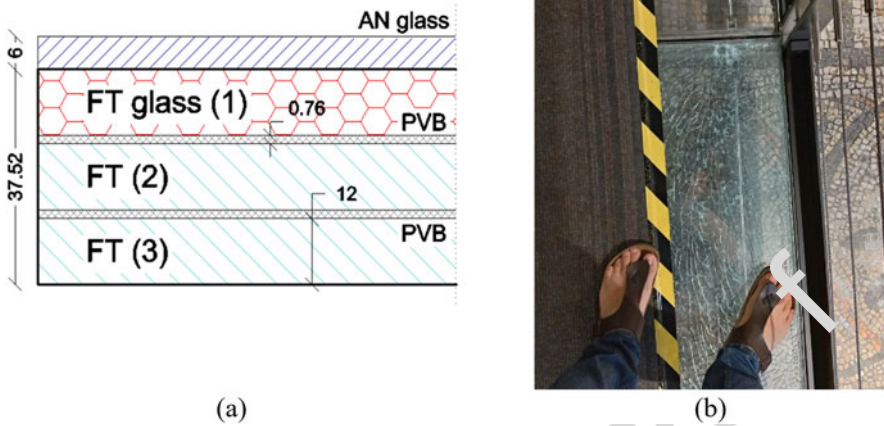
Fig. 13.5 Case-study LG slab: (a) cross-section layout with dimensions in mm (in evidence, the fractured FT layer) and (b) views of LGF fractured module

103 The tested panels are supported along the short edges (Fig. 13.4c). To limit large
 104 bending deformations under walks, two pairs of pre-stressed tendons (10 mm the
 105 nominal diameter) composed of AISI 316 steel are used. Their mechanical interaction
 106 with glass is offered by unilateral mechanical mid-span point support only. The
 107 experimental investigation was focused on two selected modules of the walkway,
 108 being characterized by identical total dimensions as in Fig. 13.4c. The difference was
 109 represented by intact glass layers (LGU), or by the presence of one fractured glass
 110 layer for the LG section (LGF), as suggested by the preliminary observations
 111 summarized in Fig. 13.5. To note that the top LG layer was fractured during
 112 maintenance operations. A carpet was temporarily installed on the top layer, while
 113 waiting for the replacement of glass module. The fracture origin can be clearly seen

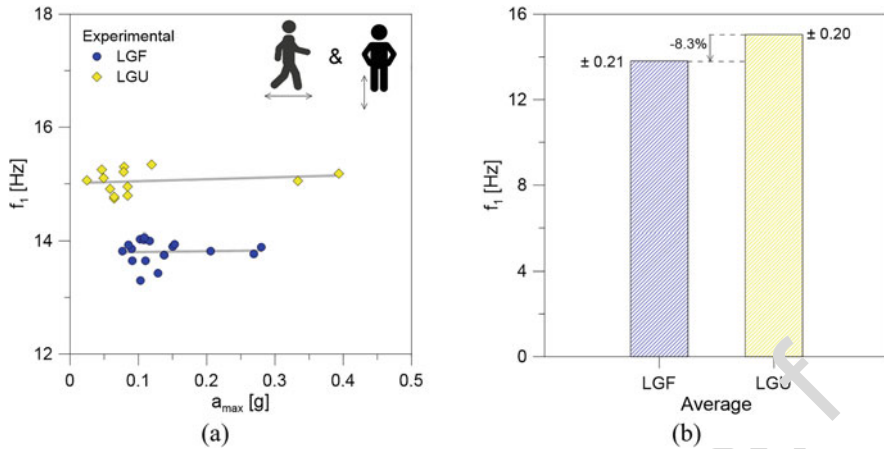
Fig. 13.7 Experimental fundamental frequency for LGU and LGF modules based on (a) vertical acceleration peaks or (b) average estimates.

146 investigated LGU and LGF modular units (Fig. 13.7b). Worth to note in Fig. 13.7a,
 147 for the explored acceleration range, is the higher sensitivity and lower vibration
 148 frequency of LGF estimates to various waking conditions, compared to LGU. The
 149 average frequency of LGF and LGU modules was calculated in 13.8 Hz (± 0.21) and
 150 15.05 Hz (± 0.2) respectively. In this regard, it is clear that a direct comparison
 151 cannot be discussed for possible uncertainties in material properties or detailing. In
 152 any case, the experimental frequency scatter was quantified in around -8.3%
 153 decrease of frequency (and thus bending stiffness) for the LGF module
 154 (Fig. 13.7b), which could be representative of an approximate damage index for
 155 the walkway object of study.
