# Ant-nest corrosion failure of heat exchangers copper pipes

Luca Cozzarini <sup>a\*</sup>, Lucia Marsich <sup>a</sup>, Chiara Schmid <sup>a</sup>

<sup>a</sup> Department of Engineering and Architecture, University of Trieste, Via Valerio 6A, I-34127 Trieste, Italy.

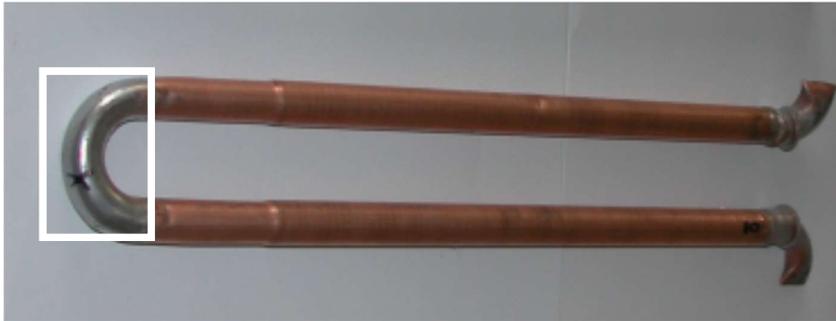
This case examined copper U-tubes from an air conditioning heat exchanger. No failure was noticed during manufacturer's pressure test. After test, pipes were drained and stored in air before commissioning. No specific drying procedure after water drainage was reported. Tubes have an outer diameter of 9.5 mm (3/8 inches) and a wall thickness of 0.25 mm; leaking happened next to the U-tube bends (area highlighted in Figure 1). The conveyed fluid was a halocarbon gas; the leakage happened after 2 month of service.

Figure 1: failed tube from Case 1 – leakage area is highlighted in the white rectangle.

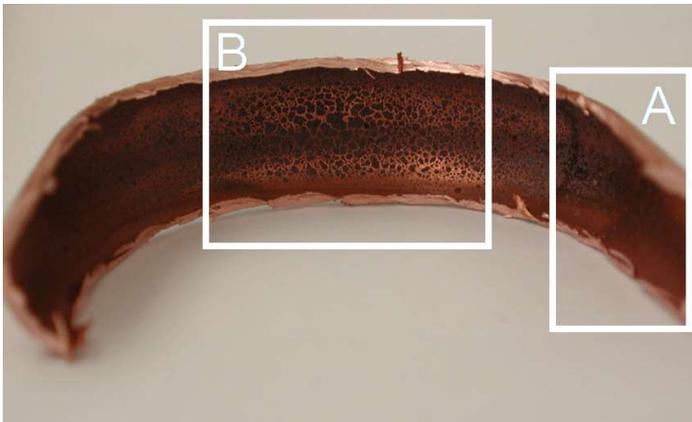
Outer surfaces of the straight regions of the tubes show a typical roughness originating from wire drawing production process. Any obvious defects have not been observed. Inner surfaces of U-tubes are instead characterized by dark spots, already noticeable by visual examination (Figure 2) and clearly visible by SM (Figure 3). These spots are larger and more concentrated in the upper part of the U-tube (Figure 4 – magnification of "B" zone of Figure 2). Dark spots and surrounding areas have been further investigated by SEM (Figure 5).

Figure 2: visual examination of inner surface of U-tubes from Case 1. Magnification of zone "A" and zone "B" are shown in Figure 3 and Figure 4.

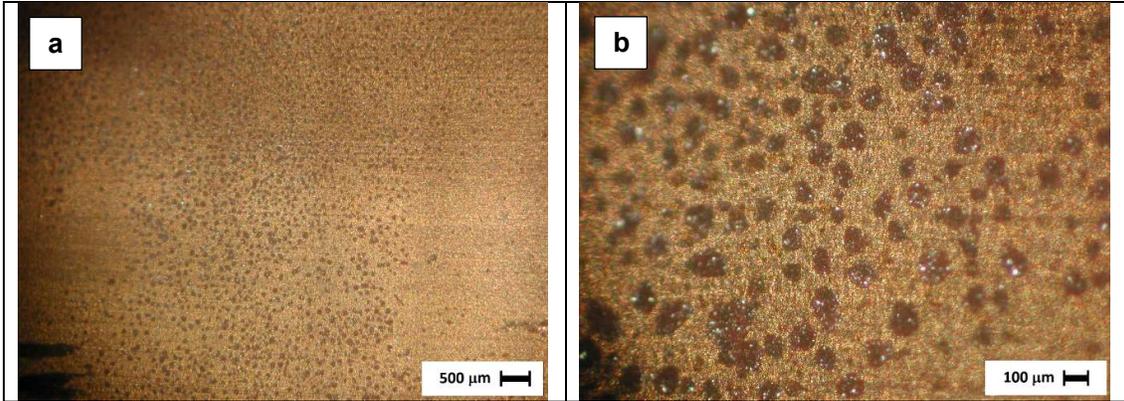
Figure 3: area "A" from Figure 2 (inner surface of U-tubes) magnified by stereo microscope. (a) lower magnification; (b) higher magnification.

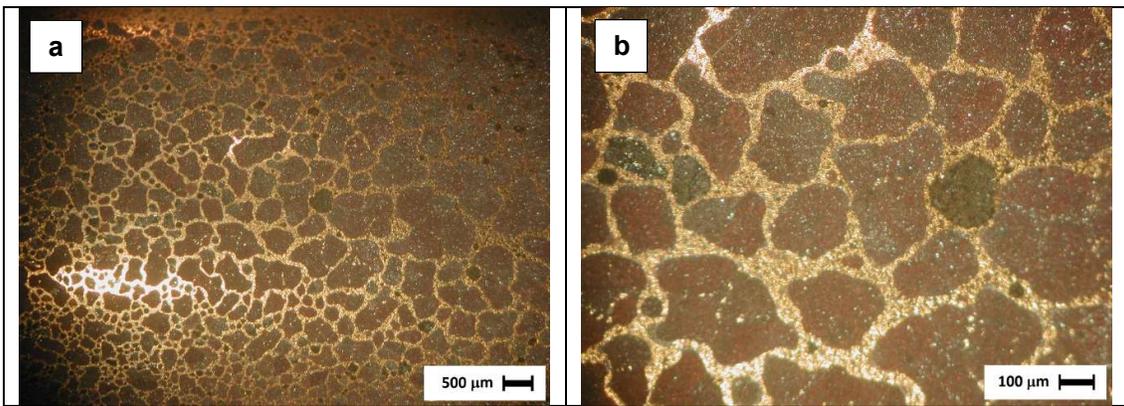
Figure 4: area "B" from Figure 2 (inner surface of U-tubes) magnified by stereo microscope. (a) lower magnification; (b) higher magnification.

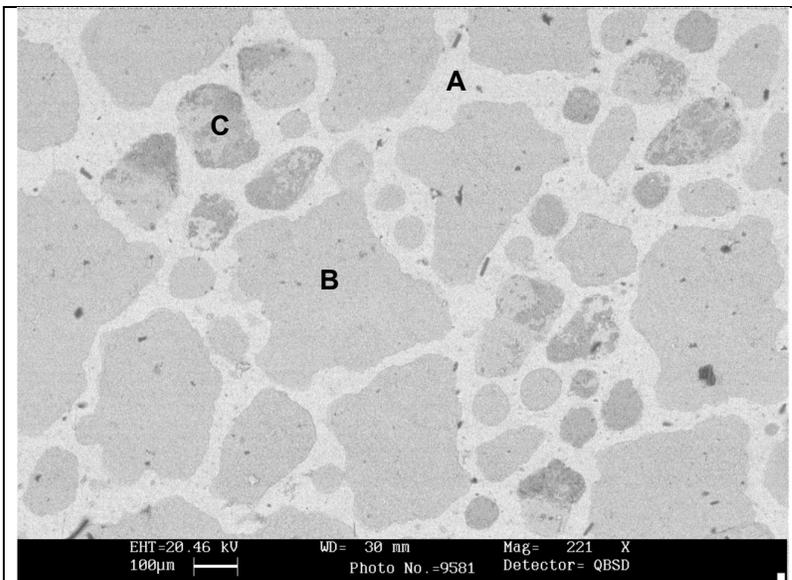
Figure 5: dark spots on inner surface of U-tubes from Case 1 examined at SEM. (A): bright area; (B): light grey area; (C) dark grey area.

SEM images (Figure 5 - backscattered electrons contrast: higher atomic number appears brighter) show dark areas surrounded by a brighter matrix. Comparing these images with SM, and taking into account different colors of Cu-based compounds and atomic numbers of Cu and O, we can speculate the composition of the different areas. Bright areas (“A” in Figure 5) are identifiable as Cu (higher atomic number; bright and reflective in optical images), light grey areas (“B” in Figure 5) as  $\text{Cu}_2\text{O}$  (dark red in optical images) and dark grey areas (“C” in Figure 5) as  $\text{CuO}$  (black in optical images; this compound is the one having the lowest average atomic number). EDS on these areas (Figure 6) pointed out a higher O/Cu ratio in “C” respect to “B”, fitting with the compounds assignments.

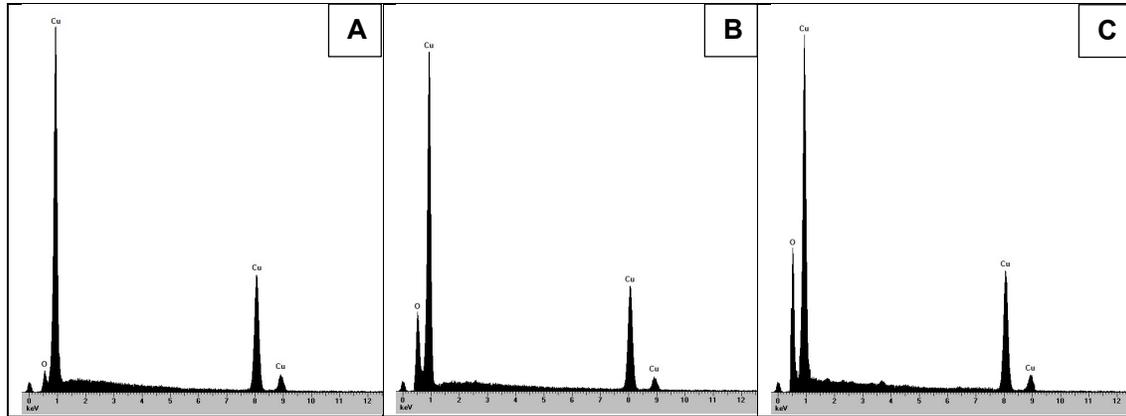
**Figure 6: EDS of inner surface of U-tubes from Case 1: (A): bright area; (B): light grey area; (C) dark grey area.**

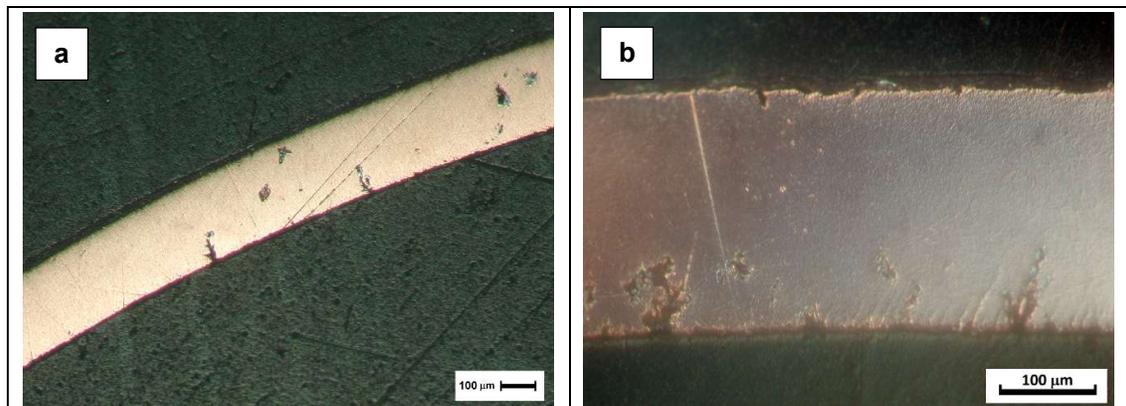
Optical images (Figure 7 and Figure 8) of metallographic sections show pit damage starting from the inner towards the outer surface of the tube. Smaller pits appear also on the outer surface. Some damaged areas emerge in the middle of the pipe wall. Higher magnification images show bright red precipitated inside the pits.

**Figure 7: failed tubes from Case 1 - metallographic section observed at stereo optical microscope. (a) lower magnification; (b) higher magnification.**

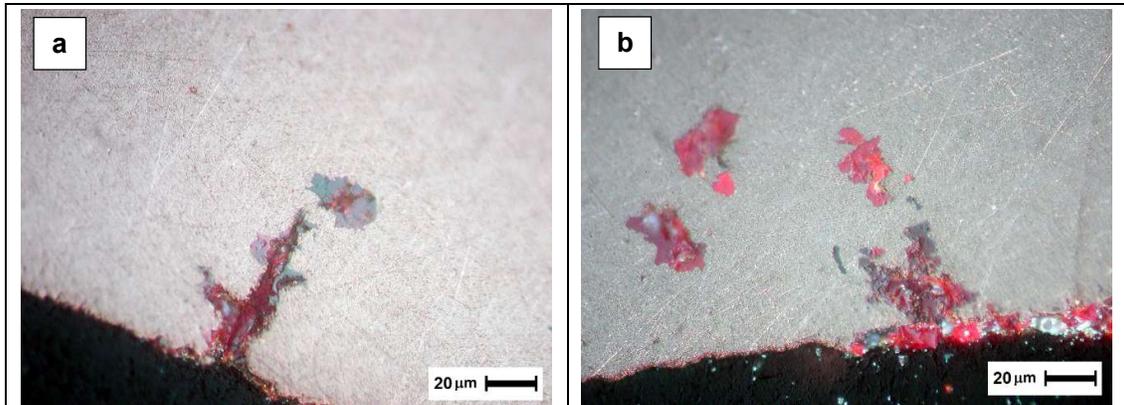
**Figure 8: failed tubes from Case 1 - metallographic section observed at optical microscope (higher magnification details of tunnels); (a) shows a pit growing from internal towards external surface; (b) shows some pits passing longitudinally through the wall**

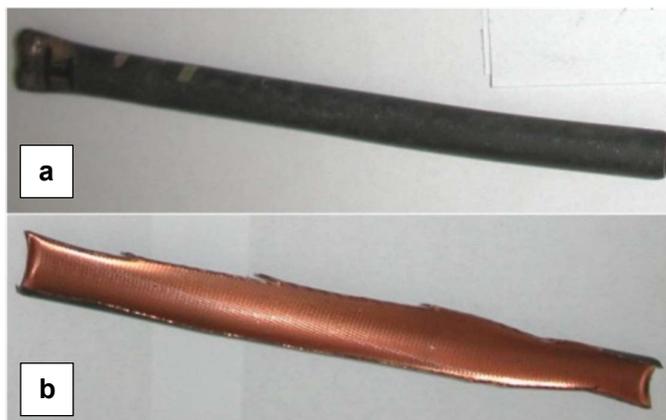
This case reports on a failed shell-and-tube heat exchanger from an office air conditioning system. Tubes are internally grooved; they have an outer diameter of 8 mm and a wall thickness of 0.28 mm; the outer surface is smooth; the tube material is copper. The conveyed fluid was a R-134 (1,1,1,2-tetrafluoroethane); the external fluid was water. The heat exchanger leaked after 1 years of operations. After manufacturing, pressure test was performed with water and no leakage was detected. After test, pipes were drained, sealed and then stored for 5 months before commissioning. A specific drying procedure before sealing and storing was not planned. A black crust can be observed on the outer surfaces of the tubes (Figure 9a); this crust has been identified by XRD as mixture of CuO and Cu<sub>2</sub>O (Figure 10). Some areas of the crust were detached, revealing red spots (Figure 11a). After SEM/EDS observation, these areas were identified as pits with inner deposits of Cu<sub>2</sub>O, due to the higher O/Cu ratio respect to the dark spots (Figure 12). Pipe section show pits growing from external wall towards the inside (optical microscope: Figure 13a; SEM: Figure 13b,c).

**Figure 9: failed tube from Case 2 - (a) external surface; (b) internal surface.**

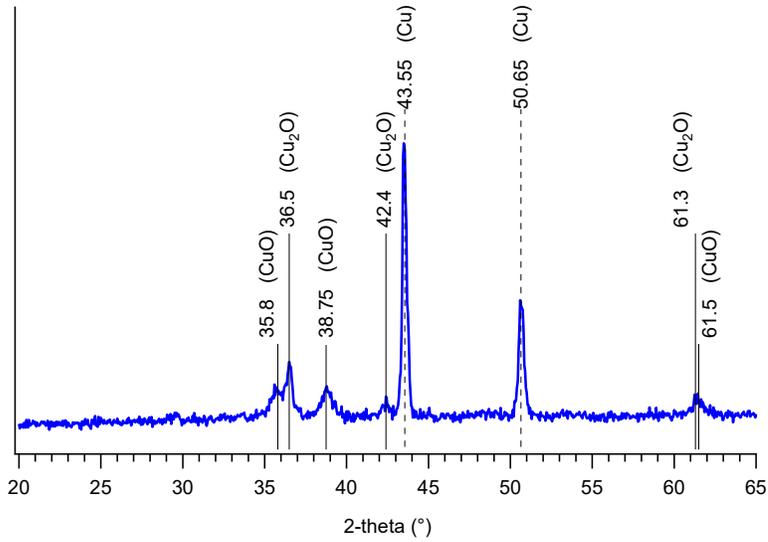
Figure 10: XRD on external surface of failed tube from Case 2

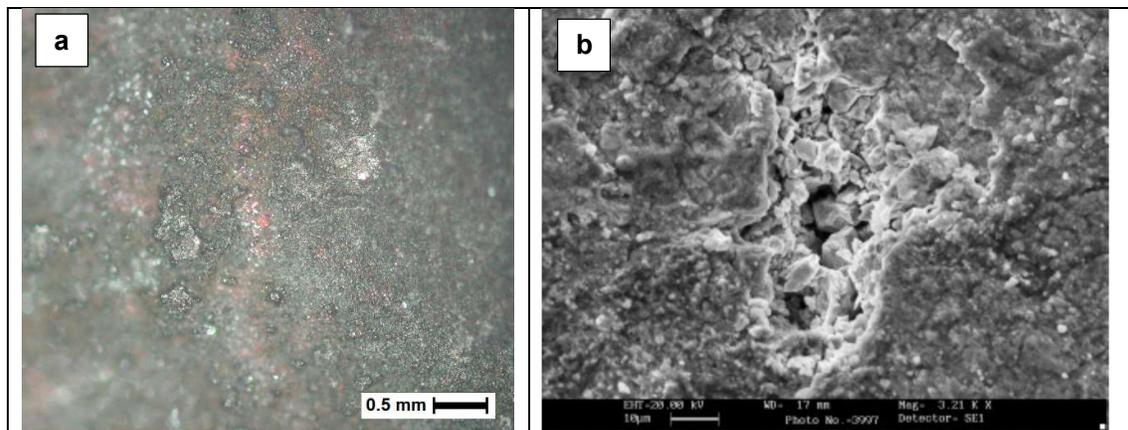
Figure 11: failed tubes from Case 2 – external surface; (a) examined at optical microscope and (b) SEM detail of the pit.

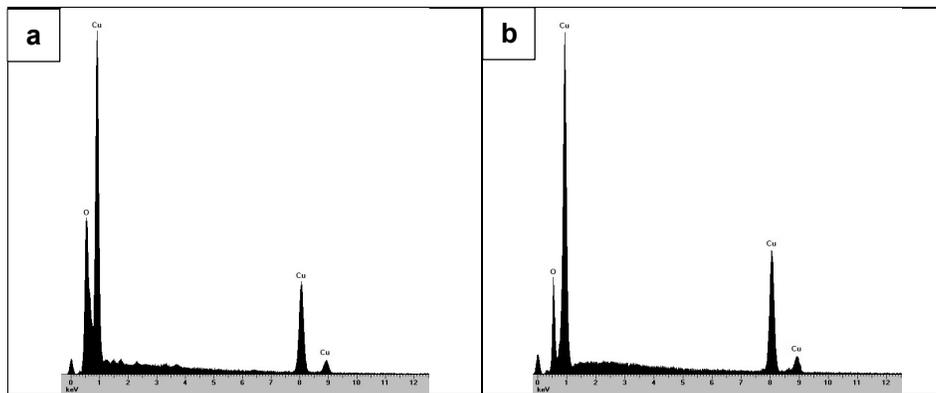
Figure 12: EDS of failed tubes from Case 2: (a) red deposit inside the pit; (b) dark external crust

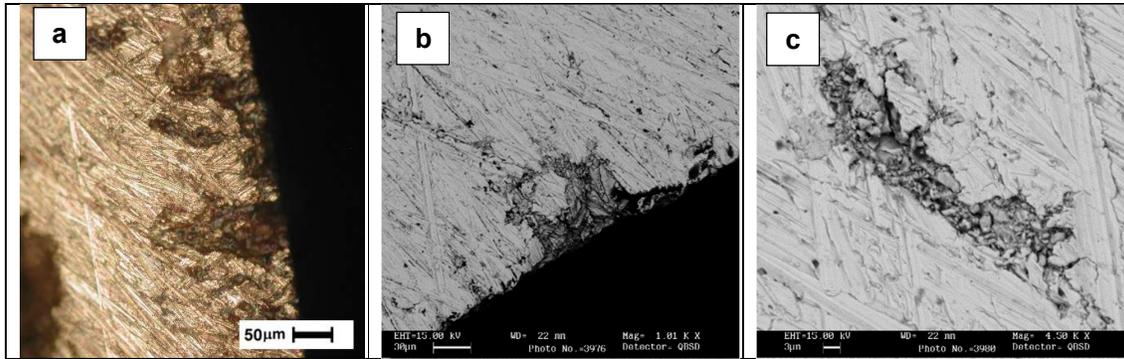
**Figure 13: failed tubes from Case 2 – metallographic section showing pit growing from external towards internal surface; (a) examined at optical microscope and (b,c) SEM. (b) shows a pit passing longitudinally through the wall.**

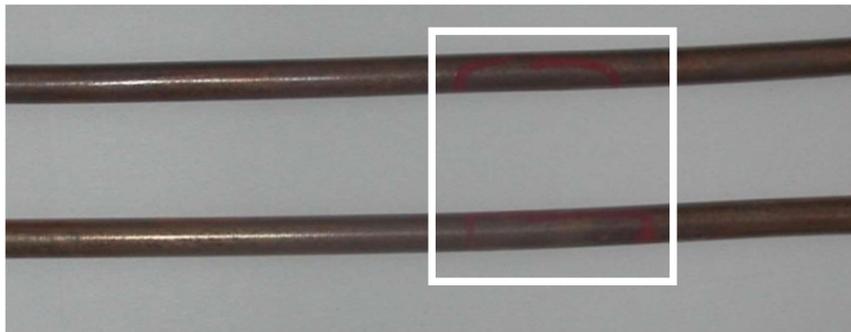
This case is similar to Case 2, but pipes derived from a different heat exchanger installed in a shopping mall in another location (pipes are shown in Figure 14). Tube material, geometry and components history are the same as those reported for Case 2. After trial tests, pipes were drained, sealed and then stored for 2 years. No specific drying procedure was applied. Leaking failure happened just after commissioning.

**Figure 14: failed tubes from Case 3 – leakage area is highlighted in the white rectangle.**

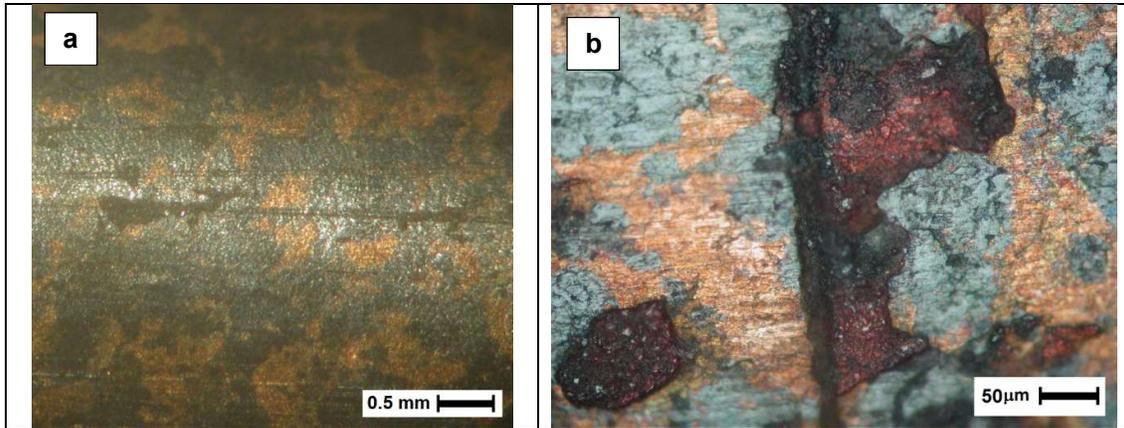
Greenish crusts, black and red deposits were observed on outer surface (Figure 15). Metallographic inspection points out pits growing through the wall section, from outside towards inside (Figure 16). Several elements (Si, S, Cl, K, Ca, Fe) in addition to Cu and O were detected by EDS in the external crust (Figure 17). XRD of external crust (Figure 18) reveals the presence of CuO, Cu<sub>2</sub>O and basic copper carbonate. Corrosion morphologies similar to those already seen in Case 2 were observed on the internal wall.

Figure 15: failed tubes from Case 3 - external surface; (a) examined at stereo microscope and (b) optical microscope.

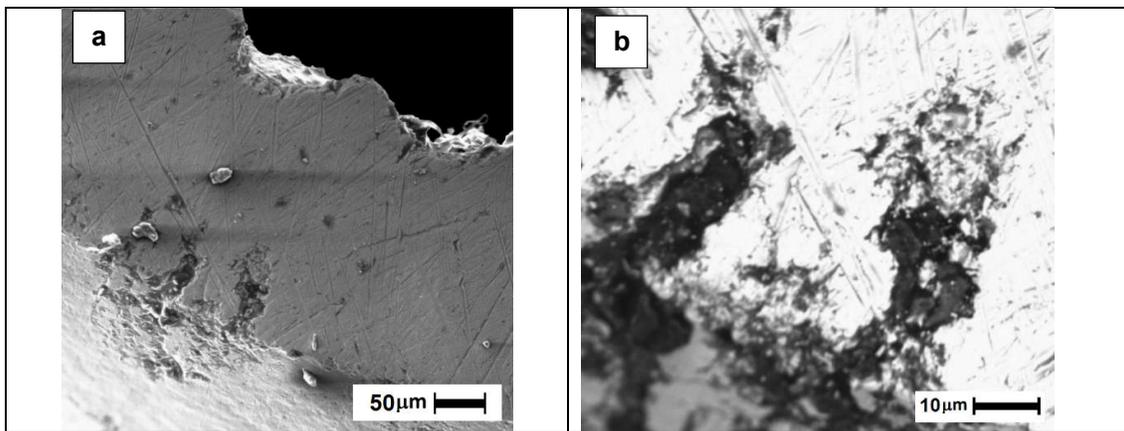
Figure 16: failed tubes from Case 3 – metallographic section showing pit growing from external towards internal surface, examined at SEM. (a) lower magnification; (b) higher magnification

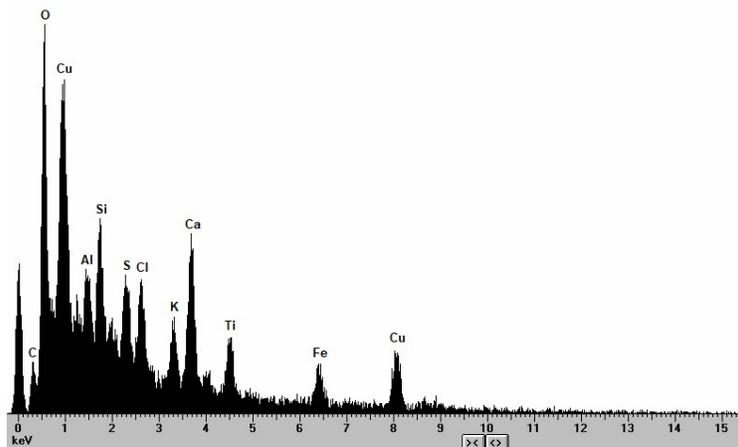
Figure 17: EDS on deposits of failed tube from Case 3

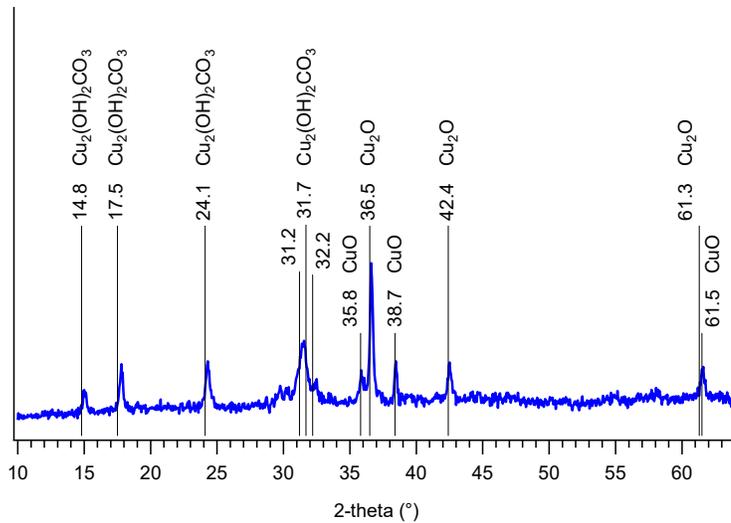
**Figure 18: XRD on external surface of failed tube from Case 3**
