An enquiry into the causes of an explosion accident occurred in a biogas plant

Marco Boscolo¹ | Luigi Bregant¹ | Stefano Miani² | Elio Padoano¹

¹Department of Engineering and Architecture, University of Trieste, Trieste, Italy

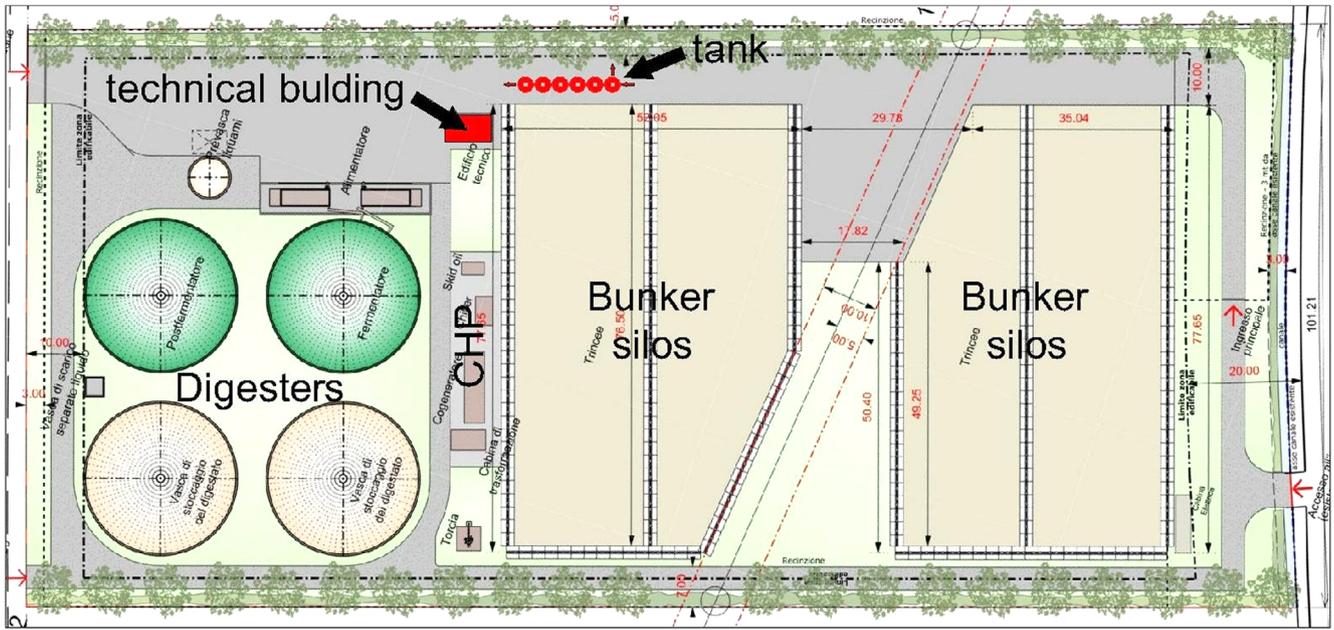
FIGURE 1 Layout of the biogas plant (the technical building is highlighted in red) [Color figure can be viewed at wileyonlinelibrary.com]

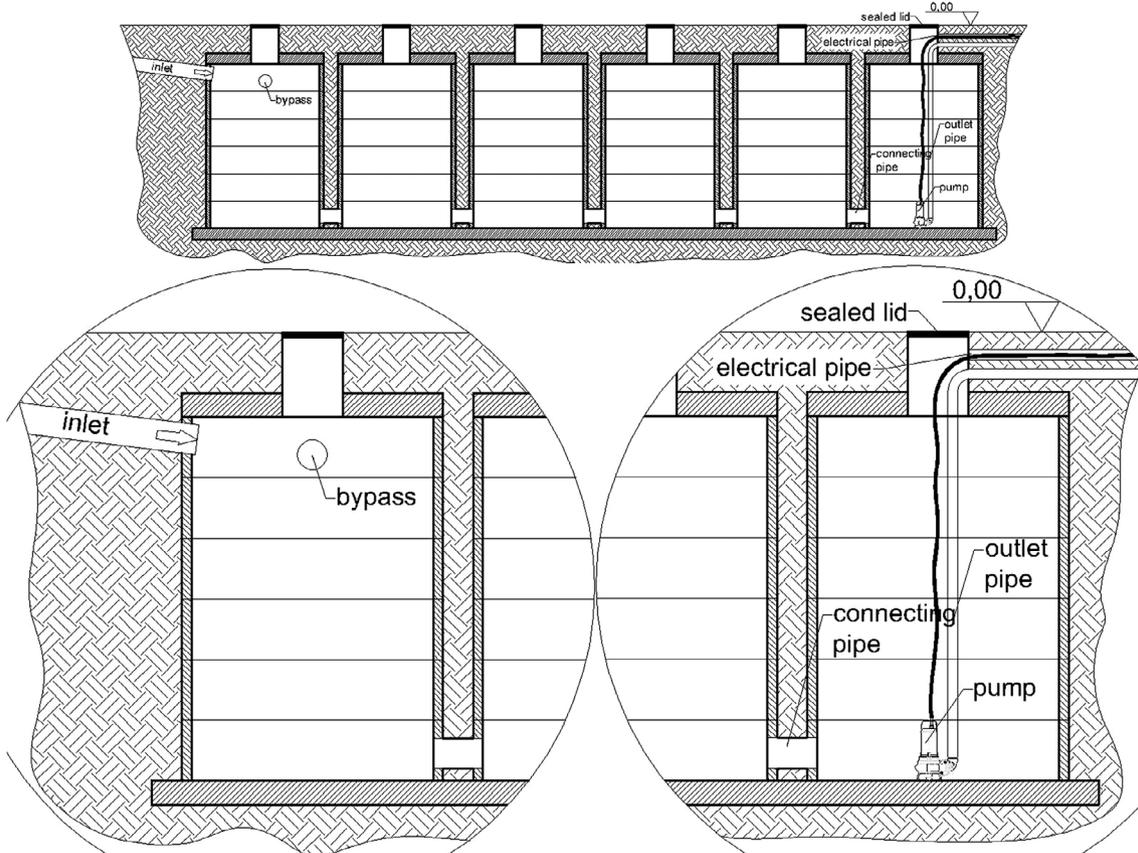
FIGURE 2 Cutaway view of the leachate tank

drainage system will convey the storm-water, rich of leachate, to a dedicated retention tank. When the tank is full, the subsequent storm-water, with negligible quantity of leachate, bypass it and reaches the ground. The system is effective when the tank is empty at the beginning of the rain, and it needs to be emptied within 48 hours after the beginning of the downpour, as the plant's operational guide foresees, with a submersed pump in the leachate tank, consisting of six interconnected concrete basins (total capacity 55 m³) (see Figure 2).

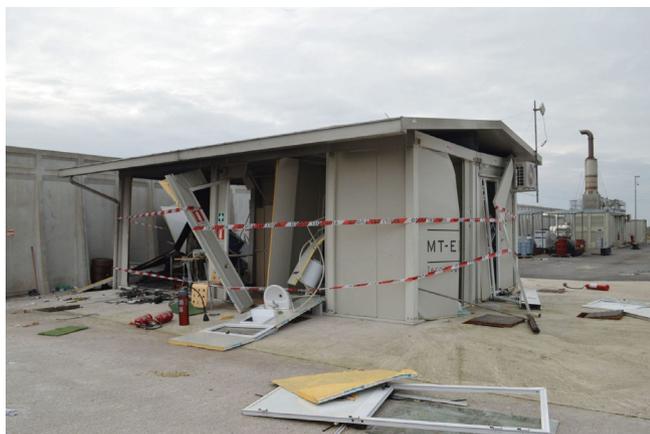
The explosion, as by the surveillance system data, occurred at 05.00 AM in the prefab where the changing room and monitoring and control equipment were located. The explosion resulted in the dislocation of the flooring of the building and the electrical equipment laying on it and the side walls (Figure 3). Inside the building, burnt furniture evidenced the presence of fire after the explosion. The fireman's record confirmed biogas presence in the electric manholes and the electrical room, which is located in a container roughly 200 m away from the building where the explosion occurred. The firemen extinguished the fire and, to prevent further biogas formation, opened all the digesters. Given the presence of biogas in the electrical piping network, all the manholes were opened as well.

FIGURE 3 The technical building after the accident [Color figure can be viewed at wileyonlinelibrary.com]

About 20 days after the accident, during the inspection of the plant, methane traces could still be found in the inspection manholes of the underground electrical piping system. The examination of the damaged building suggested that the explosion took place inside it, likely due to an explosive biogas mixture detonated by the electrical appliances. The enquiry aimed to find the path through which biogas could have reached the technical building, since there were no evident connections between the building, the underground distribution network, and the biogas production facilities (digesters, CHP, etc.), which were not affected by the explosion.

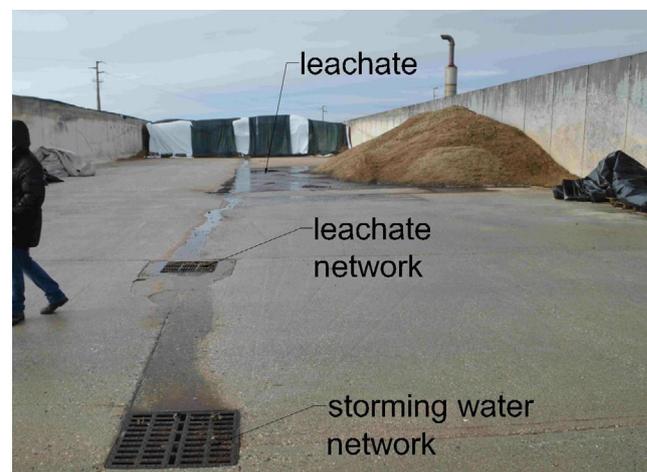
Another relevant aspect was the unusual leachate routing from the bunker silos. As shown in Figure 4, the manhole grates present a protrusion that prevent the catch basin from collecting the leachate waters, which can thus bypass the leachate tank and flow directly into the storm-water tank. The storm-water tank, along with a water-tight manhole, constitutes a hermetically sealed system, where anaerobic conditions are met and methane production can set.

FIGURE 4 Storm-water and leachate catch basins [Color figure can be viewed at wileyonlinelibrary.com]

As for point (ii), the formation of an explosive mixture in the technical rooms and electric transformer cabins should be avoided. To this aim, notwithstanding the somehow negligent operating behavior, it must be said that, according to the inherent safety operational approach,⁹ the adoption of a grated manhole rather than a sealed one would have avoided the explosion. The grated manhole would have prevented the anaerobic biogas formation while allowing biogas dilution and dispersion in the atmosphere. It seems thus natural to conclude that a reconsideration of the security levels of all the underground electrical piping and their proper aeration is needed.

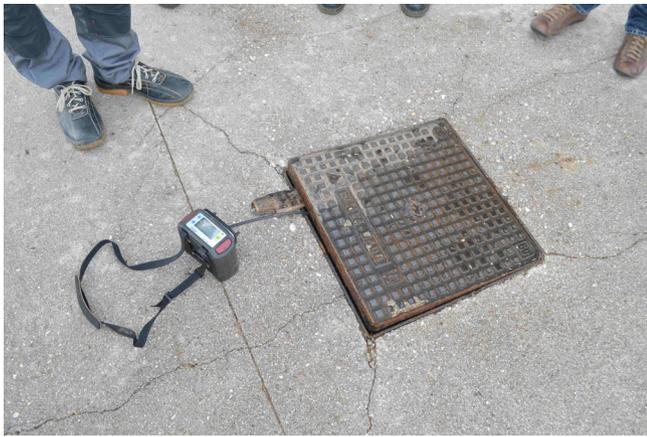
FIGURE 5 The analyzer probe during measurement [Color figure can be viewed at wileyonlinelibrary.com]

by the leachate flow. The assessment was carried out analyzing the composition of the gas present in the storm-water tank, inserting the analyzer probe in all six basins, by slightly lifting the sealed manhole lids (see Figure 5). Measurements were taken immediately after the probe insertions to limit the dilution effects (Table 1). To verify the connection between the storm-water tank and the building through the pipe, CO₂ was injected in the service manhole close to the tank and fumes at the other end of the pipe were detected.

The enquiry confirmed the presence of methane in all six basins. The presence of hydrogen sulphide (H₂S) and carbon dioxide (CO₂) was also recorded. The water temperature measured inside the storm-water tank, 20 days after the accident, was 15.1°C. Because of the thermal inertia, high volume, and the season, it is reasonable to assume that the temperature prior to the accident was about the same or higher. The gas composition measures showed oxygen concentrations sensibly lower than those normally present in the atmosphere (although not null). The carbon deposition on the sealed manhole walls was also evidence of low oxygen digestion process.

As for the measurements taken in the first basin, which is actually the only one directly connected with the technical building through the control and power line (to activate the submerged pump), a methane concentration of 32 mol% was recorded. Such concentration is sufficient to form an explosive mixture when diluted with air.⁸
