# Fracture of cobalt-chrome modular neck in total hip arthroplasty

**Summary.** Despite the advantages of modular total hip arthroplasty in terms of neck version, offset and length precise reproduction, titanium necks breakage became a concern. Consequently, titanium has been replaced by cobalt-chrome (Co-Cr). However, four cases of Co-Cr modular neck breakage have been reported in the literature. In the present paper, two cases of Co-Cr modular neck fractures are described together with a literature review. The aim of this work is to discuss the risk factors and characteristics of this rare complication. We described two cases of fracture of long varus Co-Cr modular femoral neck connected with cementless press-fit stem. Some risk factors, such as long varus type of modular neck, overweight and/or high demanding physical activity, might have contributed to implant failure. ([www.actabiomedica.it](http://www.actabiomedica.it))

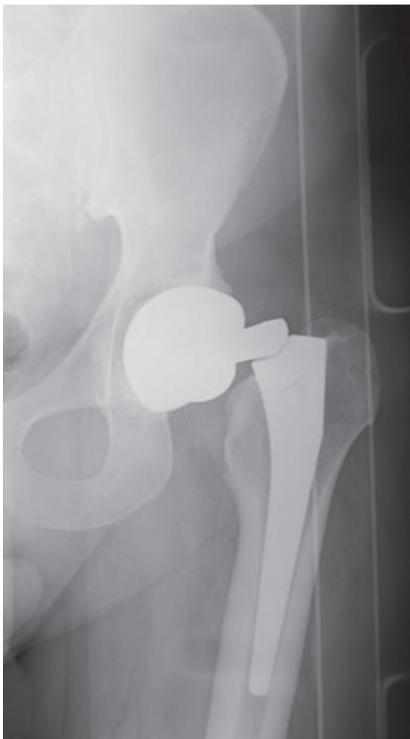
a Bilox Delta size 36 head. Postoperative radiographic control showed a correctly placed hip prosthesis, with a regular post-operative course. The patient resumed his daily activities without limitations or pain. In June 2015 (4 years postoperatively), the patient heard a crack from his left hip while he was jumping from a one-meter high wall. Thereafter, he referred severe hip pain with motion and inability to weight bearing on the affected limb. The patient came at the emergency department at our Institution, where left hip radiographs were taken demonstrating a fracture of the modular neck at the stem-cone junction (Fig. 1a). Both acetabular and femoral components seemed to be well fixed, and the femoral head remained attached to the proximal fragment of the modular neck. There were no clinical, radiographic or laboratory signs of infection.

**Figure 1a.** Case 1. Left hip AP view radiographs showing a fracture of the modular neck at the stem-cone junction

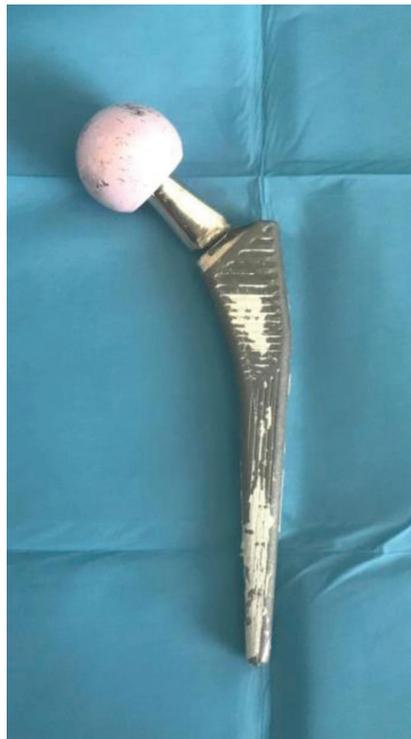
After 4 days, the patient underwent revision total hip arthroplasty through a postero-lateral approach to the left hip. The modular neck fracture resulted to be complete with fragmentation at the stem-neck junction.

Minimal fretting and corrosion damage on the surface that had mated with the femoral stem was observed (Fig. 1b). No macroscopic signs of metallosis were observed, thus no serum metal levels were obtained. Surgical intervention included femoral head and neck removal, accurate debridement of soft tissues and removal of the well-fixed stem through a Wagner femoral osteotomy. Finally, a cementless Lima Revision stem (Lima Corporate, Udine, Italy) with cerclage wires to stabilize the femoral osteotomy was implanted (Fig. 1c). The bearing surface was ceramic on poly with a Bilox Delta head size 36 head. Intraoperative microbiological cultures confirmed the absence of infection.

**Figure 1b.** Case 1. Photograph showing the removed stem, neck and prosthetic head. A complete fracture of the modular neck occurring at the stem-neck junction is visible

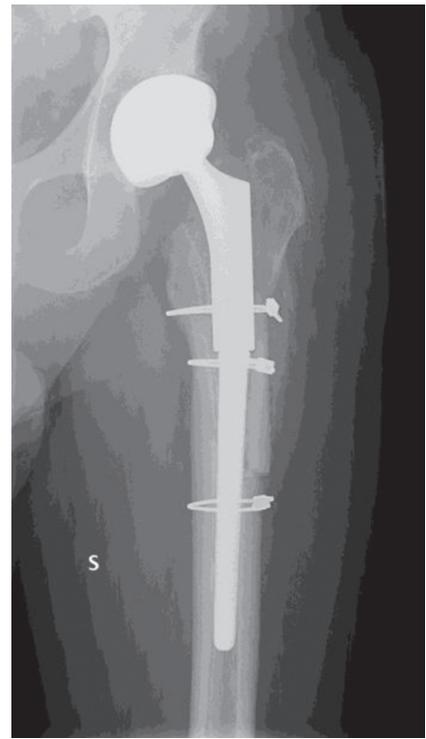
**Figure 1c.** Case 1. Left hip AP view post-operative radiographs showing implant revision

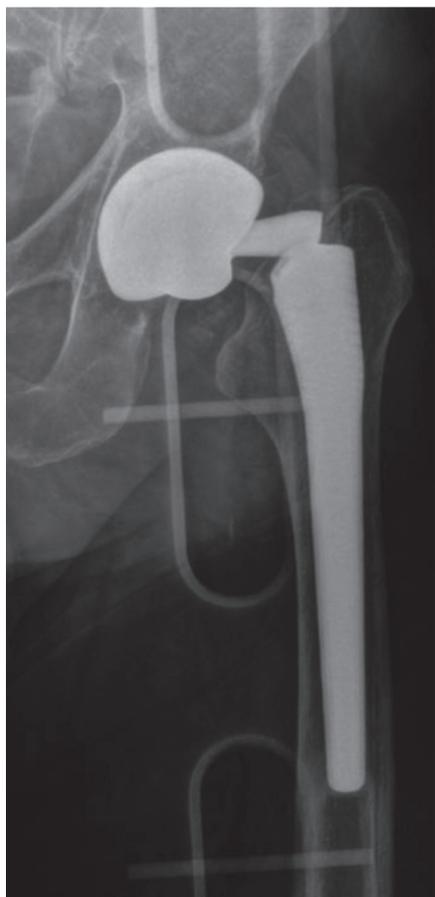
Postoperative course was uncomplicated. After 4 years from the index procedure, the patient referred to the emergency department for acute left hip pain with a subjective feeling of instability, without any reported traumatism. Radiological evaluation showed a fracture of the modular neck at the stem-cone junction (Fig 2a). The acetabular and femoral components resulted to be intact. There were no clinical, radiographic, or laboratory signs of infection.

**Figure 2a.** Case 2. Left hip AP view radiographs showing a complete fracture of the modular neck at the stem-neck junction

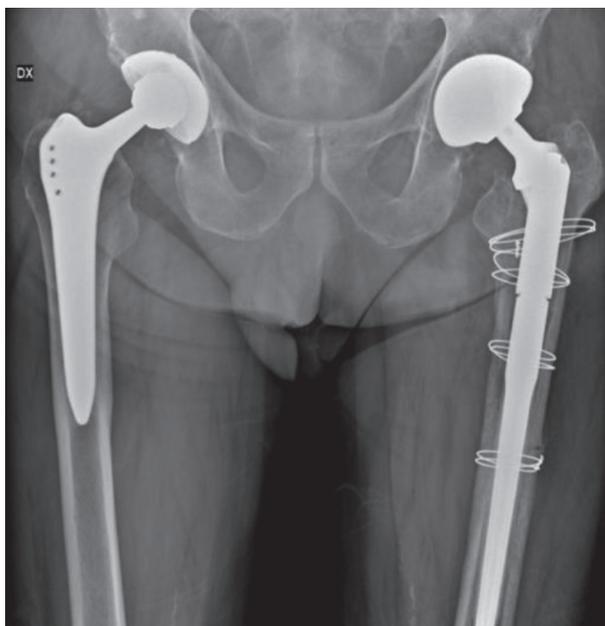
**Figure 2b.** Case 2. Pelvic AP view post-operative radiographs showing implant revision of the left hip

signs of metallosis, no iron particles or fibrosis were seen. Periprosthetic soft tissue were free from relevant alterations, being the fracture of the neck the only pathological feature. The well-fixed stem was removed via a Wagner's osteotomy, and revised with a MP Reconstruction Prosthesis (Waldemar Link, Hamburg, Germany). Four cerclage wires were inserted to secure the osteotomy (Fig. 2b).
