CASE REPORT

Two stage fracture of a polyethylene post in a 9-year-old posterior-stabilized knee prosthesis: a case report

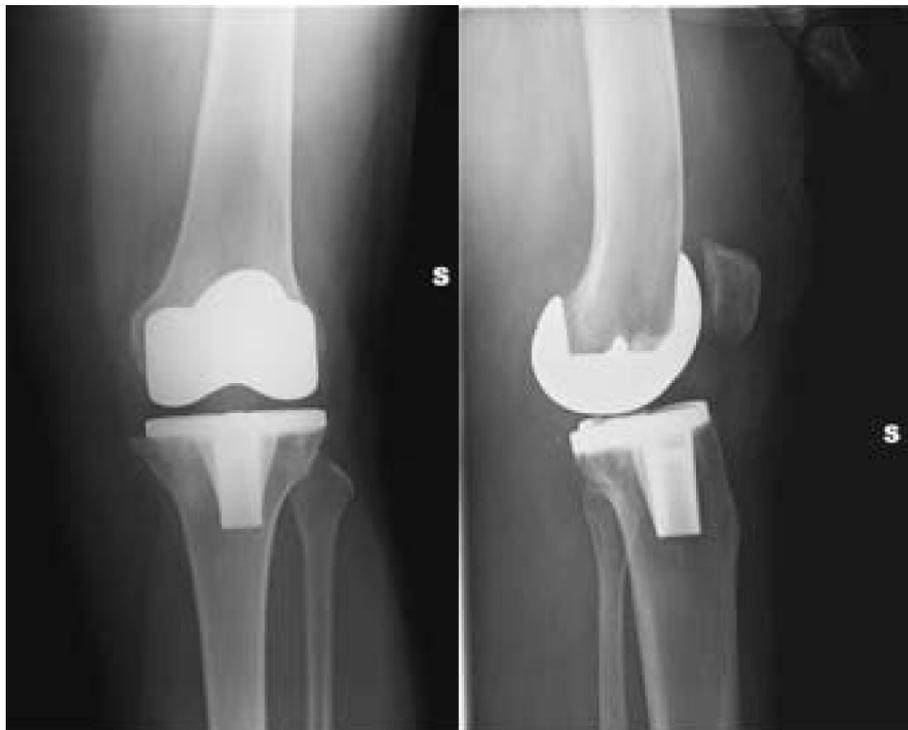
acute event she was unable to bear weight on her left knee, and was thus forced to use crutches. On physical examination she presented a mild effusion of the knee, a flexion of 90°, and knee hyperextension. The joint presented signs of both anteroposterior and varus to valgus instability. X-ray examinations showing the anteroposterior view of the knee did not indicate any remarkable alteration in polyethylene wear, while the lateral view showed a hyperextension of the tibia with a posterior subluxation of the femur (Figure 1). The hypothesis of post breakage was thus made.

Figure 1 Preoperative X-rays. The hyperextension of the tibia in relation to the posterior subluxation of the femur can be seen.

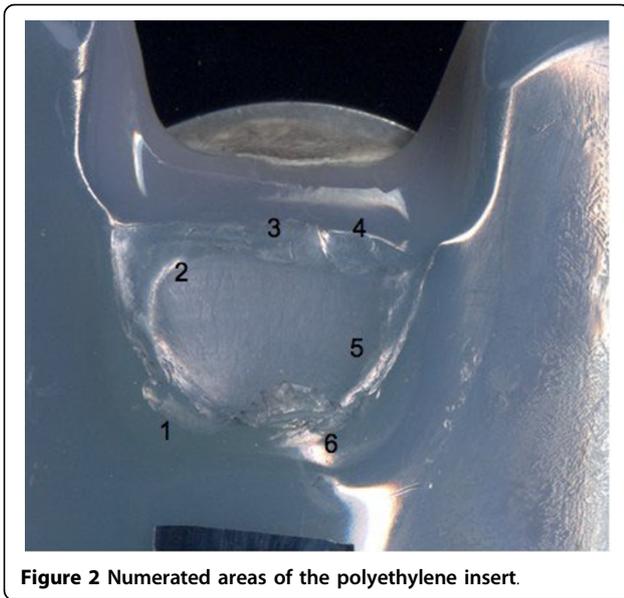
The polyethylene insert and the broken post were both prepared for scanning electron microscopy (SEM) evaluation (Figure 2).

Figure 2 Numerated areas of the polyethylene insert.

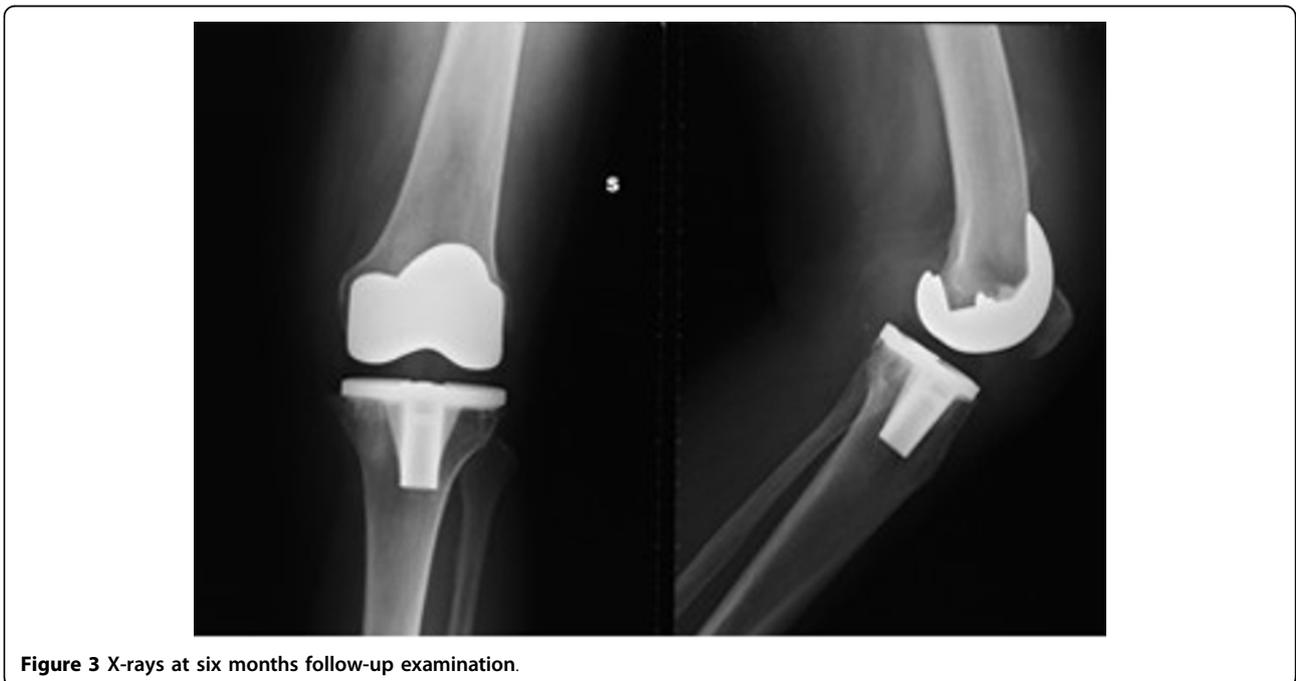
At six months follow-up the patient had recovered complete function of her left knee. She was free from pain and could walk normally without any support (Figure 3).

Figure 3 X-rays at six months follow-up examination.

The total knee components appeared to be well fixed intraoperatively. The polyethylene insert was substituted

with a 12-mm CD LPS Flex articular surface (Zimmer, Warsaw, Indiana, USA). The stability in full extension, mid-flexion, and full flexion of the knee was tested intraoperatively, and appeared to be good. The patient had no postoperative complications and recovered well.

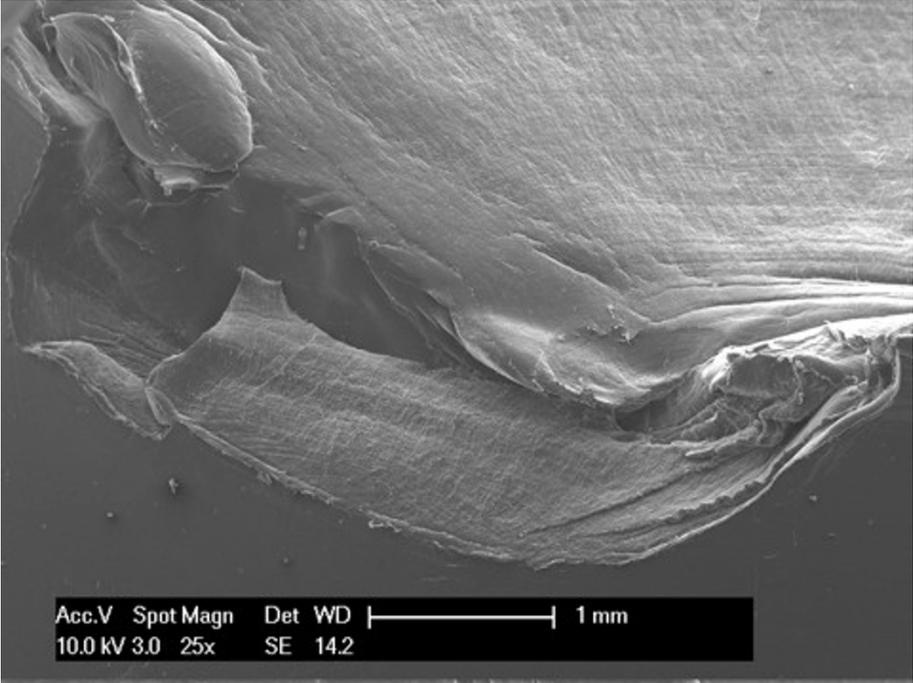
Scanning electron microscopy, as reported in the literature [14,18], is an effective modality for analyzing the surface of fatigue fractures. An evaluation of the retrieved tibial polyethylene insert via SEM revealed two different damage patterns, considering the medial part and the lateral aspect (Figure 4). The medial part (Figure 2 areas 1, 2 and 3, Figure 4, Figure 5, Figure 6) presented a fracture line laminated in front and smooth behind and with the tear lines with a mediolateral and anterior posterior orientation.

Figure 4 Area 1 of Figure 2.

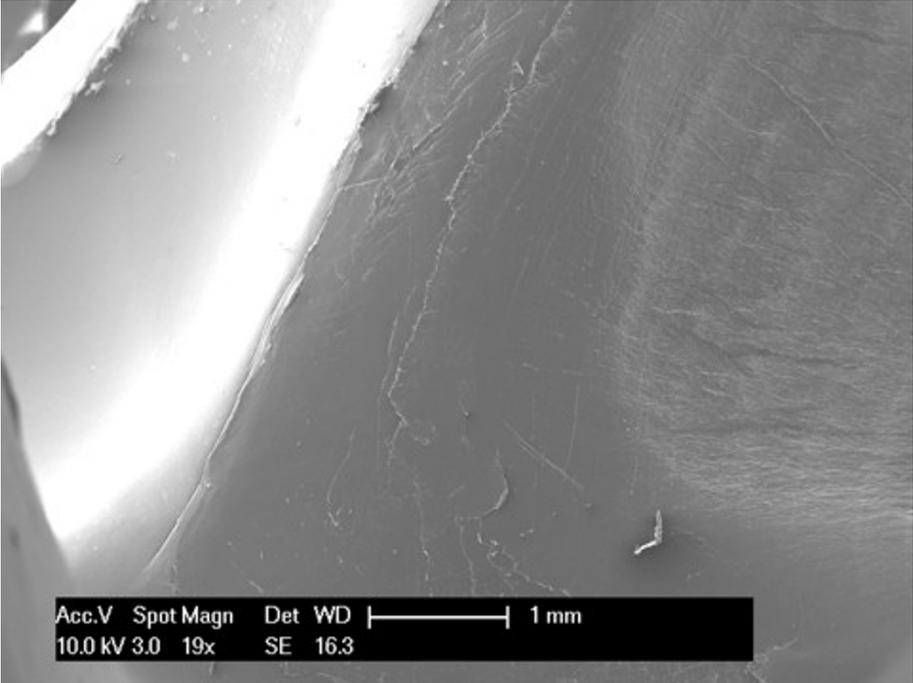
The medial part of the fracture edge appears to be smooth (Figure 2 areas 2 and 3) and with a different orientation of the fracture lines. These characteristics suggest a chronic instability of the varus valgus knee prosthesis that slowly weakened the polyethylene post.

Figure 5 Area 2 of Figure 2.

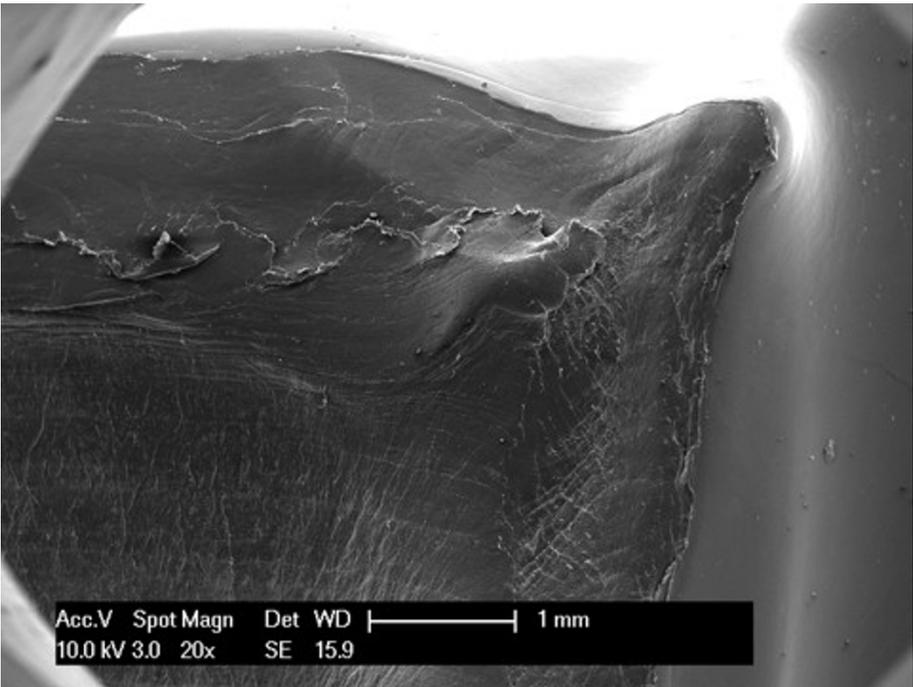
Figure 6 Area 3 of Figure 2.

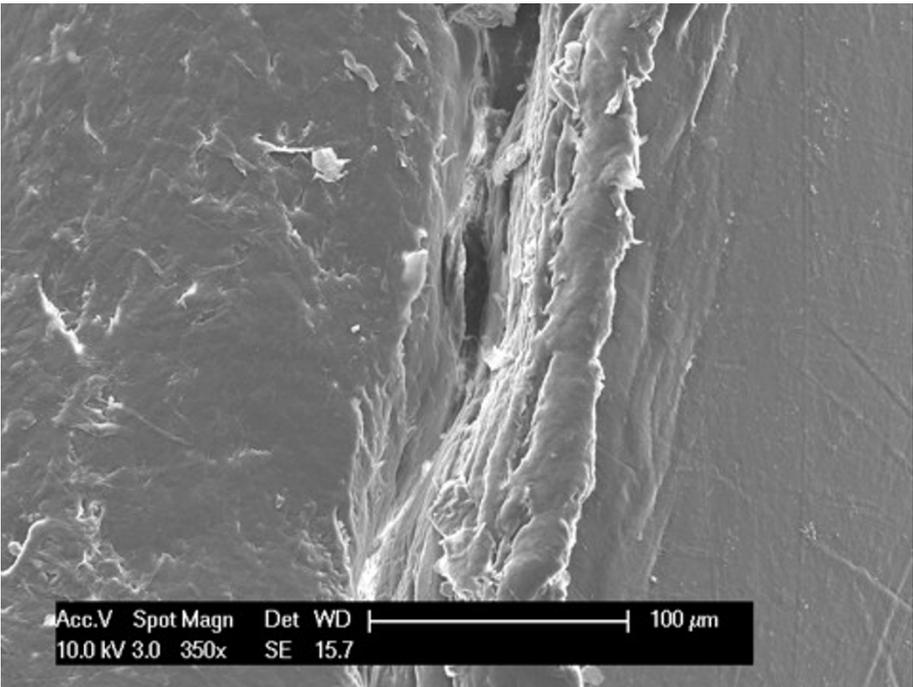
Meanwhile, the lateral part (Figure 2 areas 4, 5 and 6, Figure 7, Figure 8, Figure 9) of the fracture presented a sharp line that ends anteriorly with a laminated tear (Figure 2 area 6, Figure 9) parallel to the anterior edge of the polyethylene insert. This implies that this area could be the terminal acute failure area of the fractured post. The final rupture occurred after the chronic weakening of the polyethylene due to the mediolateral stress on the tibial post. These features could be explained with a two-stage rupture of the polyethylene post. First, a varus and anteroposterior force caused partial rupture and instability of the post, which caused progressive smoothing of the medial and posterior fracture edges. Consequently, an anteroposterior lift-off force led to the complete rupture of the post. This could have been

Figure 7 Area 4 of Figure 2.

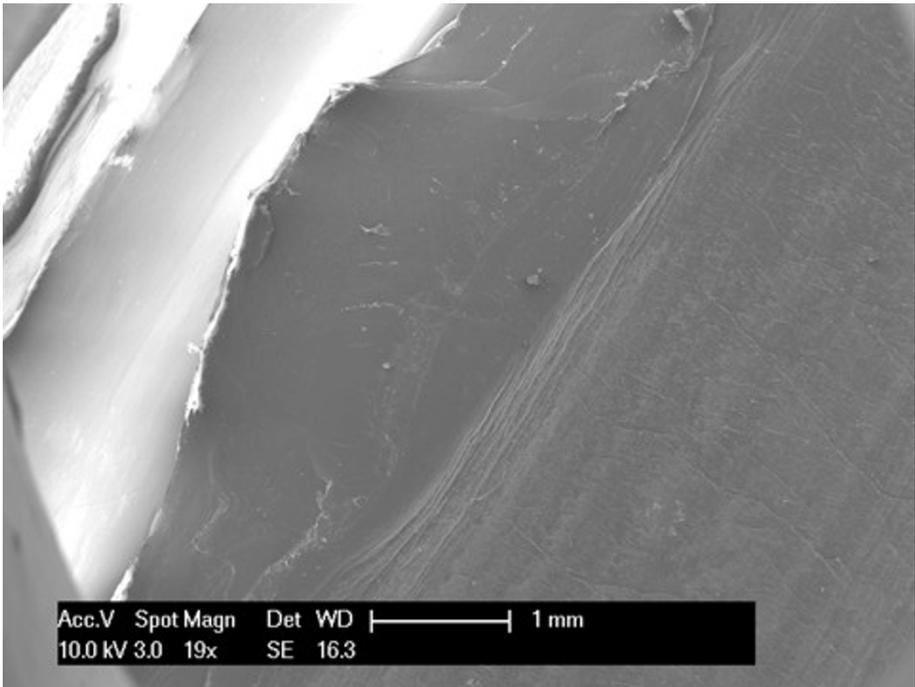
Figure 8 Area 5 of Figure 2.

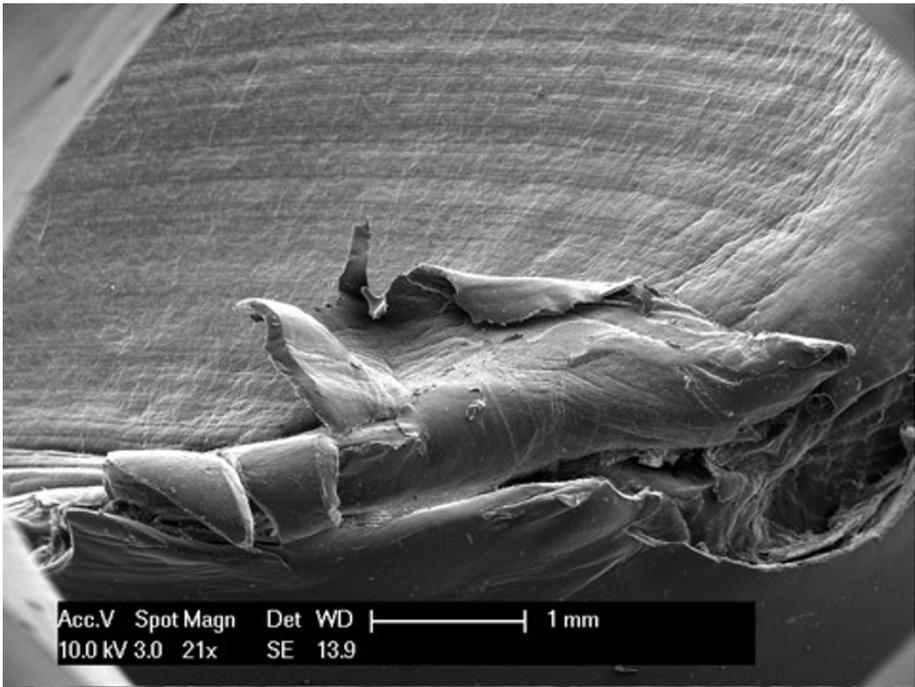
Figure 9 Area 6 of Figure 2.

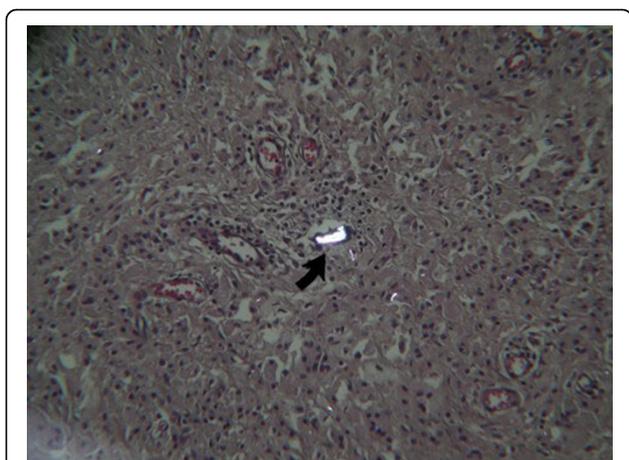
Figure 10 Dense connective tissues with typical inflammatory cells and rare polyethylene flakes (arrow) are identifiable.

Light microscopy evaluation showed a typical chronic inflammatory reaction. Rare polyethylene flakes were identifiable under polarized light. These particles appeared to be well-controlled by giant cells. No metallosis was observed (Figure 10). Von Kossa staining returned negative results. Such findings can be considered normal synovia in TKA. The absence of polyethylene particles confirmed the macroscopic evidence of the absence of wear, which could have caused the breakage.
