Chemical and physical analysis of phaco handpiece tip surfaces before and after cataract surgery

J Cataract Refract Surg 2017; 43:1107-1114 © 2017 ASCRS and ESCRS

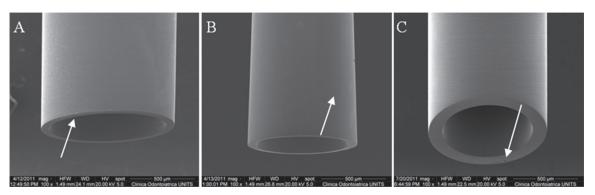
Figure 1. Scanning electron microscope images of new tips. A: Laminar Flow 19-gauge 15-degree straight tip. B: Turbosonics miniflared ABS tip 30-degree Kelman 0.9 mm tip. C: MICS tip. White arrows indicate the minimal production superficial irregularities.

The SEM images showed all new tips were of good quality. The surface was smooth, and the end of the phaco tip presented a sharp, squared cutting edge (Figure 1). Rare and

minor production defects consisting of superficial scratches and material flaws were observed (Figure 1).

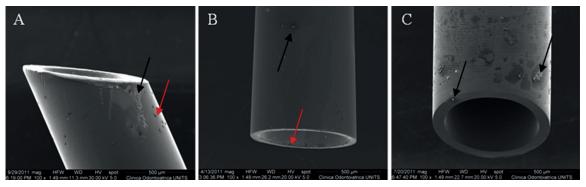
Figure 2. Scanning electron microscope images of tips after a single cataract procedure. A: Laminar Flow 20 gauge 30-degree curved tip. B: Turbosonics miniflared ABS tip 30-degree Kelman 0.9 mm tip. C: MICS tip. Black arrows indicate possible metallic debris and the red arrows, possible organic debris.

After cataract surgery, all tips showed superficial deterioration (Figure 2). Debris was found on the surface, mainly at the end of the tip. The nature of most of the debris appeared to be metallic, while others could have been organic in origin. The profile of the edge, previously squared, tended to be circumferentially rounded and irregular. The main area of alloy wear did not extend for more than 0.5 mm from the end of the tip. This region of deterioration was not homogeneous in shape, and the debris had collected in small clusters (Figure 2).

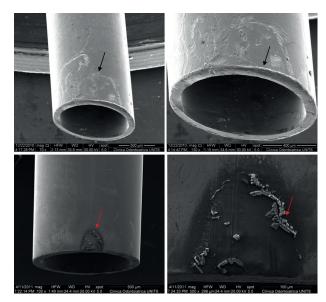
After 20 cataract cases, the decay in the quality of the tip was even more evident and the amount of superficial metallic rubble and irregularities was impressive (Figure 3).

Figure 3. Scanning electron microscope images of tips after 20 cataract cases (Laminar Flow 19-gauge 15-degree straight tip). Black arrows point to the irregular and rounded edge and surface scratches and the red arrows, to the superficial debris.

tip, this difference was statistically significant. The surface average roughness value after 20 surgeries (Laminar Flow 19-gauge 15-degree straight tip) was almost twice the value of the new samples.

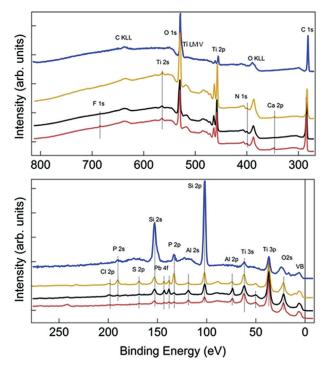
Figure 4 shows a sample comparison of the photoemission spectra recorded on the 2 Abbott Medical Optics tips, 1 Alcon tip, and 1 Bausch & Lomb tip. The surface chemical composition of the alloy between the 3 brands was similar, with minor differences, such as the presence of iron (Fe), Zn, sodium (Na), potassium (K), and calcium (Ca) in some tips and a relative amount of Al, Si, P, Pb, Cl, and F. This partially confirms the manufacturers' data regarding the construction materials used, which is a Ti–Al-vanadium (V) alloy.

Figure 4. Photoemission spectra measured using a photon energy of 900 eV on 4 new phaco tips. The red line represents the turbosonics mini-flared ABS tip 30-degree Kelman 0.9 mm tip; the black line, the Laminar Flow 19-gauge 15-degree straight tip; the yellow line, the Laminar Flow 20-gauge 30-degree curved tip; and the blue line, the MICS phaco tip. The elements that were identified in the spectrum are indicated. The numbers (eg, 1s, 2s, 3s, 2p) indicate the electron shell (identified by the principal quantum number; eg, 1, 2, 3) and the subshell (identified by s, p, d, f labels) within the atoms for each element. In these spectra, for the used photon energy (900 eV), the Ti LMV Auger peak superimposes to the V 2p core level region (AI = aluminum; arb. = arbitrary; C = carbon; Ca = calcium; CI = chlorine; F = fluorine; N = nitrogen; O = oxygen; P = phosphorus; Pb = lead; S = sulfur; Si = silicon; Ti = titanium; VB = valence band).

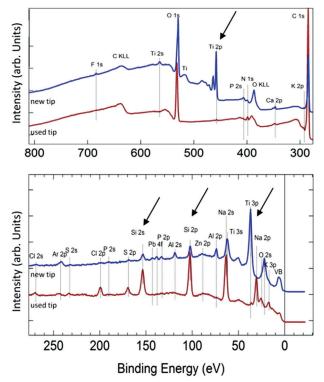
The main outcome was the increase in Na, Si, S, Cl, N, K, and C on the surface of the tip after surgery. As an example, Figure 5 shows a comparison between the photoemission spectra (collected at 900 eV) measured on 1 tip before use (new) and after use. The Ti peak is strongly reduced, while the Si and Na peaks show a significant increase. The tips after use appeared to be covered by a layer mainly composed of Na and Si.

Figure 5. Photoemission spectra, measured using a photon energy of 900 eV on a new and a used turbosonics mini-flared ABS tip 30-degree Kelman 0.9 mm. Note the difference in the Ti and Si peaks between the new tips and used tips (black arrows) (AI = aluminum; Ar = argon; arb. = arbitrary; C = carbon; Ca = calcium; CI = chlorine; F = fluorine; K = potassium; N = nitrogen; Na = sodium; O = oxygen; P = phosphorus; Pb = lead; S = sulfur; Si = silicon; Ti = titanium; VB = valence band; Zn = zinc).

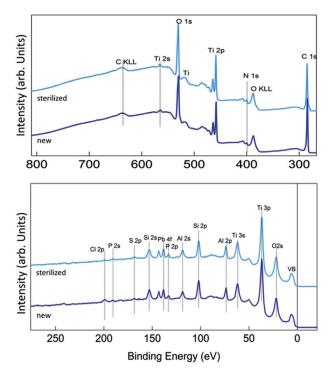
3 new phaco tips of each model were washed and sterilized as previously described for the used tips. The sterilization process did not increase the Si concentration on the surface of the new tips (Figure 6).

Figure 6. Photoemission spectra measured using a photon energy of 900 eV on a new phaco tip and a resterilized new phaco tip. No changes in the chemical composition or in the relative intensity of the peaks occurred (AI = aluminum; arb. = arbitrary; C = carbon; CI = chlorine; N = nitrogen; O = oxygen; P = phosphorus; Pb = lead; S = sulfur; Si = silicon; Ti = titanium; VB = valence band).

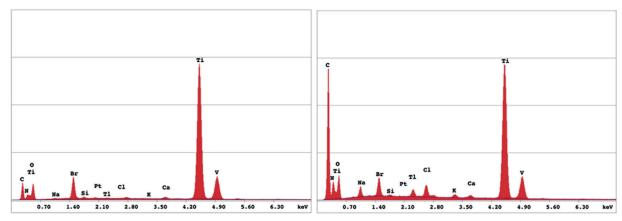
Energy Dispersive X-Ray Spectroscopy Energy dispersive x-ray spectroscopy showed that all the tips were made of a Ti alloy. The principal element detected was Ti followed by V and bromine, both in new tips and used tips. Minor elements, such as Na, K, Cl, C, and Ca were detectable, especially on used tips (Figure 7).

The debris on used phaco tips contained a high level of C, while on new phaco tips the presence of C was almost absent (Figure 7). Moreover the presence of C was low even on used tips when the analysis focused on the tip in an area free of debris. (Scanning electron microscopy images were used to guide the EDS analysis.)

The C peak was surprisingly high and equaled that of the Ti. The presence of C was constant in all used tips for which the debris areas were analyzed. The SEM imaging in the control group of new tips submerged in the enzymatic solution and resterilized did not show debris on the tips,

Figure 7. Example of EDS analysis of a new (*left*) and a used (*right*) phaco tip (turbosonics miniflared ABS tip 30-degree Kelman 0.9 mm). Analysis of the debris showed a high peak of C, which was almost completely absent on the bare shaft of the tip (Br = bromine; C = carbon; Ca = calcium; Cl = chlorine; K = potassium; kev = kilo electron volt; N = nitrogen; Na = sodium; O = oxygen; Pt = platinum; Si = silicon; Ti = titanium; Tl = thallium; V = vanadium).

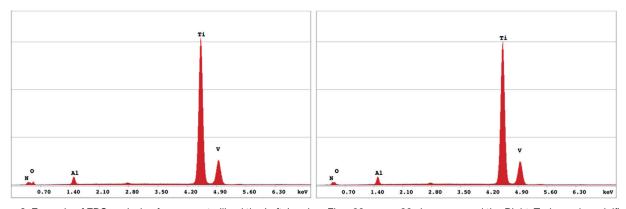
and the EDS analysis did not detect a C peak on their surface (Figure 8 and Figure 9, respectively). These data strongly suggest that the origin of the debris was related to biological material contamination after use.

Figure 9. Example of EDS analysis of a new resterilized tip. *Left*: Laminar Flow 20-gauge 30-degree curved tip. *Right*: Turbosonics miniflared ABS tip 30-degree Kelman 0.9 mm. No carbon peak was detected (AI = aluminum; kev = kilo electron volt; N = nitrogen; O = oxygen; Ti = titanium; V = vanadium).
