# Malfunction of cardiac devices after radiotherapy without direct exposure to ionizing radiation: mechanisms and experimental data

Accepted after revision 29 June 2015

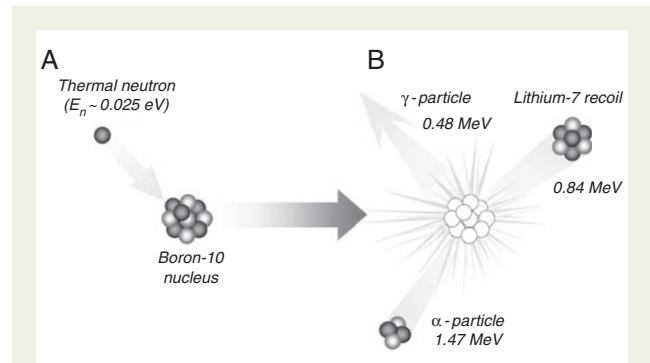
contained in memories and battery (Figure 1) and this can be source of PM and ICD malfunctions due to soft errors.<sup>5</sup> In a population study,<sup>1</sup> a low risk of damages was detected, but a beam energy  $\geq 15$  MV, often used for the treatment of sub-diaphragmatic tumours, was the greatest predictor of malfunctions, particularly electrical reset. Very recently, German guidelines developed by the German Society of Radiation Oncology (DEGRO) and the German Society of Cardiology<sup>6</sup> and a detailed review of the literature by Zaremba *et al.* were published.<sup>7</sup> However, the incidence, precise mechanism, and the variety of effects on different devices are still unknown.

**Figure 1** Effect of thermal neutrons (A) interaction with Boron producing (B) ionizing particles ( $\alpha$ ).

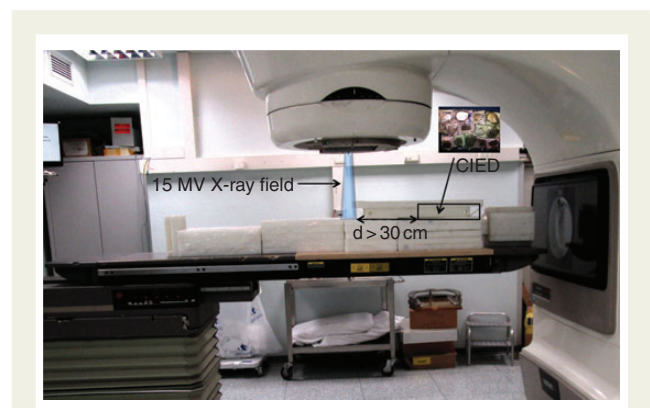
**Figure 2** One of the two anthropomorphic phantoms (Ryan) designed for neutron dosimetry according to the indications of the International Commission on Radiological Protection,<sup>8</sup> the minimum distance between cardiac implantable electronic devices (CIED), positioned under a polyethylene layer of 3 cm (simulating for neutrons the adipose tissue and skin) and the radiation field (30 cm) is pointed out.

the size of the average man (71 kg), was used, as Jimmy was no longer available. All devices were positioned, in several sessions, on the phantom, in a site equivalent to the pectoral region, under a polyethylene layer of 3 cm simulating for neutrons the adipose tissue and skin (Figure 2).

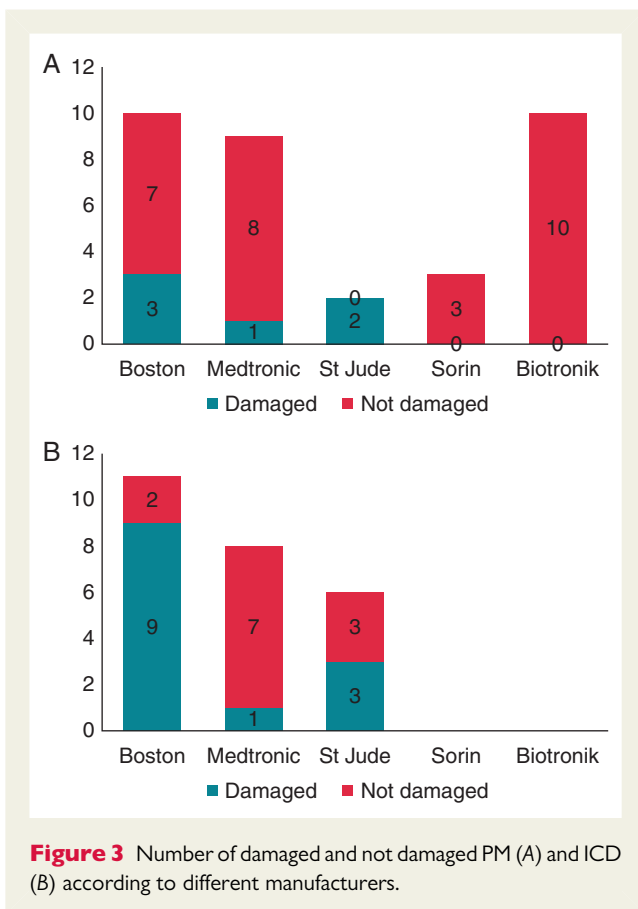
Among PM, some malfunctions were present in 1 of 9 Medtronic, in 3 of 10 Boston, and in both the St Jude devices. No malfunctions were evident among Biotronik (0/10) and Sorin (0/3) devices (Figure 3A).

Among ICD, malfunctions were more frequently detected in Boston (9/11) and St Jude (3/6) devices, while failures were less frequent among Medtronic ICDs (1/8) (Figure 3B).

**Figure 3** Number of damaged and not damaged PM (A) and ICD (B) according to different manufacturers.
