Vulnerability assessment and dynamic characterisation of a glass footbridge: on-site vibration tests and FE numerical modelling

Chiara Bedon

University of Trieste, Department of Engineering and Architecture

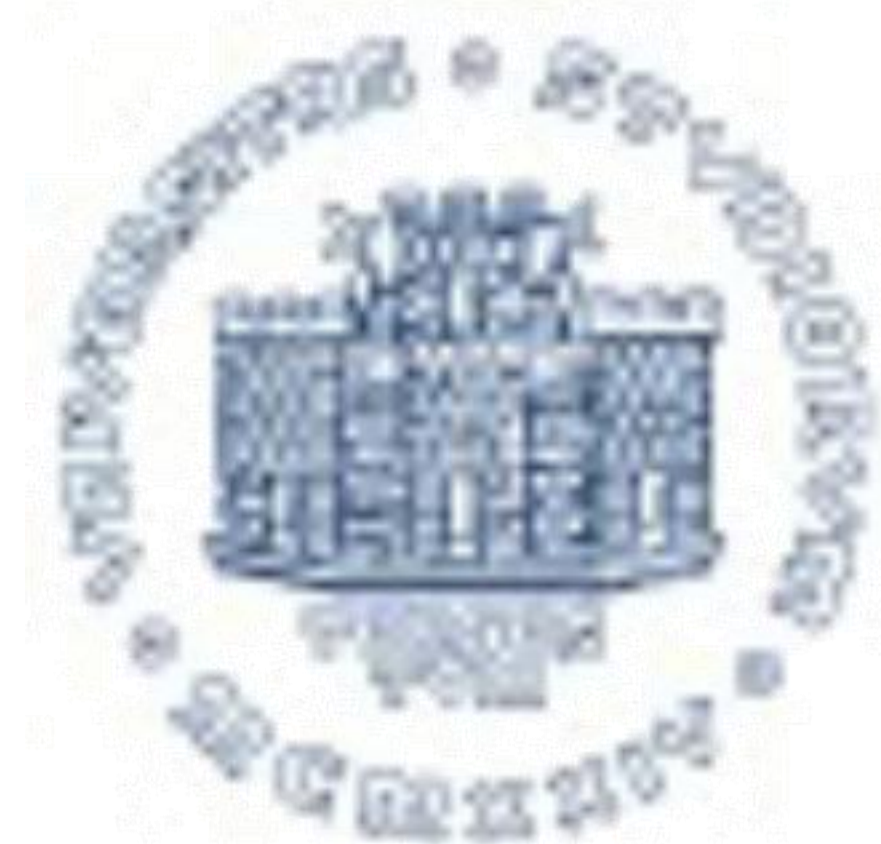
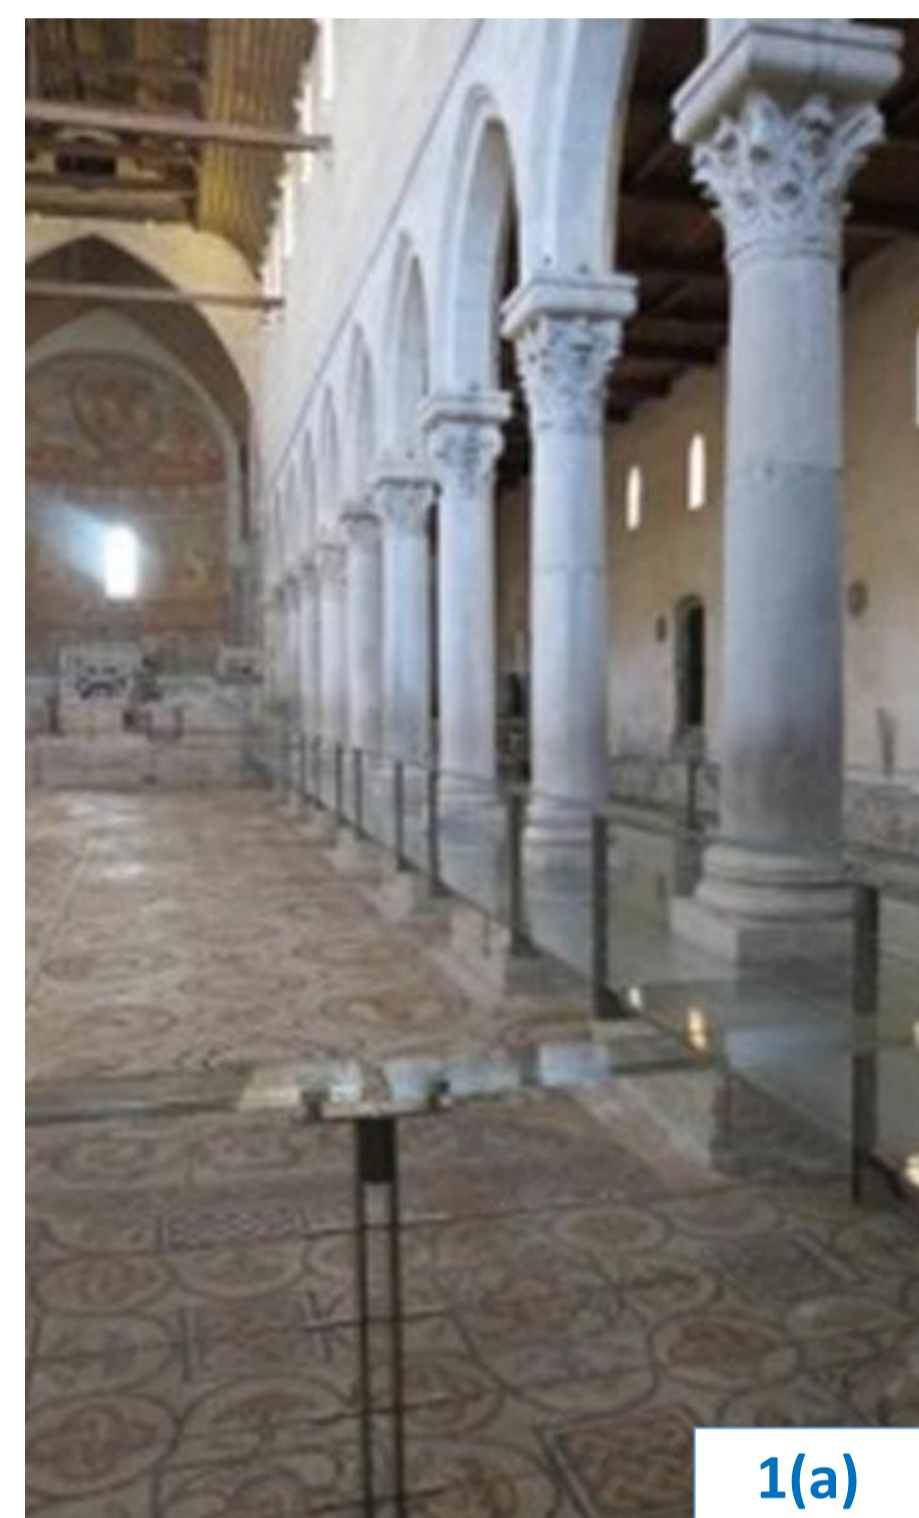
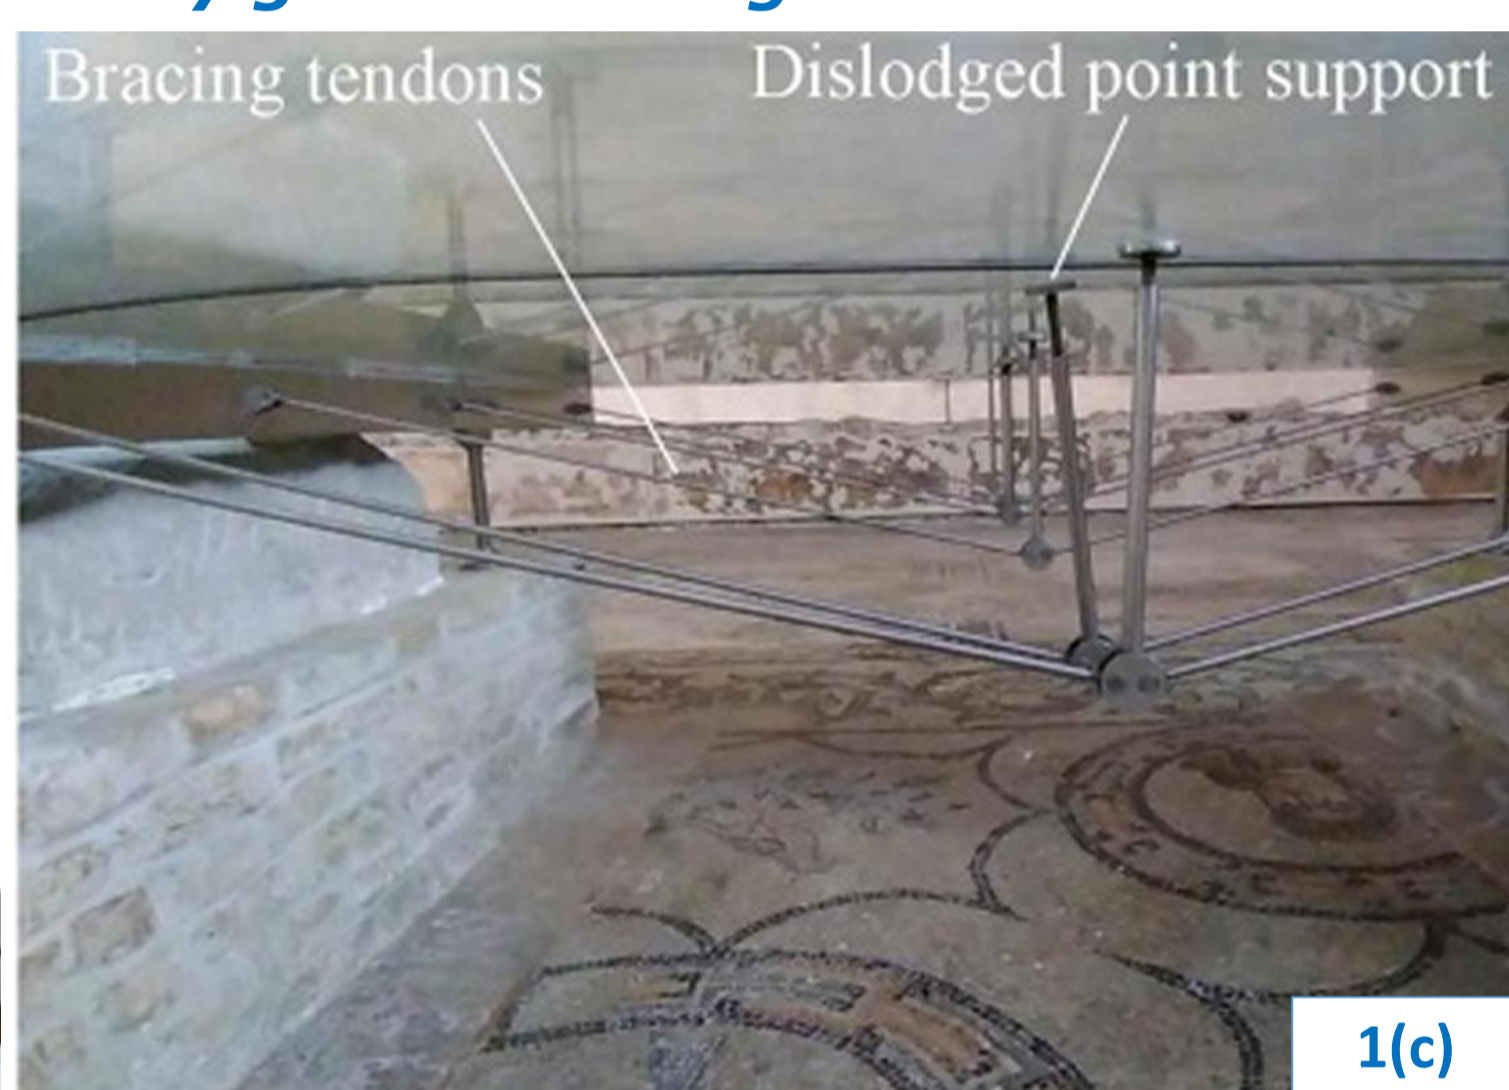
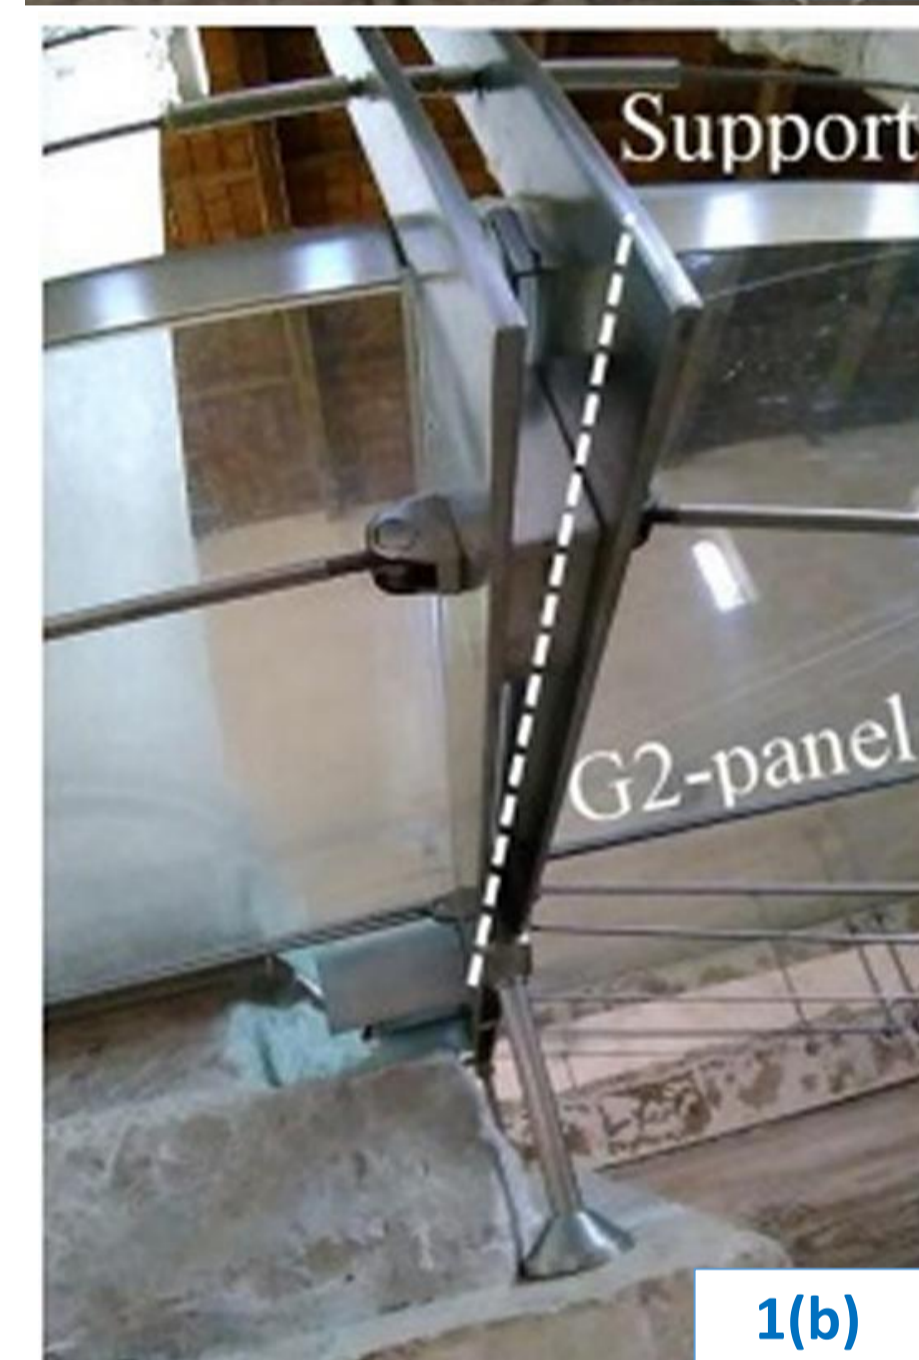
Figs.1(a)-to-(d): general view and details of the case study glass footbridge

Preliminary observations carried out to qualitatively assess the state-of-the-art of the structure gave in fact evidence - for some of the panels only - of (d1) surface abrasion and minor glass cracks; (d2) condensation and debonding phenomena; (d3) dislodgement and pre-stress losses, for the steel supports and bracing tendons (Fig.1(c)).

All the test measurements were properly analysed (SMIT), to detect the fundamental mode of the footbridge (Fig.2(b)). Careful consideration was spent for the 1.45x2.65m G2-panel of the central nave. According to the test setup of Fig.1(d), through the post-processing phase, the glass structure showed a beam-like bending response (Fig.2(b)), with $f_{TEST}=14.97\text{Hz}$ the fundamental frequency and $\xi_{TEST}=1.20\%$ the modal damping.

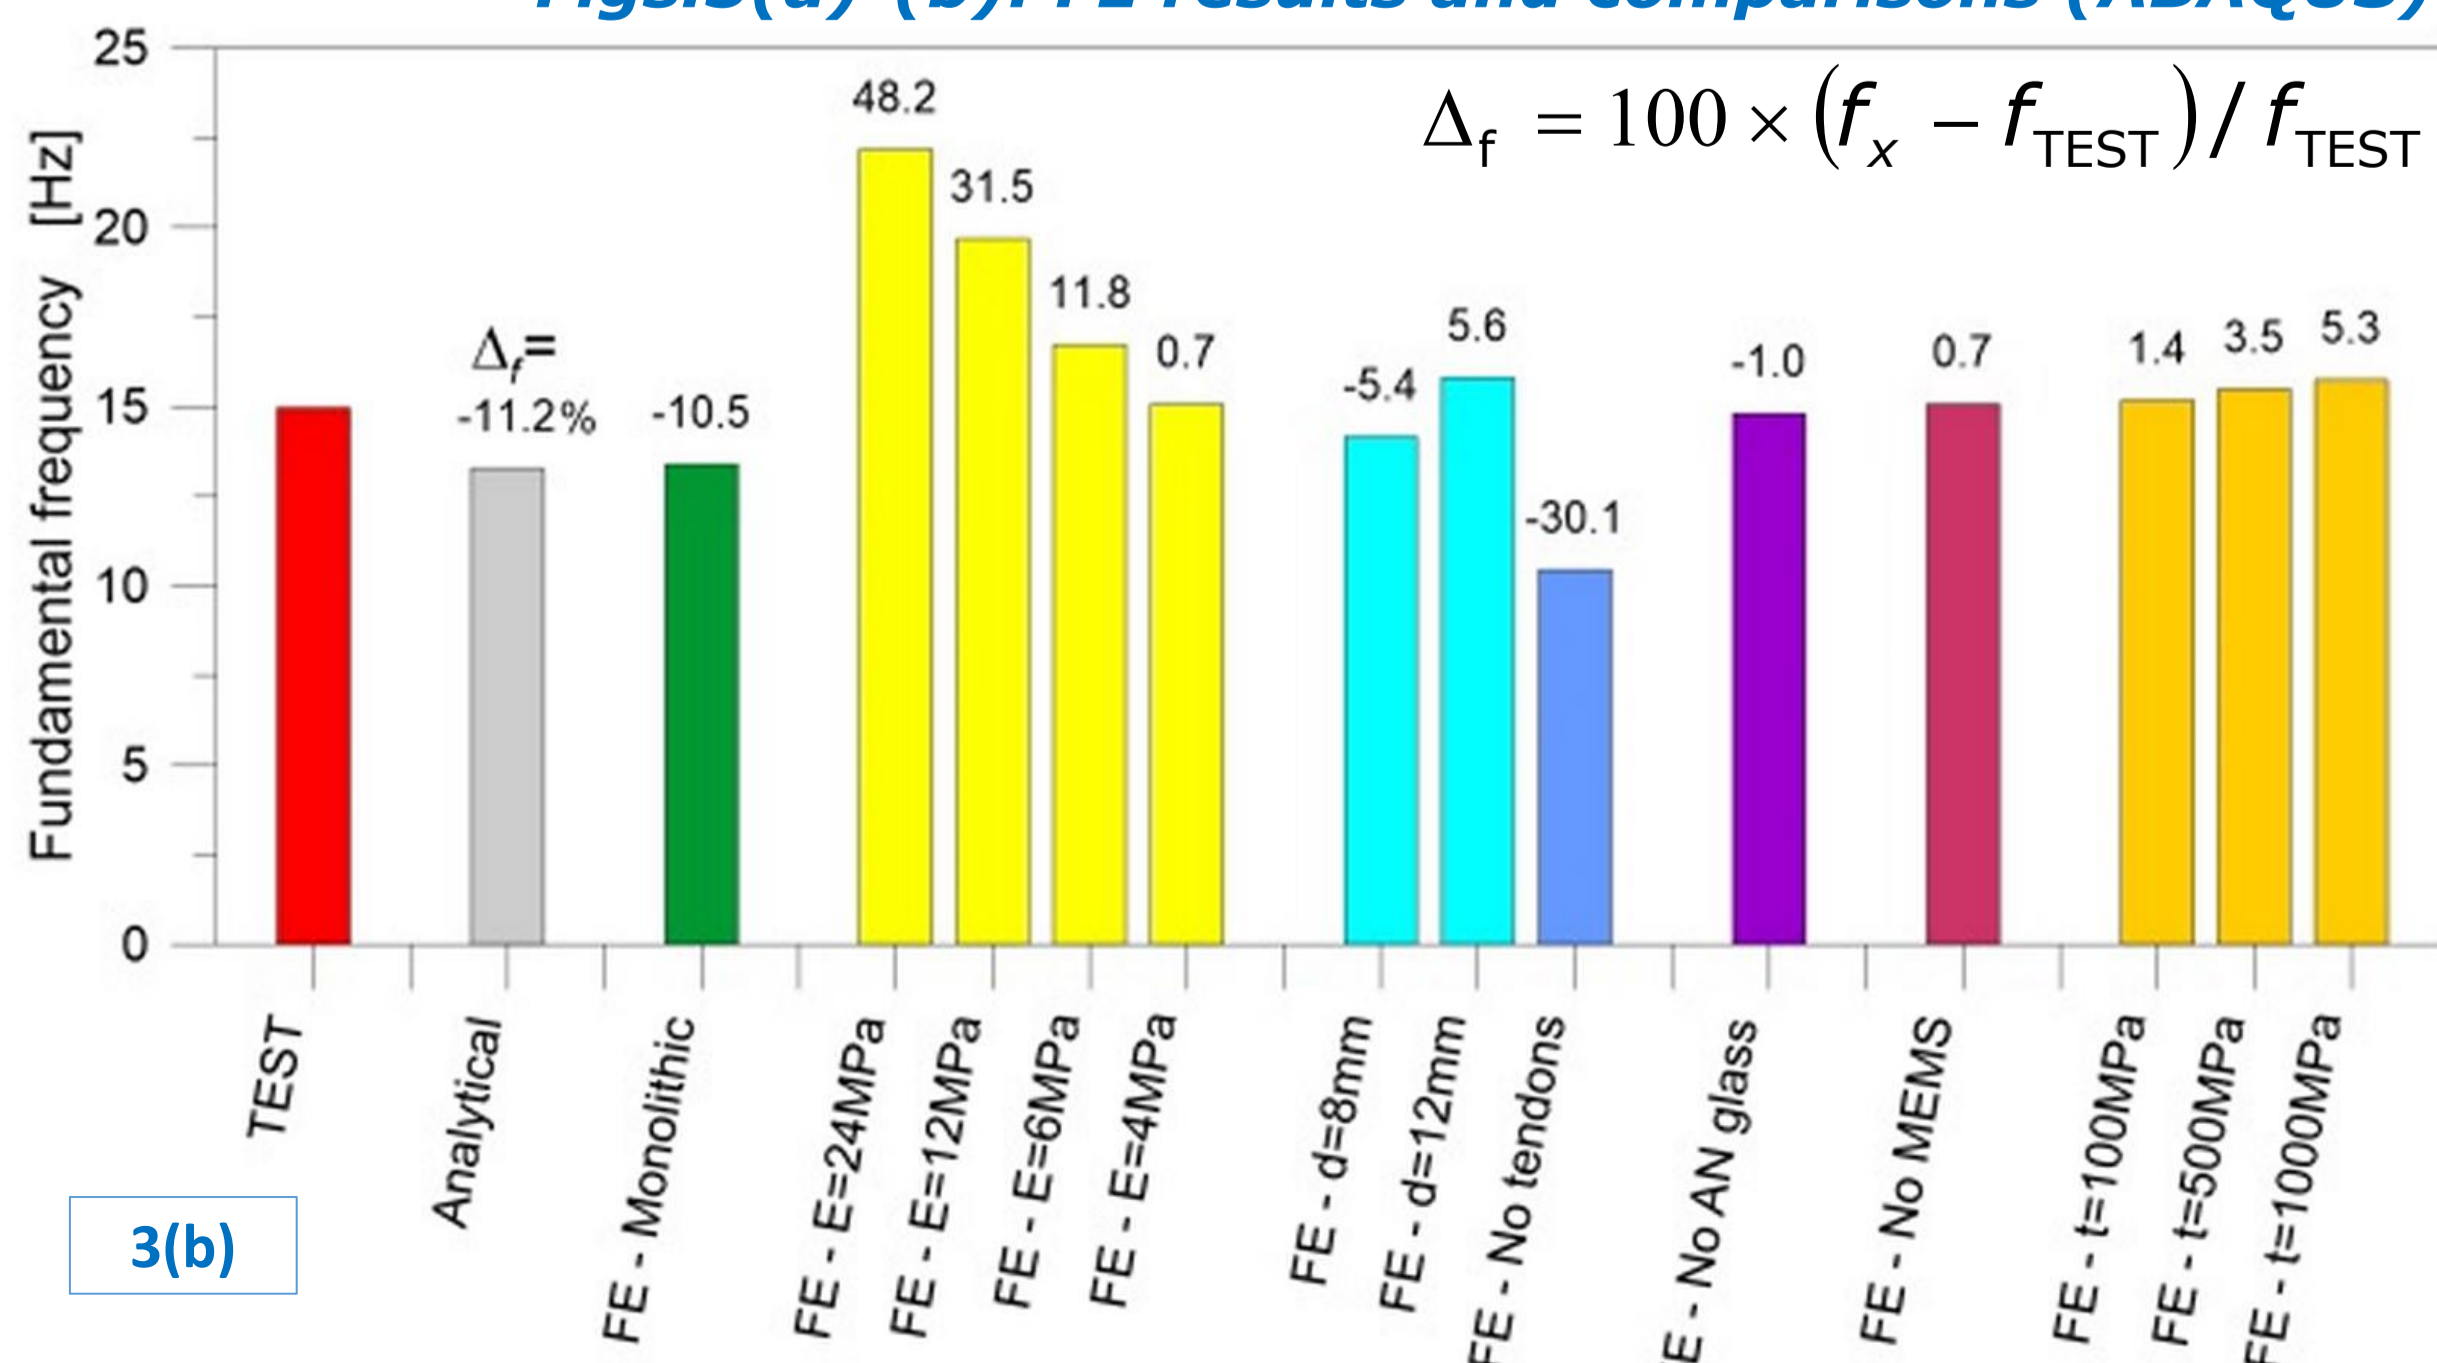
Figs.3(a)-(b): FE results and comparisons (ABAQUS)

Worth of interest in Tab.1 and Fig.3(b) is that the analytical model does not capture the vibration response of the footbridge (poor description of the LG section, lack of tendons, etc.). The FE model, conversely, can describe its bending behaviour and provide useful feedback. The actual role and interaction of structural components was also emphasised.

Severe FE frequency variations resulted especially from the PVB stiffness. Compared to design ($E_{PVB}=24\text{MPa}$, $\Delta_f=+48.2\%$), the optimal rigidity of PVB foils was found in $E_{PVB}=4\text{MPa}$ ($\Delta_f=+0.7\%$), hence confirming a weak connection of the LG section, due to material degradation and possible debonding, to properly address. The AN layer resulted in minimum variations ($\Delta_f=-1\%$). Modifications of tendons size and pre-stress showed a $\Delta_f=\pm 5\%$ scatter. The full removal of bracing tendons from the FE assembly, finally, proved to largely underestimate the frequency of the footbridge ($\Delta_f=-30.1\%$), since disregarding the actual boundary conditions of the structure.

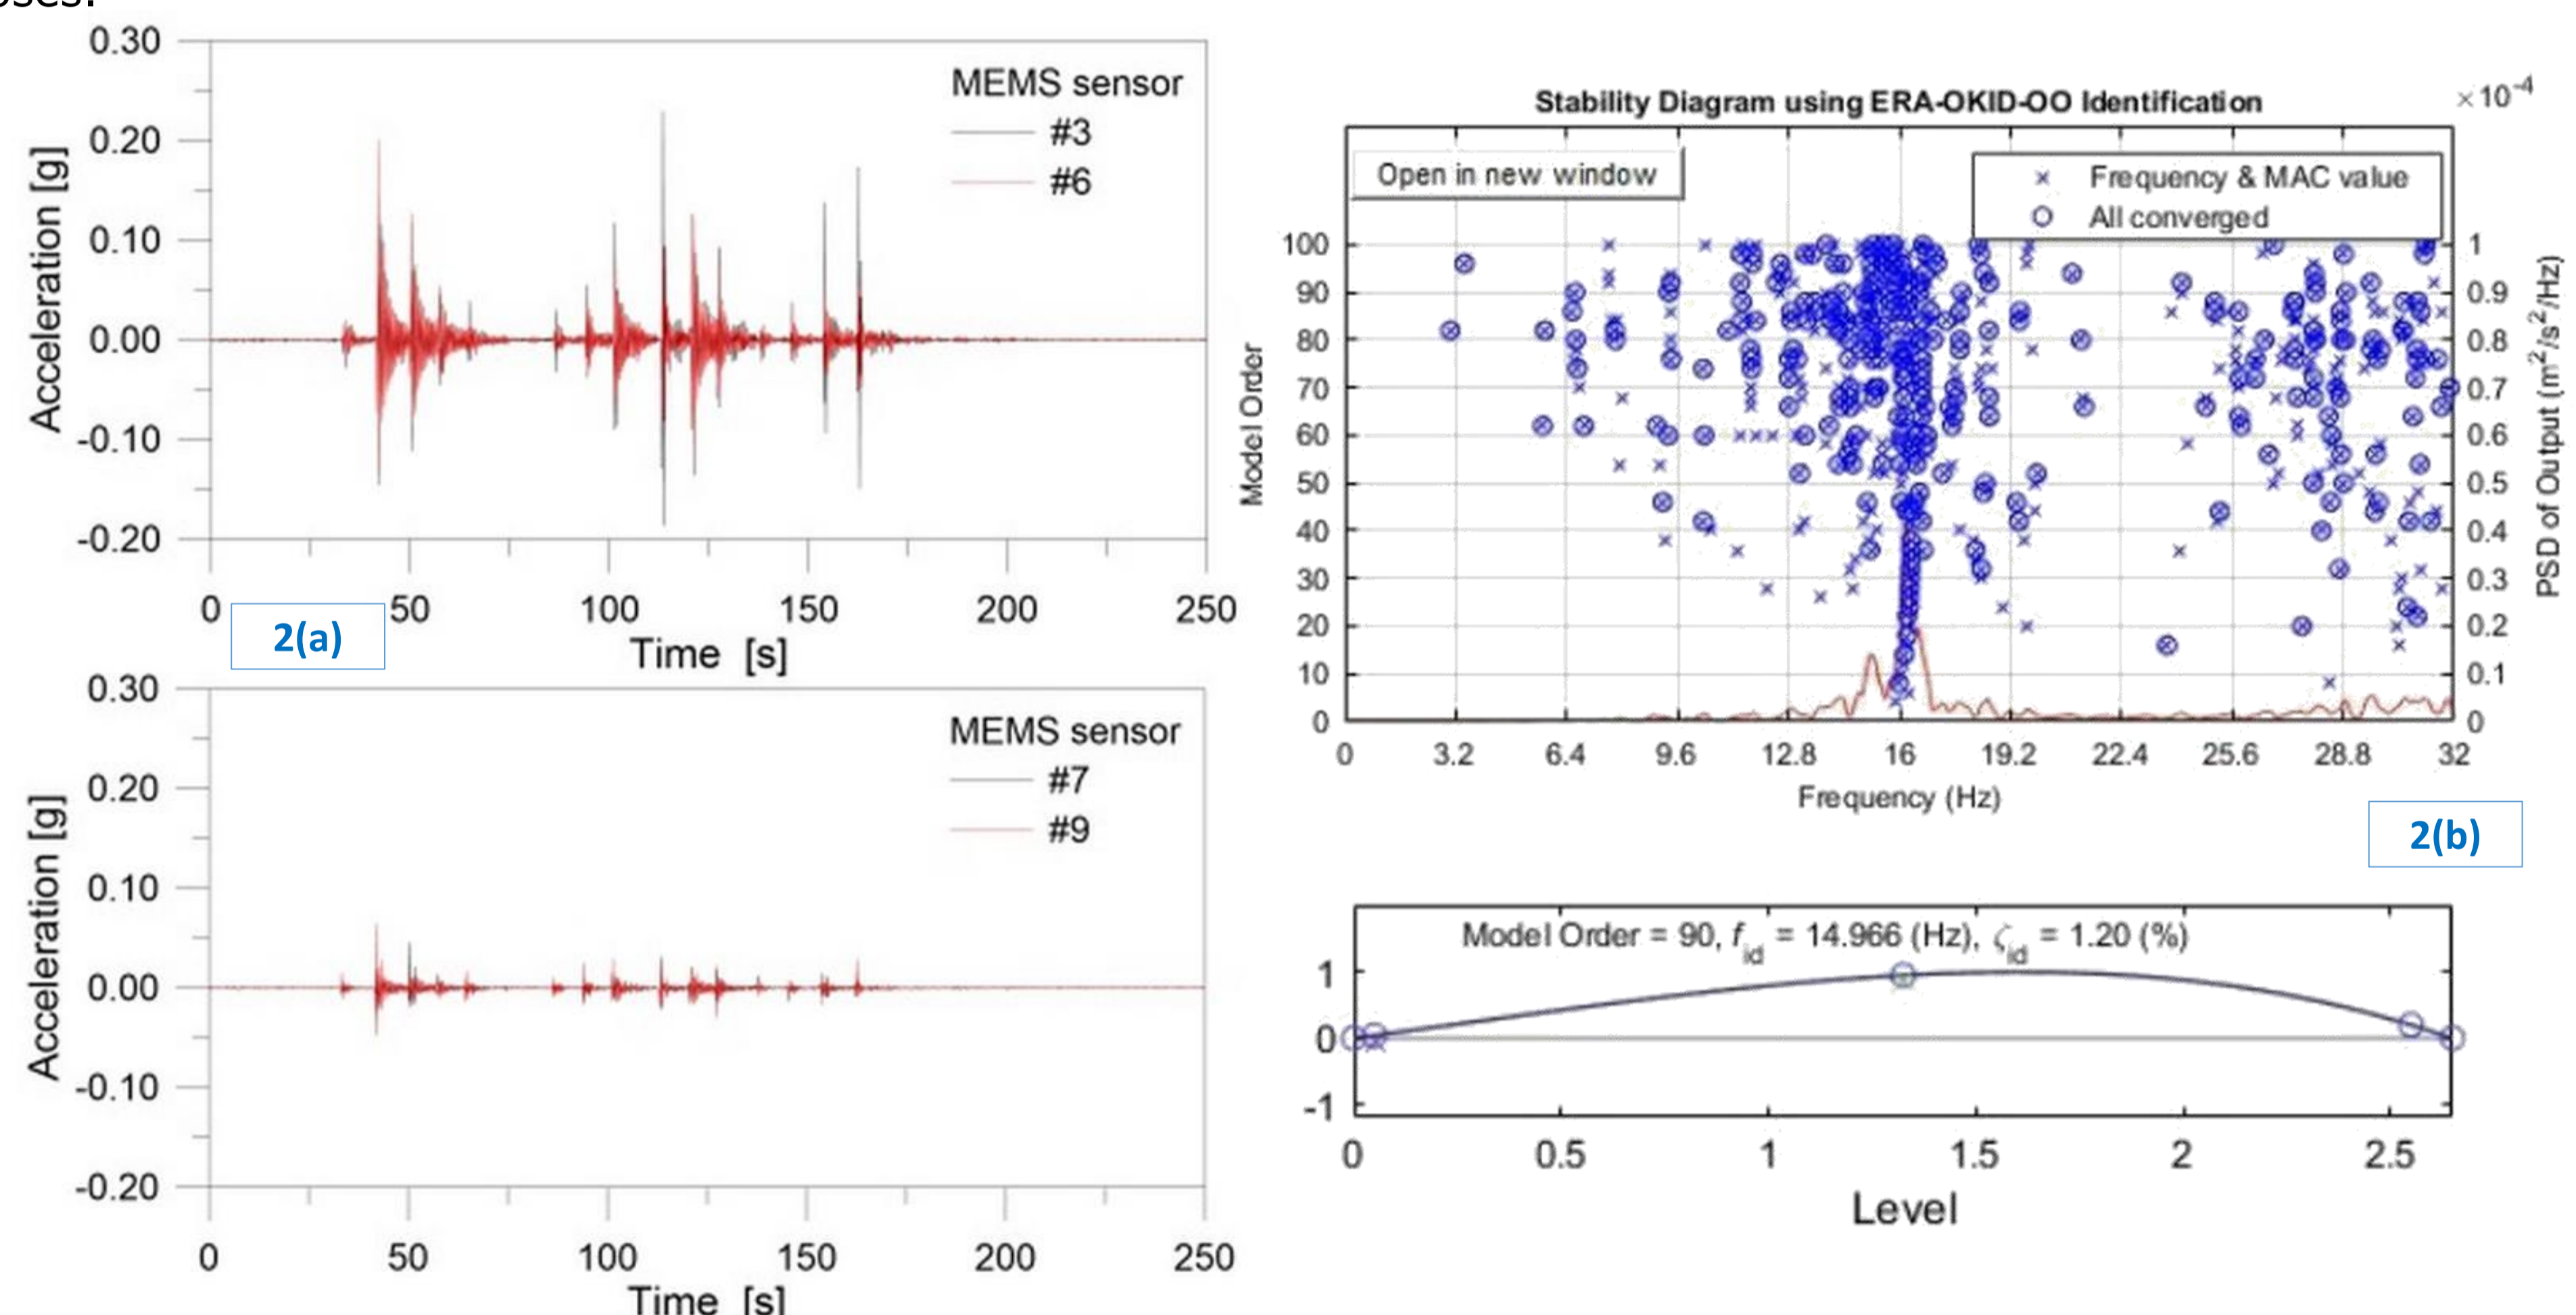
Figs.2(a)-to-(c): Experimental predictions and Finite Element numerical methods (ABAQUS)
