# Failure analysis of three rigid block assemblies – A real collapse resulting in death

A 7 years old girl died due to the disarticulation of an historical holy water stoup in the Santa Chiara Church, in Udine, Italy, caused by the force applied by the girl on the basin.

The stoup is realized as a three rigid block assembly with connections of the type mortise and tenon both between the basement and the shaft and between the shaft and the basin. In the connections the presence of mortar is detected. In order to evaluate the ability of the mortar to stabilize the connections between the three rigid blocks, the mineralogical and petrographic analyses of a mortar sample are performed. Moreover, a loading test is carried out in laboratory to obtain an experimental value of the holy water stoup failure load. This value is determined by applying a vertical force to the outer circumference of the basin.

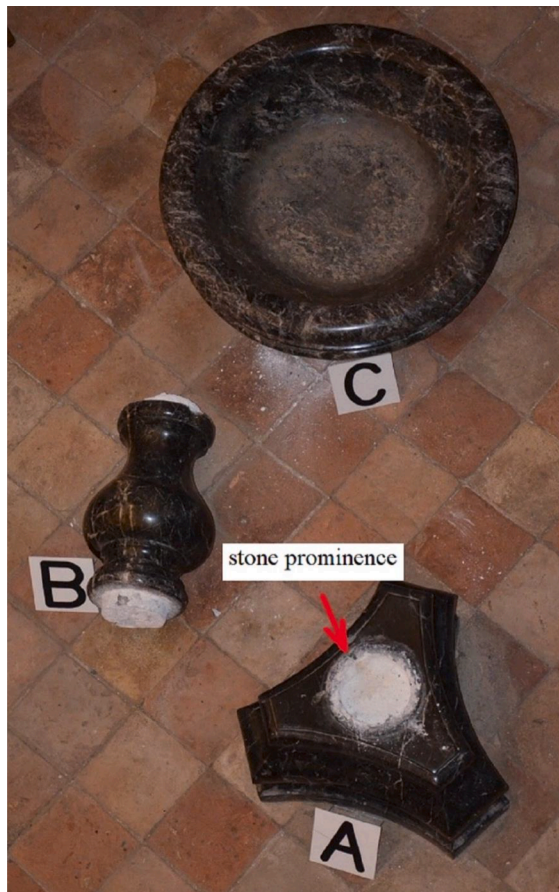
During the accident, caused by the disarticulation of the holy water stoup, the three elements got separated from each other, as shown in the photo in Fig. 3, taken after the accident.

Fig. 3. Location of the holy water stoup elements on the floor of Santa Chiara Church after the accident.

By the visual inspection of the holy water stoup elements at the site of the accident (see Fig. 3), two scratches on the upper surface of the basement, near the stone prominence of the mortise, are detected (Fig. 11). In particular, referring to Fig. 11, the scratch circled in green is caused by the friction between the shaft and the basement on the compression side, and the scratch outlined with a yellow rectangle is due to the collision of the shaft with the basement, during the collapse.

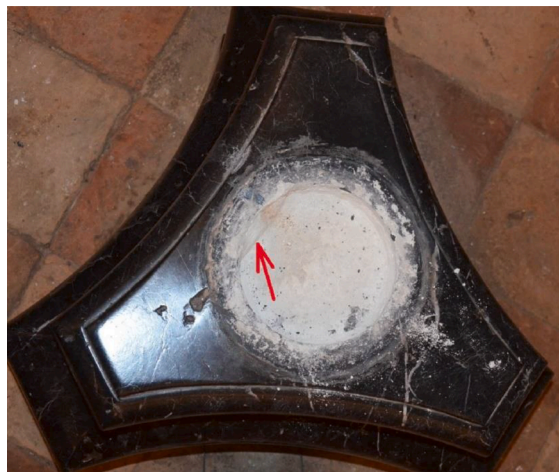
Fig. 4. Stone prominence of the basement mortise.

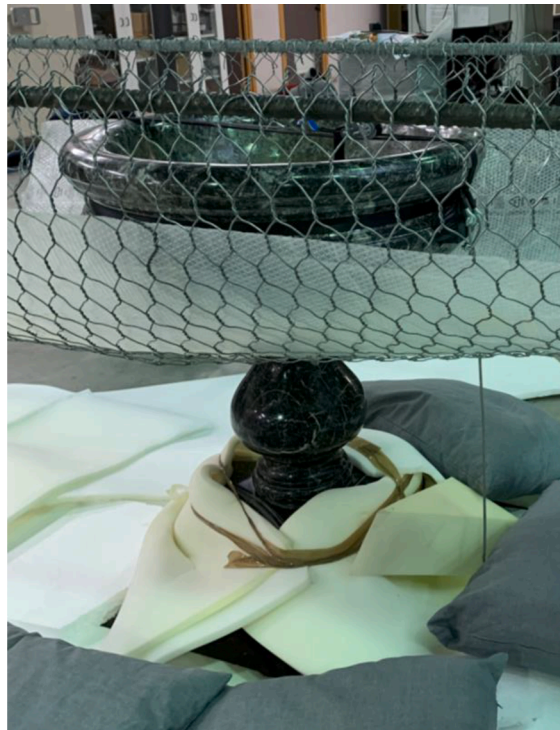
Fig. 6. Force application on the holy water stoup during the loading test.

Moreover, to determine the failure load of the holy water stoup under a vertical force applied on the outer circumference of the basin, a loading test on the holy water stoup reassembled in the configuration before the collapse is carried out.
