Integration of seasonal frequency domain electromagnetic surveys and geological data for assessing the integrity of earthen levee systems. The case study of the Panaro River (Northern Italy)

Frequency domain electromagnetic survey
Earthen levee integrity
Internal erosion
Panaro river

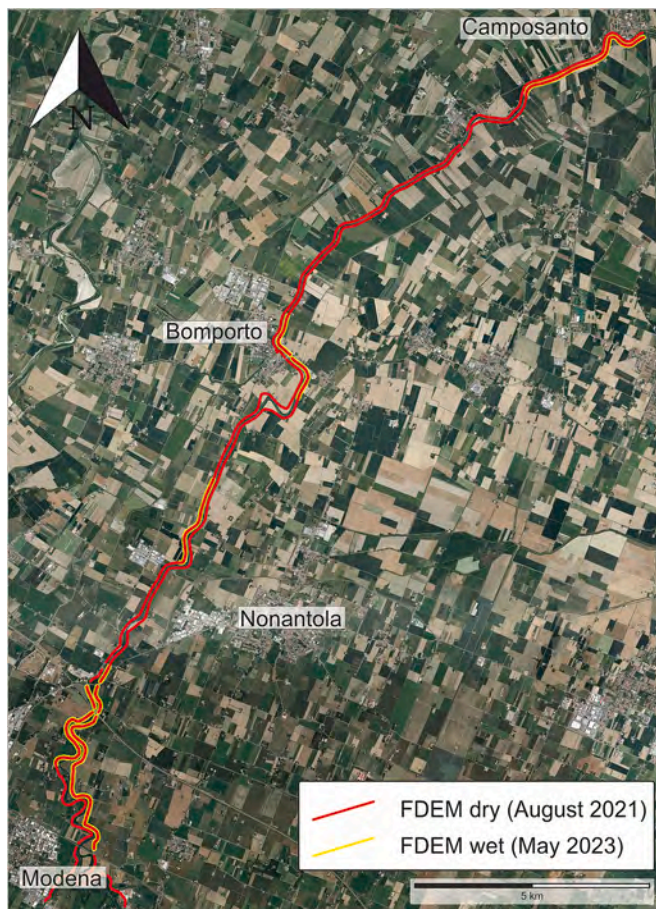
Fig. 2. Study area showing the Panaro levee system between Modena and Camposanto municipalities surveyed with FDEM in dry and wet boundary conditions. The basemap is sourced from [GeoPortale Regione Emilia-Romagna](#).

In the following sections, the initial calibration procedure with ERT, geological data and the FDEM surveys in different boundary conditions performed in the study area (Fig. 2) will be described.

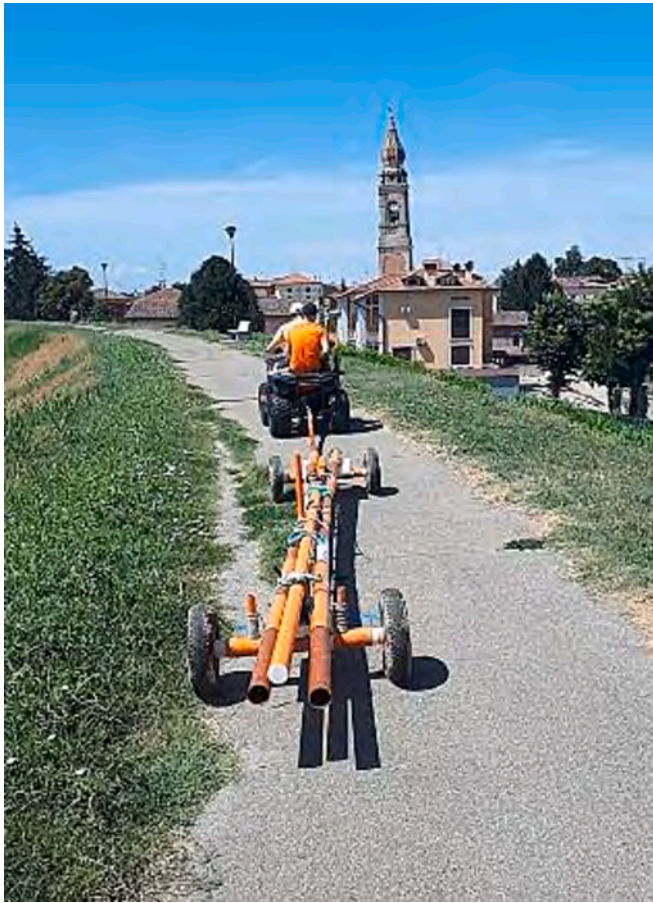
Fig. 4. Acquisition phase during the dry survey. The CMD-Explorer by GF Instruments has been mounted on a PVC and Teflon sledge and towed by a quad to cover 60 km of levees (performed two times, one for each coil's configuration – HIGH and LOW, for a total of 120 km).

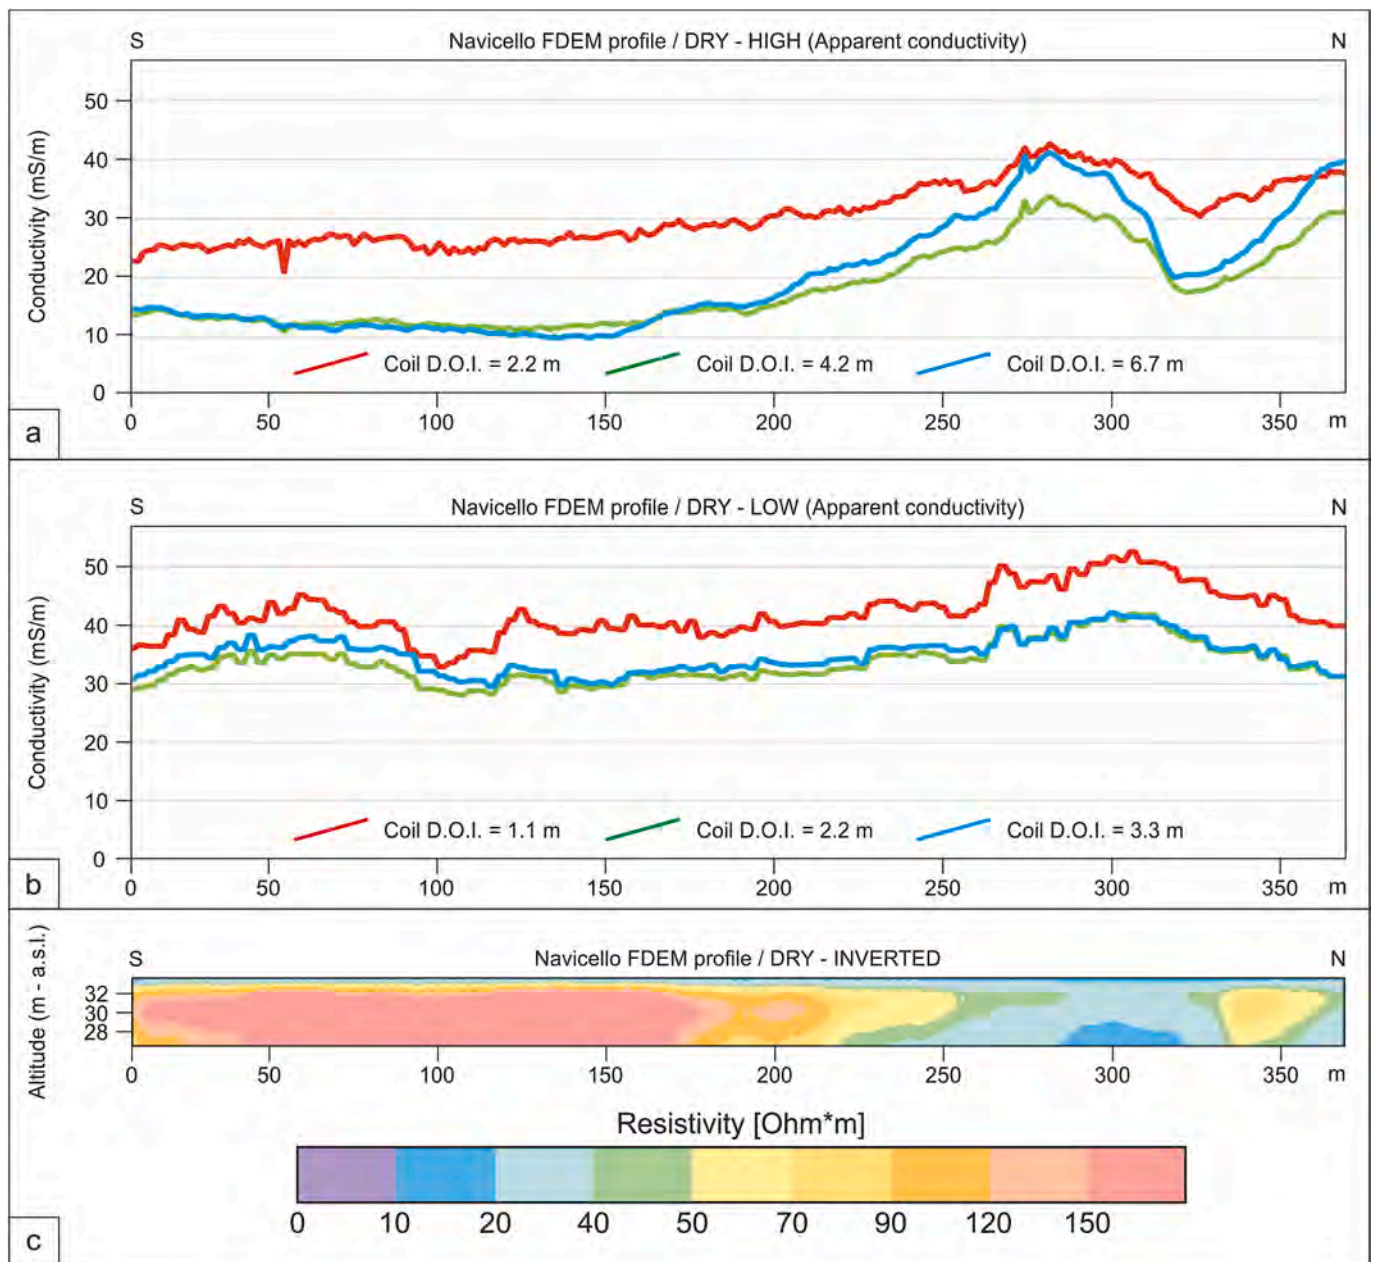
Fig. 5. Processing of FDEM data. a) HIGH coil's configuration apparent conductivity data (the reciprocal of apparent resistivity). b): LOW coil's configuration apparent conductivity data (the reciprocal of apparent resistivity). c) the resulting inverted resistivity section by combining HIGH and LOW data and its corresponding resistivity color scale.

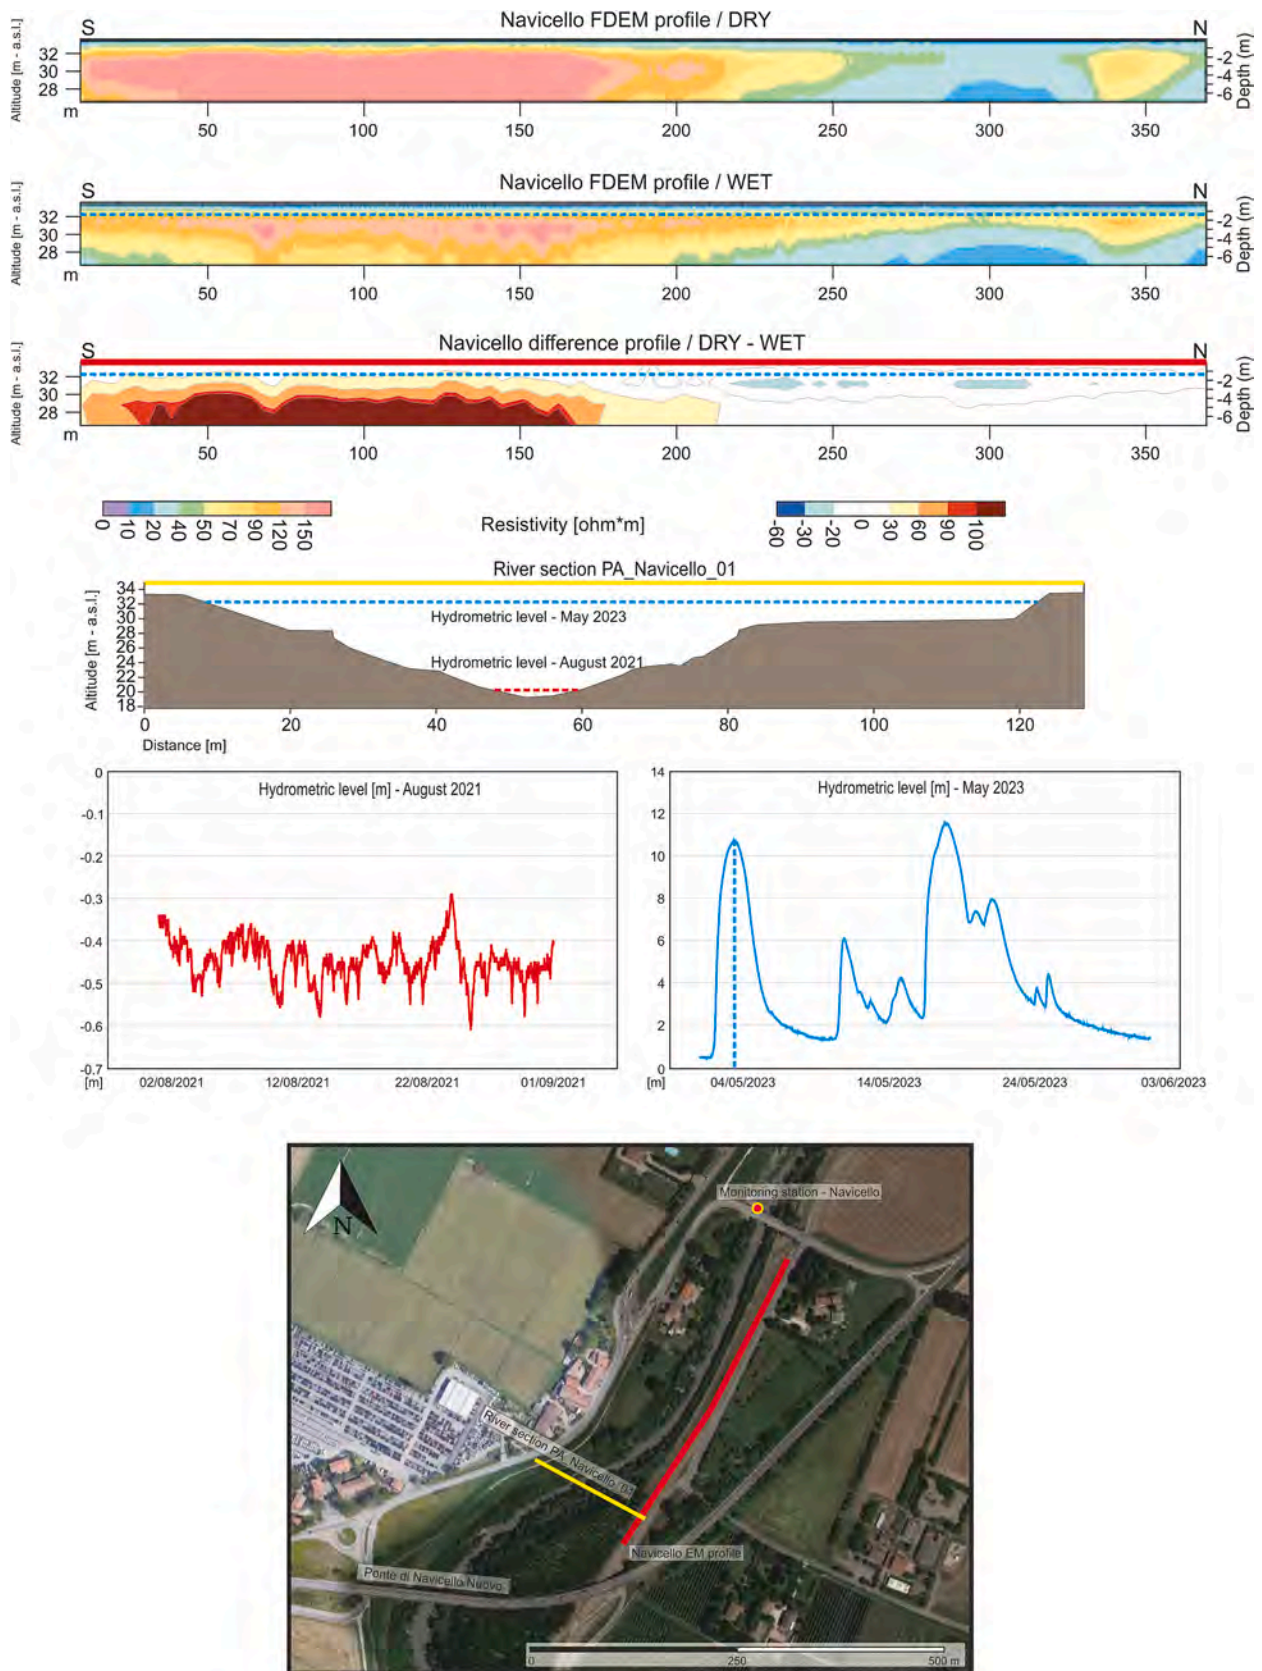
Fig. 6. Comparison between geophysical results and the flood monitoring data coming from the Navicello monitoring station. River section taken from the [Geo-Portale AIPo](#) website. Hydrometric level from the [Dext3r ARPAE](#), Navicello gauge station.

and wet-conditions, a consistent correspondence between high river stages and identified resistivity variations has been found. Specifically, the largest resistivity change, from higher to lower resistive values, was observed at the base of some sections of the levees, aligning well with the river stage records during the May 2023 flood phase (Fig. 6). This suggests enhanced seepage processes occurring through the base of a total of about 4 km of levees sections, where predominantly sandy materials were already been identified during the dry-conditions survey.

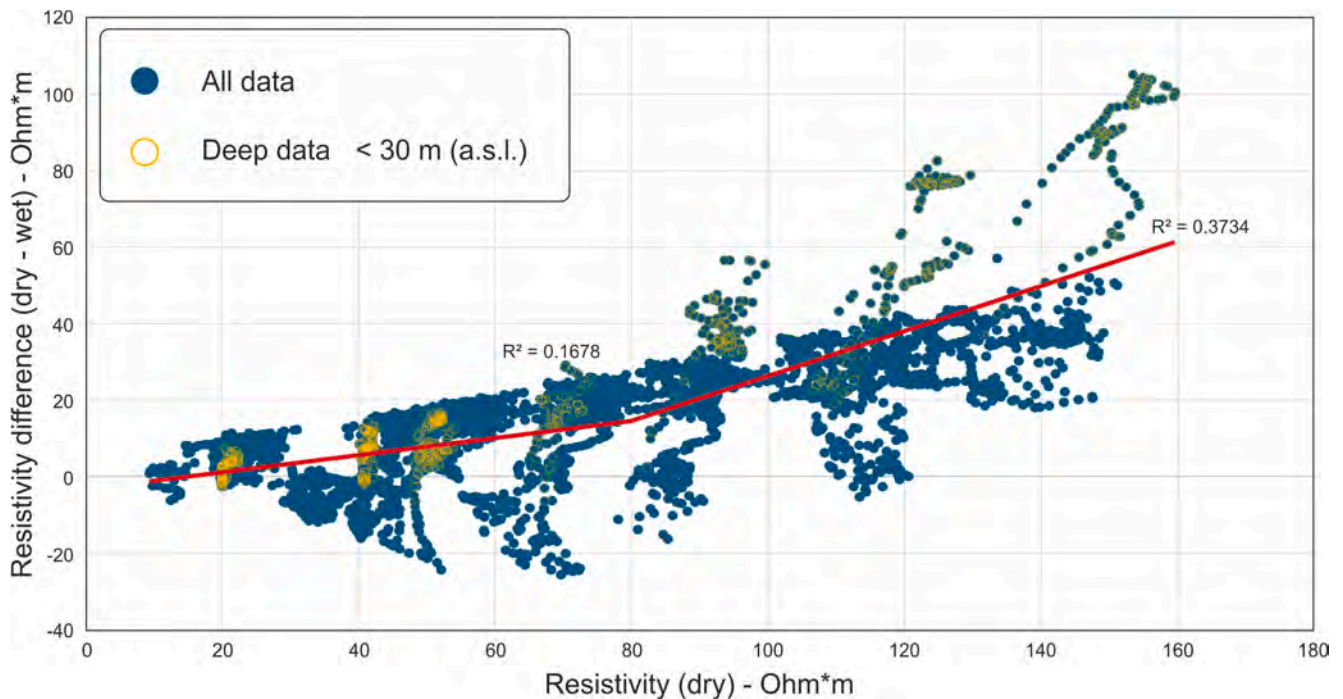
Fig. 7. Crossplot of resistivity values measured in dry conditions and the difference of resistivity between dry and wet conditions along the Navicello FDEM profile shown in Fig. 6.

Fig. 7 illustrates the relationship between the electrical resistivity measured in dry conditions and the resistivity difference between dry and wet conditions, highlighting the impact of water on the resistivity values. From the cross plot in Fig. 7, it can be observed that for resistivity values lower than 80 $\text{Ohm}\cdot\text{m}$ in dry conditions the difference between dry and wet resistivities is always less than 30 $\text{Ohm}\cdot\text{m}$. However, for higher resistivity values, the difference increases, reaching up to nearly 100 $\text{Ohm}\cdot\text{m}$. This confirms that the dry resistivity values are primarily related to the grain size of the embankment materials, with higher resistivities corresponding to coarser materials, mainly sandy sediments, and lower values associated with silty and clayey sediments. Additionally, high-resistivity values coupled with low resistivity differences correspond to the shallowest layers, which were largely unaffected by the rise in the Panaro River's water level during the flood stage. These layers experienced minimal water infiltration or groundwater flow, except for direct rainfall infiltration. As a result, their resistivity values show little variation between dry and wet conditions, reflecting the

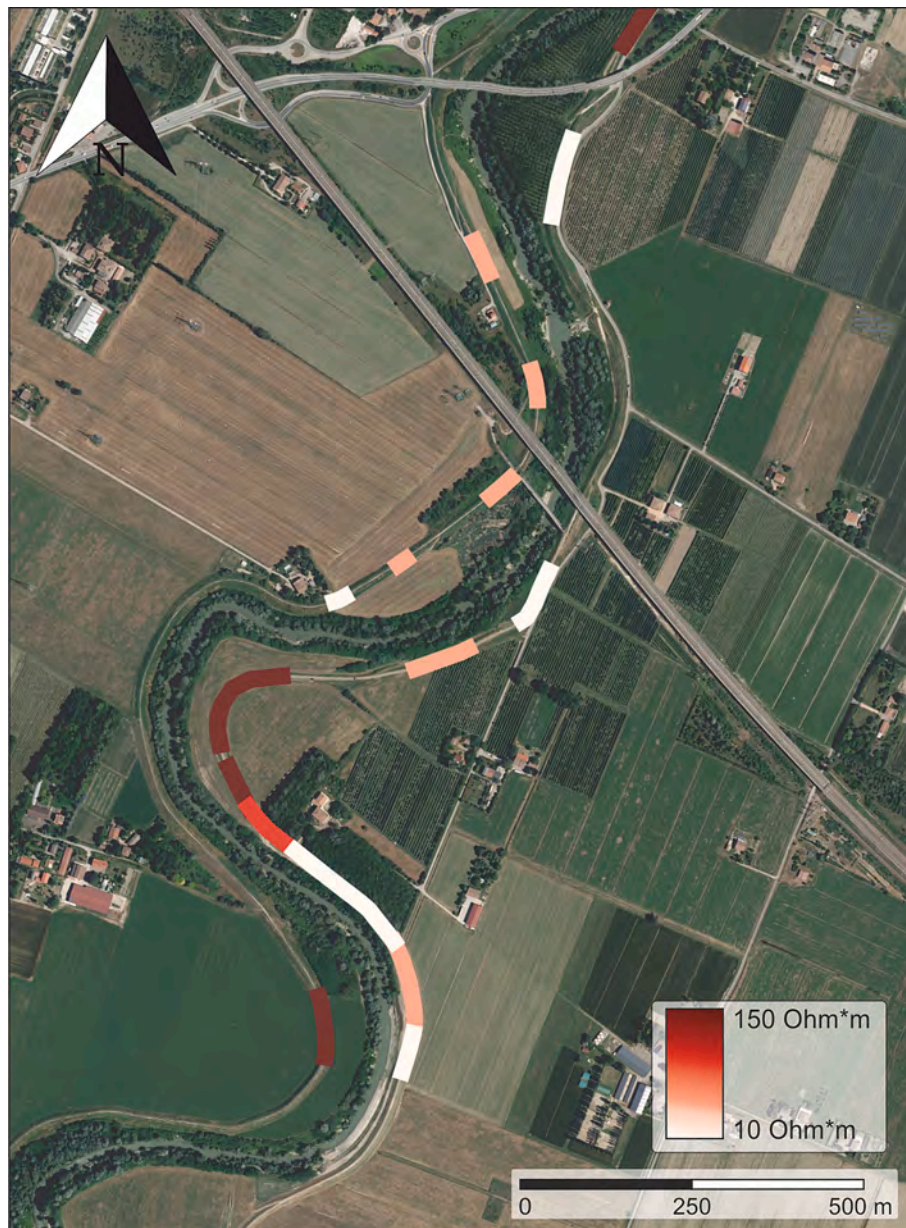
Fig. 8. An example of the results obtained from the difference between dry and wet FDEM surveys shows resistivity differences plotted along the levees, providing a zonation of areas prone to higher vulnerability.

One of the key outcomes of this three-year study is the development of a map highlighting areas that require further investigation, close monitoring, or structural interventions. Beginning with a broad coverage of 60 km, the mapping process has progressively refined its focus to 4 km, prioritizing areas based on their vulnerability to seepage and internal erosion. An example is shown in Fig. 8, where the difference between dry and wet resistivity is plotted. Zones with higher resistivity differences are more prone to seepage and internal erosion following the rise in river water levels, as previously described. This approach serves as a robust tool for decision-makers and authorities involved in infrastructure management, enabling targeted interventions.
