Full-scale cyclic tests on a stone masonry building to investigate the effectiveness of a one-side application of the composite reinforced mortar system

The results of an experimental study on a full-scale, two-storey rubble stone masonry building, strengthened with a Composite Reinforced Mortar (CRM) system applied on the external face of the walls, are herein presented. The CRM system consisted of a mortar coating reinforced with Glass Fiber Reinforced Polymer (GFRP) mesh and injected steel transverse connectors, which connect the separated wythes of the masonry. The aim of the research is to investigate the effectiveness of this strengthening technique. The study concerns two cyclic experimental tests: the first was carried out on the unreinforced masonry building up to a damage level not far from the ultimate limit state. Then, the building was repaired, strengthened with the proposed technique, and tested again. The second test was carried out up to a near-collapse condition. This allowed to evaluate the effectiveness in terms of seismic performances provided by the reinforcement.

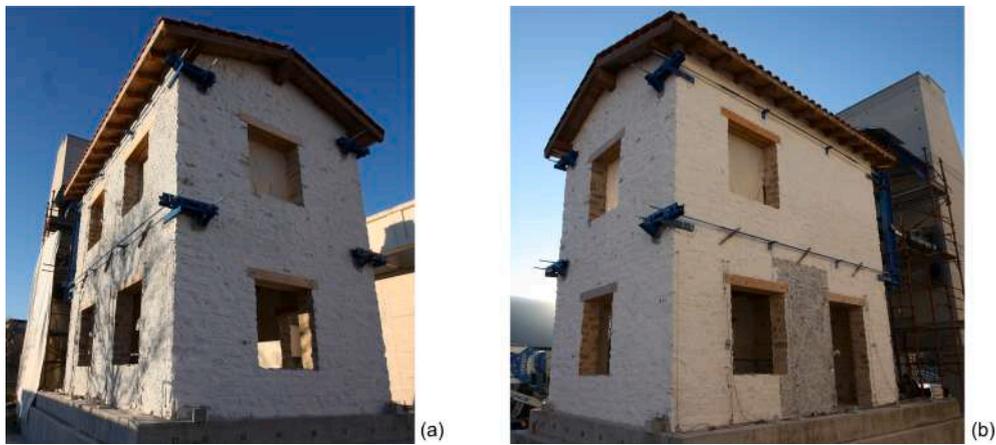
Fig. 1. Views of the building from outside: (a) East and North walls; (b) North and West walls.

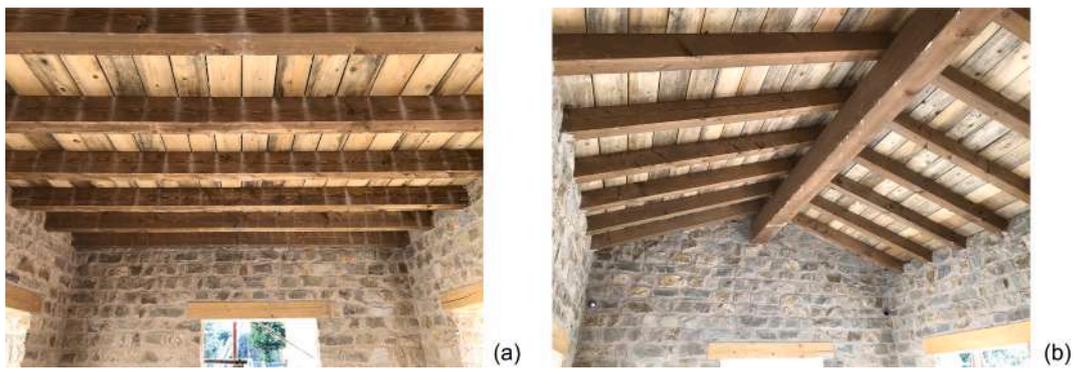
Fig. 2. Views of the building from inside: intrados of the intermediate floor (a) and of the roof (b).

The intermediate wooden floor (Fig. 2a) consisted of solid timber joists (cross-section of 120 × 160 mm², 3950 mm length) spaced at 600 mm, located into masonry pockets providing a support length of 150 mm. To represent planks typically used in historical constructions of Northern Italy [29], 25 mm thick timber boards were nailed to the floor joists. Three of the floor joists were connected to the East and West walls by means of steel anchors, 1800 mm spaced, passing through the masonry wall, and clamped by a steel wedge (Fig. 1a,b; Fig. 5a). The anchors were fastened to the floor joists through a plate using three wood screws per plate. The wooden pitched roof (Fig. 2b) consisted of 533 mm

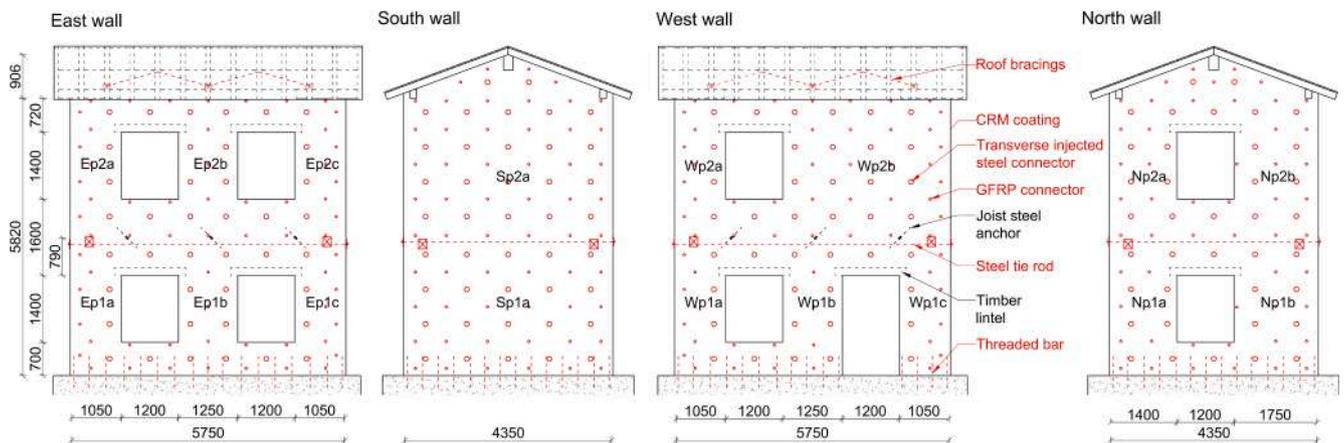
Fig. 3. Side views of the building and coating connection details (dimensions in mm).

The coating was anchored to the walls by GFRP L-shaped connectors ($4/\text{m}^2$) and transverse injected steel connectors ($2/\text{m}^2$), following the arrangement reported in Fig. 3.

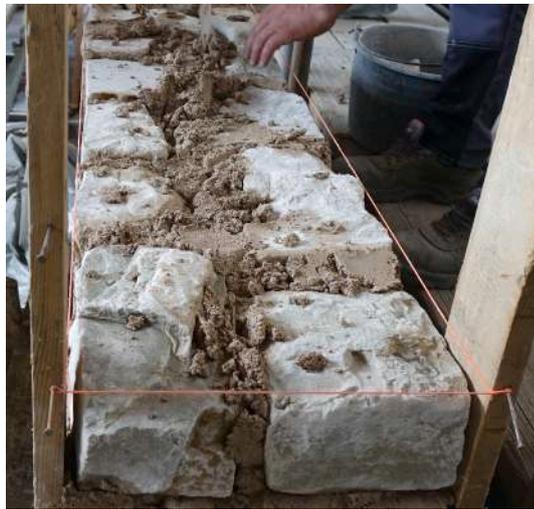
Fig. 4. Typical view of the horizontal cross-section of the stone-masonry walls during construction;

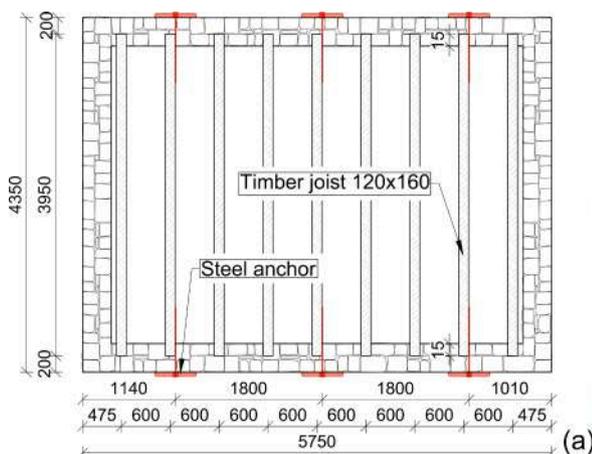
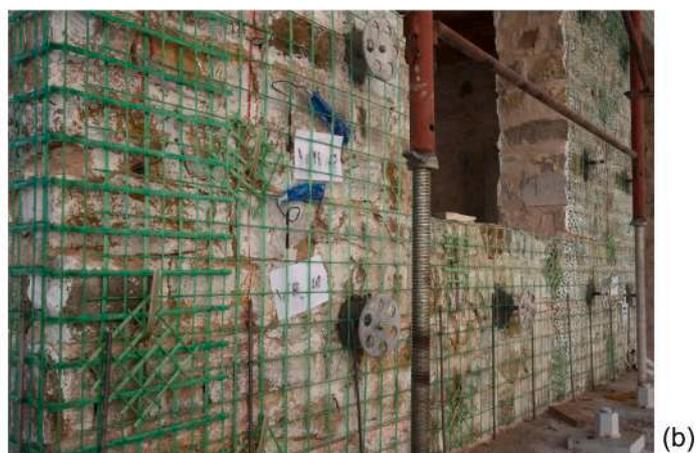
Fig. 5. (a) Plan view of the steel anchors layout (dimensions in mm); (b) GFRP mesh and anchors just before the application of the mortar coating. Note the additional angular elements at the corner, the GFRP connectors, the head washers of the transverse injected steel connectors and the anchor bars with the foundation.

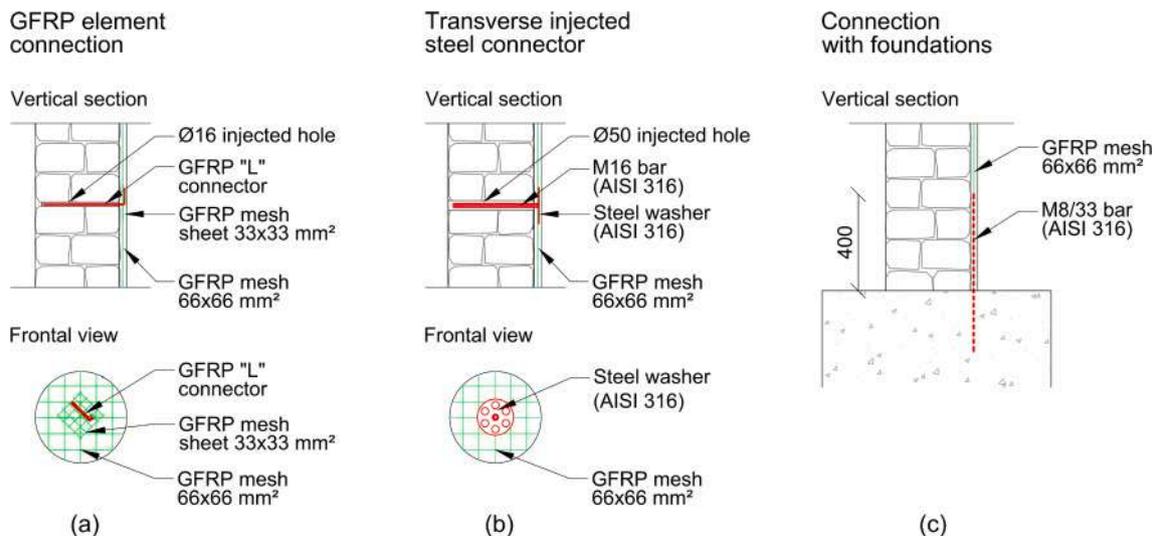
Fig. 6. Details of the retrofitting intervention: connection to the wall with (a) GFRP elements, (b) transverse injected steel connectors and (c) connection to the foundation by steel bars.

The L-shaped connectors were inserted into 16 mm diameter holes drilled in the masonry, for a depth of 300 mm, and injected with a vinyl ester epoxy resin as in Fig. 6a. The connectors had a cross-section of $7 \times 10 \text{ mm}^2$, and a nominal dry fiber cross-section equal to 32.4 mm^2 ; they had a nominal characteristic tensile strength of 17 kN and an ultimate strain of 1.9 %. In front of each connector, a GFRP mesh sheet ($150 \times 150 \text{ mm}$) with a $33 \times 33 \text{ mm}$ grid dimension was positioned to distribute stresses within the coating.

The transverse injected steel connectors were made with a 16 mm diameter threaded stainless steel bar, 365 mm long, centered in a 50 mm diameter hole and embedded in a high resistance thixotropic cement-based mortar (Fig. 6b). The holes were drilled by using a water-cooled core drilling machine. The transverse connectors had the important role of connecting the wythes of the wall and also anchoring the CRM system. To connect the mortar coating to the transverse connectors, perforated stainless steel washers (4 mm thick), with a nut welded at the center, were screwed on the head of the threaded bar, at a half thickness of the CRM coating, above the GFRP mesh.

To increase the in-plane flexural resistance of the walls, the CRM coating was anchored to the foundation by 8 mm diameter stainless steel threaded bars (characteristic yield strength 200 MPa). The bars were anchored 250 mm deep into the RC foundation by epoxy resin, and 400 mm into the coating (Fig. 6c). The bars were distributed along the entire perimeter of the building, three per meter, at about 10 mm from the masonry wall surface. The bars were installed beneath the GFRP mesh to avoid possible splitting failure mechanisms of the mortar coating. Previous pull-out tests [35], carried out on 6 mm diameter threaded steel bars showed that an approximate length of 50 times the diameter is enough to anchor the bars in the reinforced mortar coating.

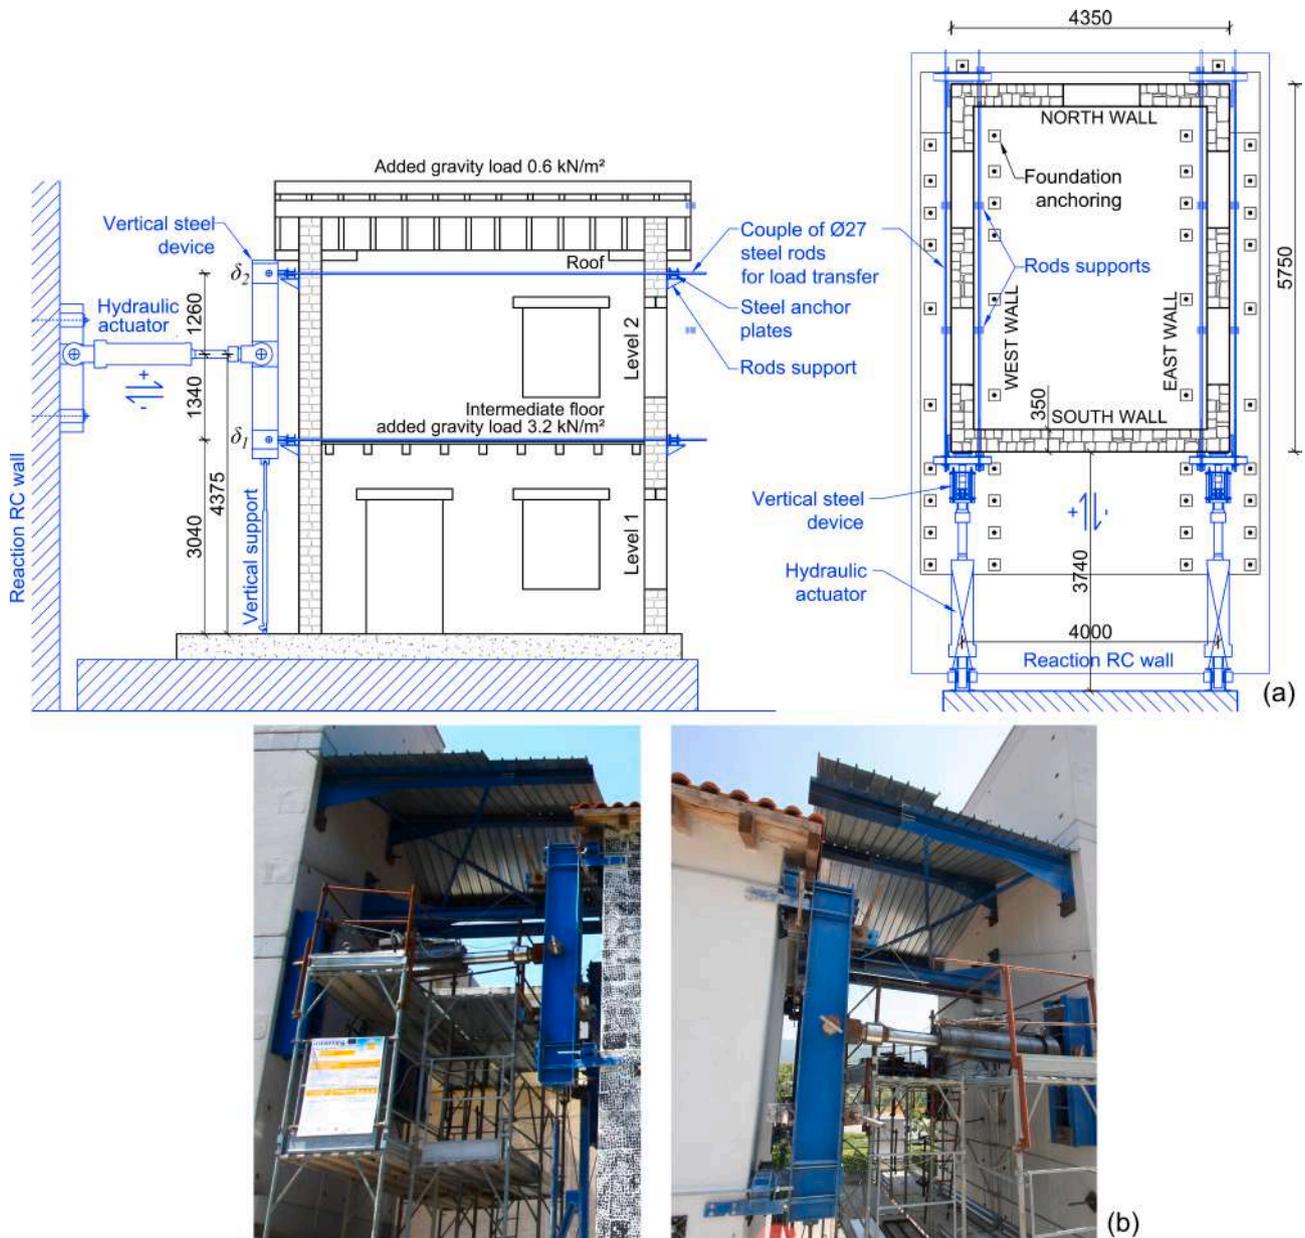
Fig. 7. Loading apparatus: (a) schematics section and plan view (dimensions in mm); (b) actual view.

wall and the other on the West wall. The load applied by each actuator was subdivided between the intermediate floor and the roof through a vertical steel beam hinged to the actuator, so that 51 % of such force was applied at the top of the first level and 49 % at the top of the second level of the building. This distribution was proportional to the product of the floor mass with the corresponding floor level.

determined by dividing δ_2 by the wall's height from the foundation, equal to 5640 mm (Fig. 7). The drift at the intermediate floor (γ_1) was determined by dividing δ_1 (Eq. (2)), by the height from the foundation, equal to 3040 mm.

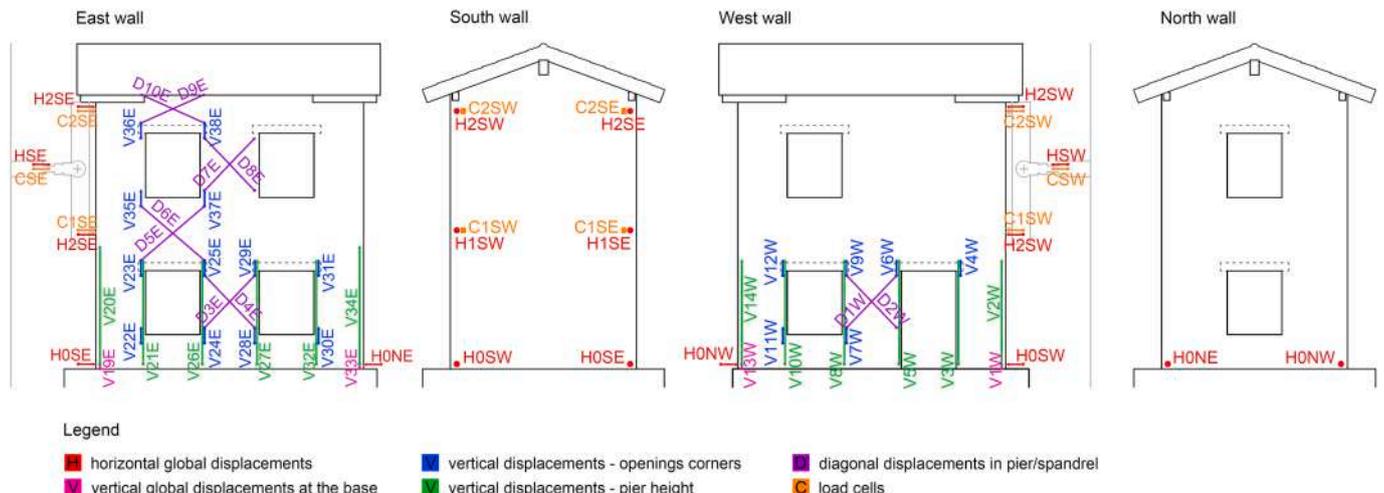
Fig. 8. Load and displacement transducer set-up.

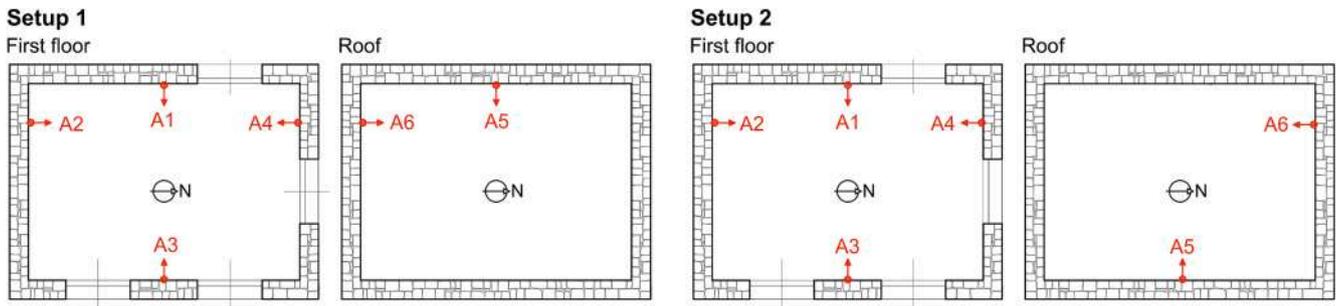
Fig. 9. Accelerometer set-ups.

For the experimental process, six seismic accelerometers were positioned across two experimental setups that shared four reference sensors. The instruments effectively captured ambient-induced vibrations caused by external factors such as traffic and wind to allow for the estimation of the rigid body motions of the four walls at both the first floor and roof level, as shown in Fig. 9. Data acquisition was performed in the horizontal plane, in the transverse direction of the walls. The temporal data were sampled at a frequency of 300 Hz, with each measurement session having a minimum duration of 40 min.

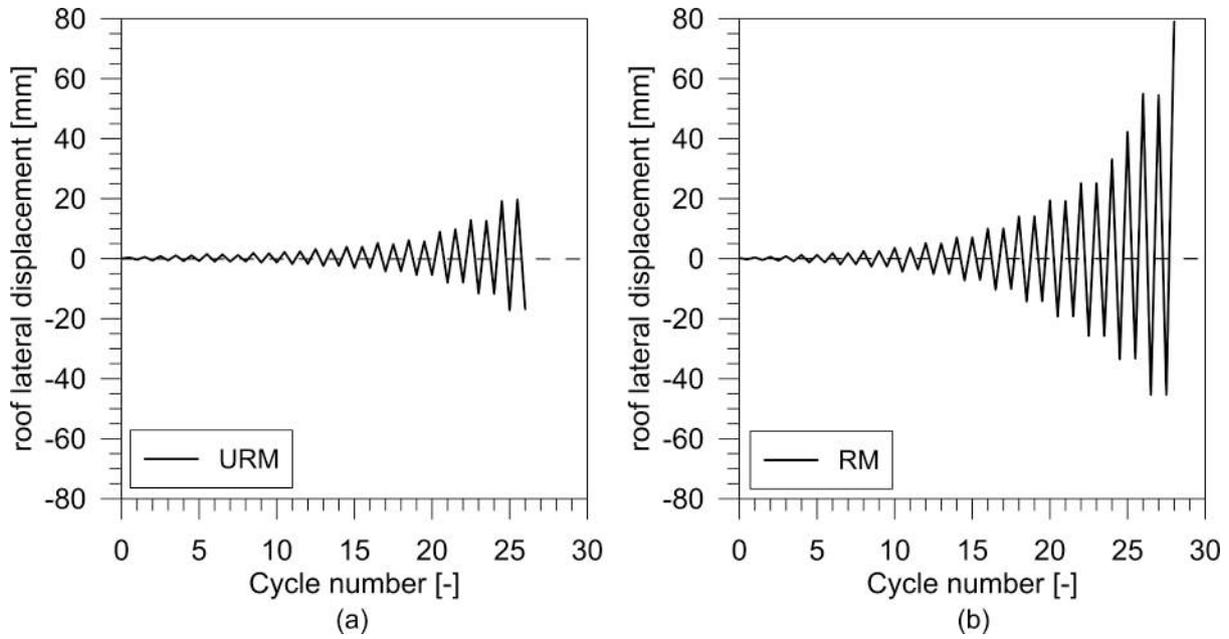
Fig. 10. Loading cycles for the (a) unreinforced structure test and (b) for the retrofitted one.

The first test, on the unreinforced masonry (URM) structure, was stopped close to the ultimate limit state when the damage was significant but repairable. Then, the repair and strengthening operations were carried out. The second test on the retrofitted masonry (RM) structure, was carried out up to near collapse. The loading cycles are presented in Fig. 10.

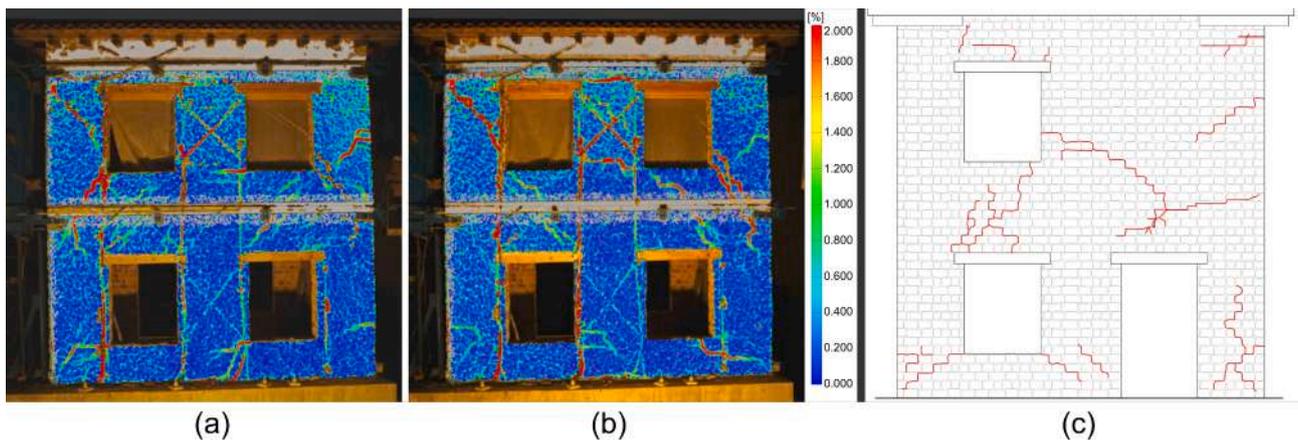
Fig. 11. URM building cracks (maximum strains) on the East wall at the end of the test, detected by the DIC System for negative N-S (a) and positive S-N (b) loading directions, and crack configuration on the West wall (c).

The URM building was tested about six months after its construction. The crack pattern at the end of the test is illustrated in Fig. 11. In more detail, in Fig. 11a,b are shown the maximum strains of the East wall detected with the DIC system, whereas Fig. 11c reports a sketch of the cracks directly surveyed on the West wall. Note that the path of the cracks followed mainly the mortar joints.

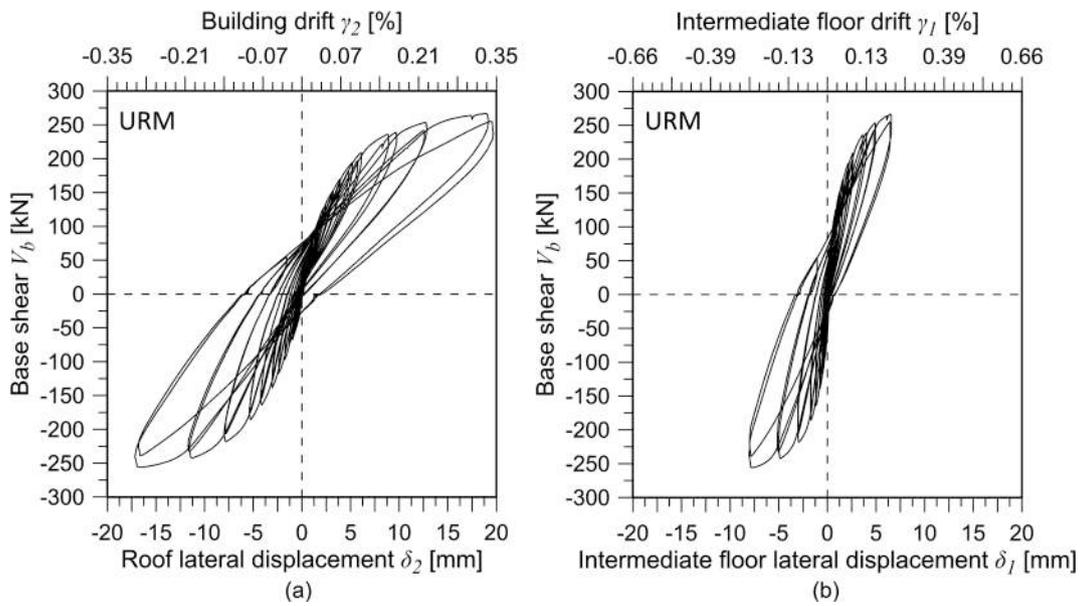
Fig. 12. URM: lateral load–displacement curves (a) V_b - δ_2 and (b) V_b - δ_1 .

The significant events that occurred during the test of the URM building are summarized in Table 4 and the experimental load–displacement curves, V_b - δ_2 and V_b - δ_1 , are illustrated in Fig. 12a, b. The curves are almost linear until the first flexural cracks occurred at the top and bottom of the pier Ep2b (see id. in Fig. 3 for location), for a total lateral force V_b of about +66 kN. At the attainment of $\delta_2 = +1.2$ mm, the stiffness of the building gradually started to reduce, as cracks developed close to the corners of openings on the first and second level and horizontal cracks occurred at the top of the pier Ep2a. A further reduction of the lateral stiffness was caused by visible diagonal shear cracks on the West and East wall spandrels above the windows of the first level ($\delta_2 = +2.1$ mm). One of these cracks formed above the door and then extended to the window's corner of the second level. With increasing lateral displacements, shear cracks formed on piers Ep2a and Ep2b, and the building attained the maximum capacity, equal to +267 kN. Then, the force slightly decreased to +251 kN as the existing cracks further expanded (Fig. 13a). During the test, no building up-lift phenomena were observed at the base of the walls. The cracks at the first level were visibly thinner than those at the second level.

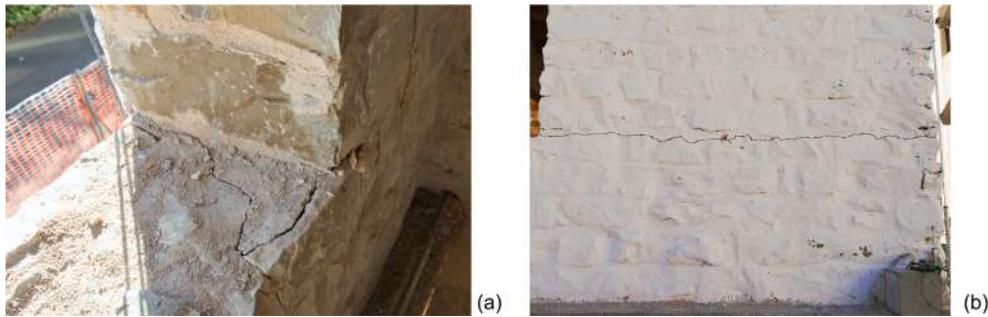
Fig. 13. Diagonal crack in the bottom right corner of pier Ep2a (a) and horizontal crack at the base of pier Np1b (remarked in black) (b).

The transversal walls (South and North) exhibited some localized cracks around the loading points of the second level. Thin cracks also opened inside of the building, along the walls' intersections, evidencing a slight separation between orthogonal walls; moreover, a horizontal crack appeared at the base of the pier Np1b (Fig. 13b), related to out-of-plane bending, involving also a portion of the pier Wp1a.

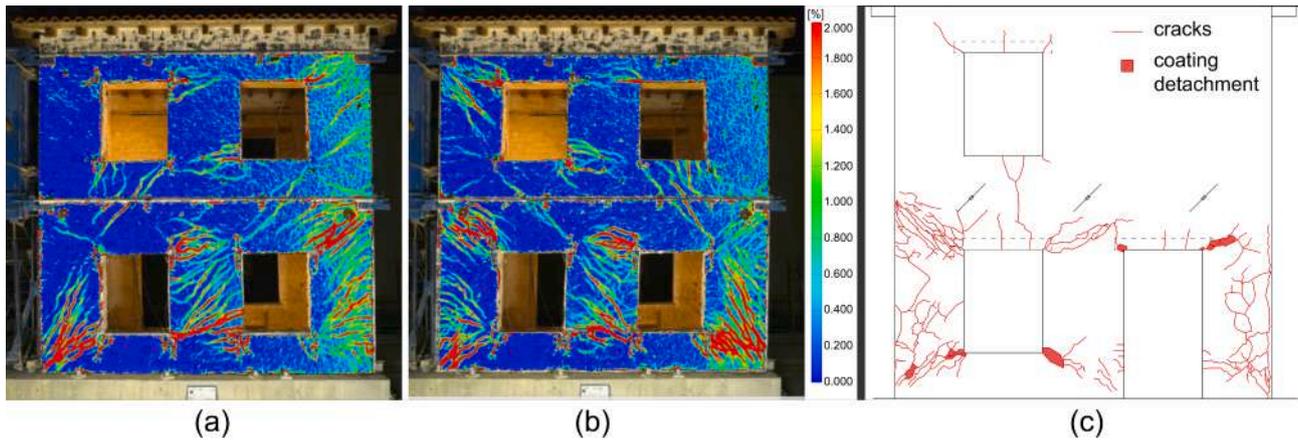
Fig. 14. RM building: cracks (maximum strains) on the East wall at the end of the test, detected by the DIC System for negative N-S (a) and positive S-N (b) loading directions, and crack configuration on the West wall (c).

The crack pattern at the end of the test is illustrated in Fig. 14a,b (East wall) and Fig. 14c (West wall); the experimental capacity curve V_b - δ_2 is presented in Fig. 15, in black color. A summary of the significant events during the test is reported in Table 5.

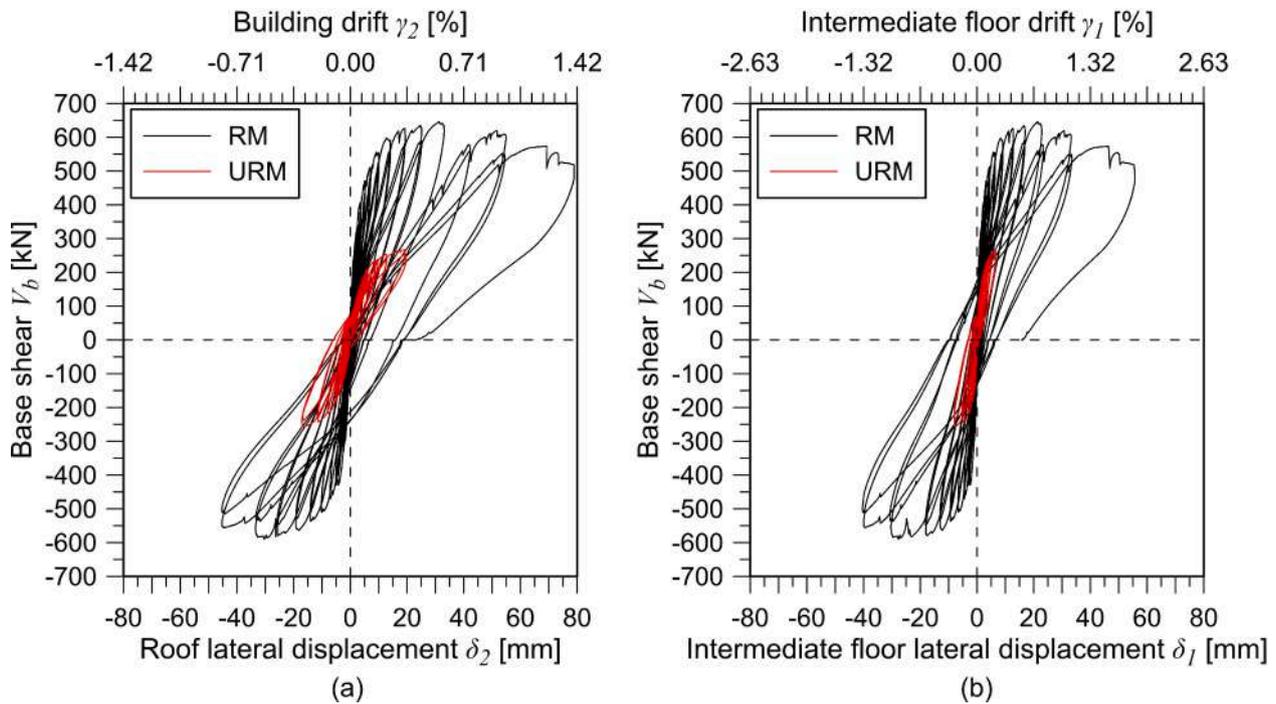
Fig. 15. RM: lateral load–displacement curves (a) V_b - δ_2 and (b) V_b - δ_I .

The curve is almost linear until the first flexural cracks occurred at top and bottom of the piers of the first level, on the unreinforced wall side, at a displacement $\delta_2 = \pm 0.3$ mm. At almost $\delta_2 = +0.4$ mm, the stiffness of the building gradually started reducing, as cracks developed on the coating, close to the corners of the first level openings. With increasing lateral deflection, similar cracks occurred near the openings of the second level, while diagonal shear cracks appeared on the coating of the spandrels above the openings of the first level, causing a further reduction of the global stiffness. At about $\delta_2 = +3.2$ mm, the flexural cracks of the first level piers and the diagonal cracks of the spandrels began to spread locally and, contemporarily, diagonal shear cracks appeared in the piers. When exceeding $\delta_2 = +9.2$ mm, the cracks widely spread, causing a significant stiffness degradation. The maximum shear capacity was attained at +645 kN ($\delta_2 = +31.4$ mm) and -590 kN ($\delta_2 = -30.5$ mm). After the peak load, a gradual resistance decrease was observed. At $\delta_2 = -32.0$ mm, the first level piers suffered a significant opening of their cracks, promoting a sharp reduction of the global lateral stiffness in the subsequent cycles. Once a decrease in post-peak resistance of about 15 % was achieved, the test was conducted monotonically in the positive loading direction, up to near collapse. A sharp decrease of resistance from $V_b = +573$ kN to +509 kN occurred, as the GFRP mesh failed at the base of the piers Ep1b and Wp1a (Fig. 16a,b). Only two transverse injected steel connectors, located at half height of the piers Ep1b and Wp1b, were crossed by the diagonal cracks, but no wall leaves separation was detected. The pier Wp2b did not show any damage.

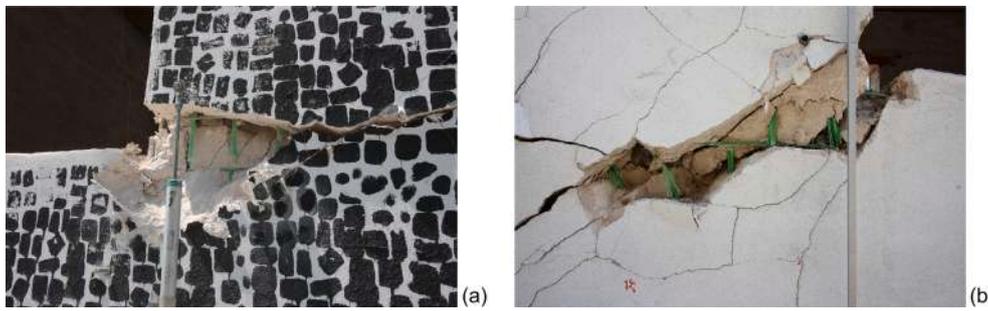
Fig. 16. Mesh failure at the bottom left corner of the pier Ep1b (a) and at the bottom right corner of the pier Wp1a (b).

8. Significant opening of the piers' cracks of the 1st level; abrupt decrease of the global lateral stiffness.	-537	-29.68	-31.95	-0.976	-0.566
9. GFRP mesh failure at the base of piers Ep1b and Wp1a.	+509	+46.88	+69.28	+1.542	+1.28

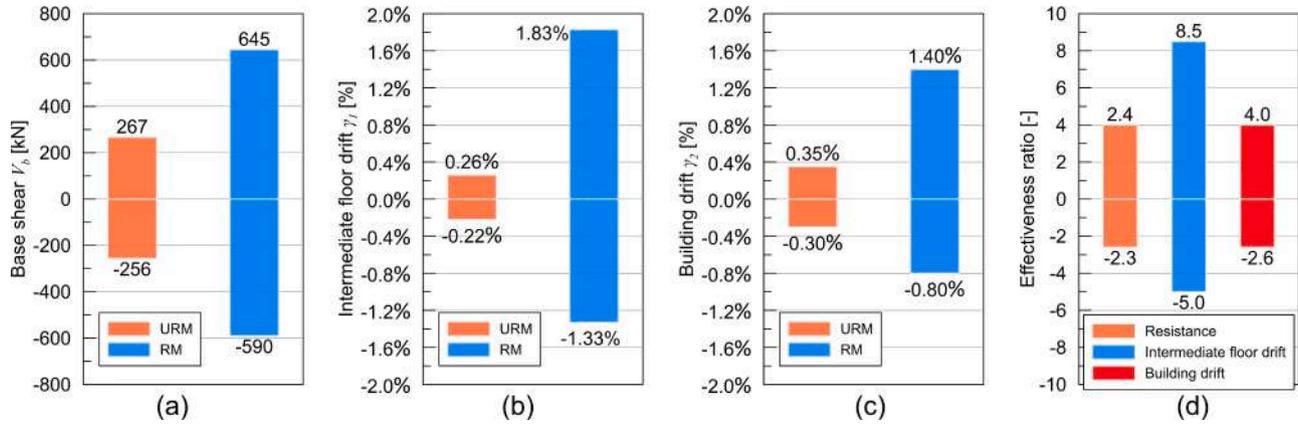
Fig. 17. Comparison between the URM and RM building: attained base shear V_b (a), intermediate floor lateral displacement δ_1 (b), roof lateral displacement δ_2 (c), and effectiveness ratio (d).

The maximum values of V_b , δ_1 , γ_1 , δ_2 and γ_2 obtained in the URM and RM building tests are summarized in Fig. 17. The effect of strengthening can also be assessed by comparing the hysteretic response of the two tests in Fig. 15, which show that lateral resistance increased by about 2.4 times, the displacement capacity became four times higher.

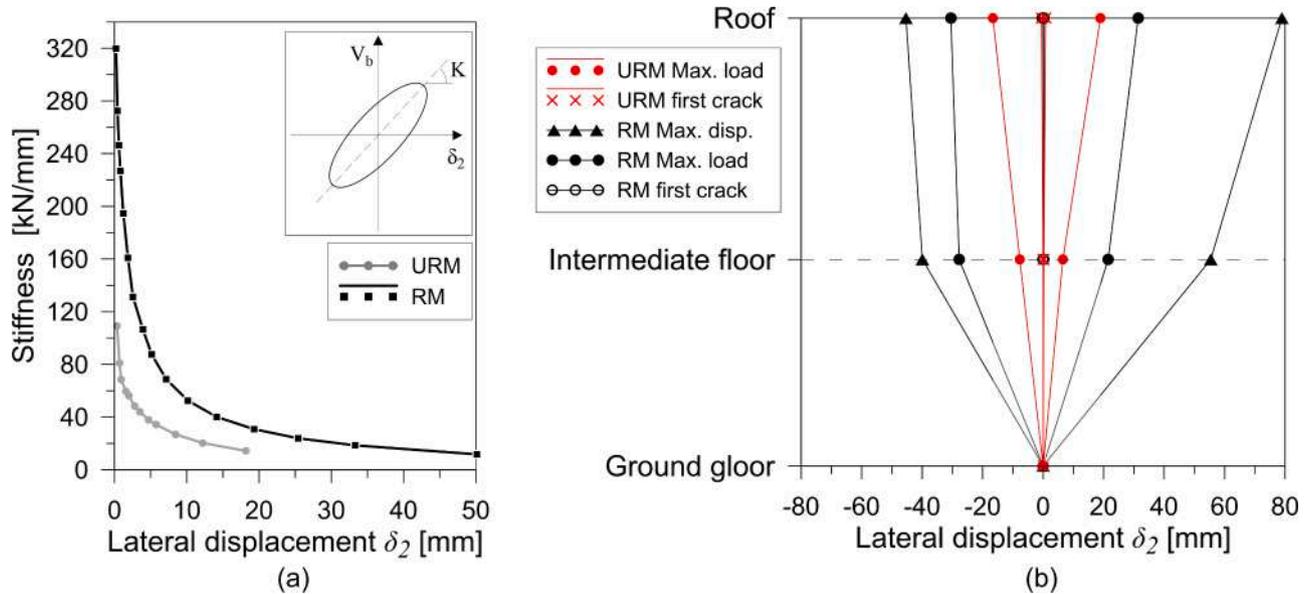
Fig. 18. URM and RM building: comparison in terms of (a) evolution of lateral stiffness and (b) deformed shape at different loading levels.

To evaluate the stiffness (K) degradation, the slope of the peak-to-peak line within the first loop performed at each displacement level of the V_b - δ_2 curves was calculated (Fig. 18a). In the URM building, the secant stiffness in the first cycle was 109 kN/mm and ultimately decreased to 14 kN/mm. The stiffness of the first cycle of the RM

This change in behaviour can clearly be seen in Fig. 18b, where the displacements measured at the intermediate floor and at the roof are reported in different significant steps, for both URM and RM building: the larger displacements in the unreinforced structure occurred in the upper level, while in the reinforced structure the displacements of the lower level were more significant. In the URM building, the test was interrupted after reaching the maximum load. The first cracks were reached at the same displacement values for the URM and RM building.

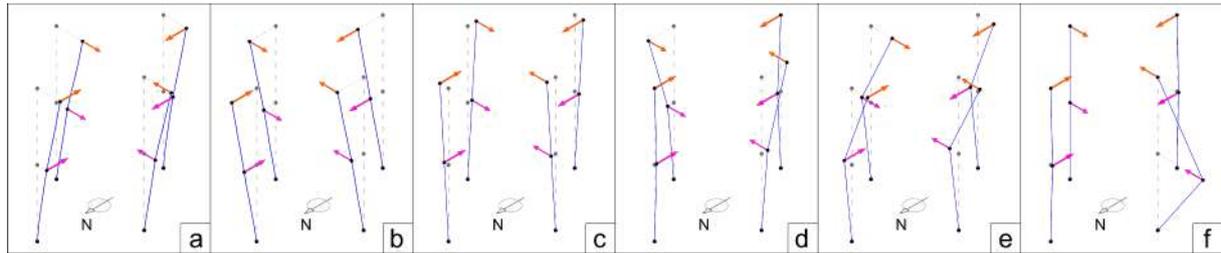
Fig. 19. Vibration mode shapes.

In the undamaged URM building, mode 1 was translational in the transversal direction (type “a” mode shape in Fig. 19) and mode 2 in the longitudinal one (“b”); mode 3 was rotational about the vertical axis (“c”); mode 4 described longitudinal walls oscillating out of plane in phase opposition (“d”); in mode 5 the longitudinal walls oscillate out of plane with floors in phase opposition (“e”).

In the damaged URM building, the fundamental vibrating modes were inverted: modes 1 and 2 were translational in the longitudinal (“b”) and transversal direction (“a”), respectively. Comparing with the undamaged configuration, the frequency of the mode shape “a” decreased by -14.9% and that of “b” by -24.6% . This is reasonably related to a stiffness degradation due to the damaging. The rotational mode about the vertical axis was not detected. Mode 3 described the out of plane oscillation of the longitudinal walls in phase opposition (“d”); in mode 4 the longitudinal walls oscillated out of plane, with floors in

In the damaged RM building, modes 1 and 2 were translational in the longitudinal (“b”) and transversal (“a”) direction, respectively; mode 3 was rotational about the vertical axis (“c”); modes 4 and 5 were of type “d” and “e”, respectively. As for the RM, the damage induced an evident frequency decrease. The change was -21.0 % with respect to the

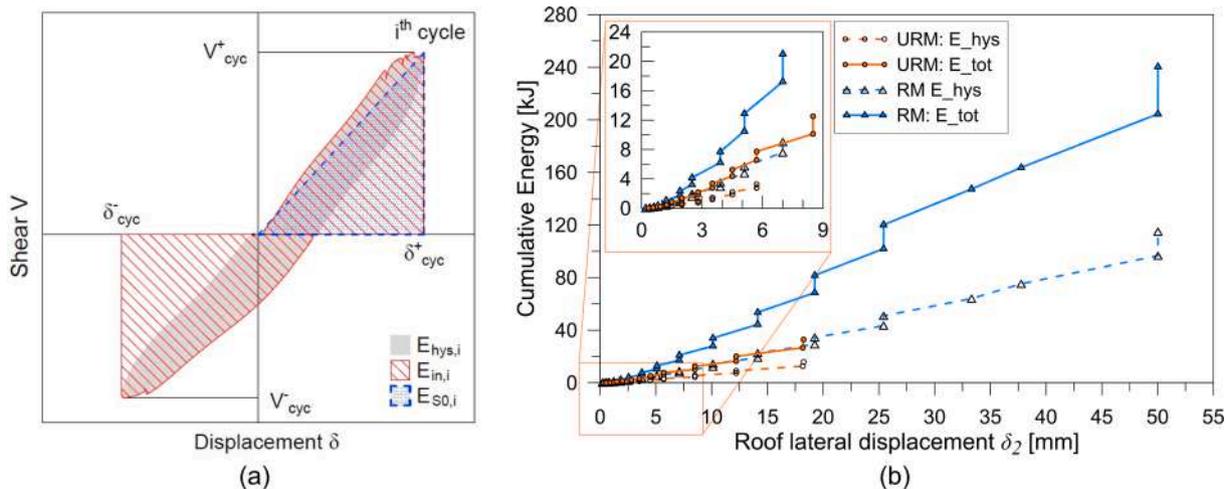
Fig. 20. (a) Schematization of input energy and dissipated hysteretic energy referred to a single base shear vs. displacement loading cycle; (b) comparison between the URM and RM building in terms of cumulative dissipated E_{hys} and total E_{in} energies.

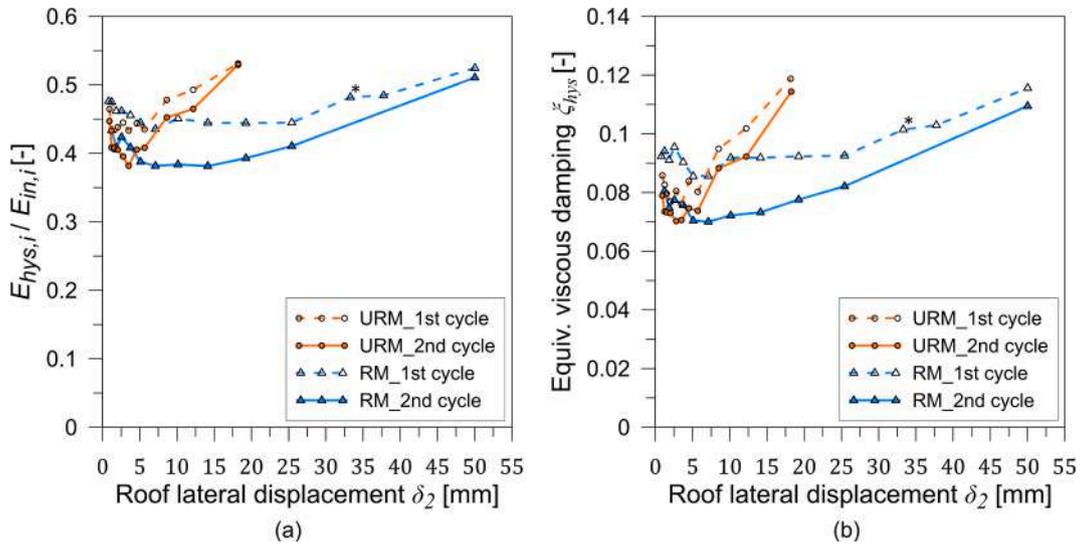
Fig. 21. Comparison between the URM and RM building in terms of (a) $E_{hys,i}/E_{in,i}$ ratio, varying the lateral roof displacement δ_2 and (b) evolution of the equivalent hysteretic damping ratio ξ_{hys} .

In Fig. 21a, the total and dissipated cumulative energy determined at each loading cycle are plotted as a function of the lateral roof displacement, δ_2 , for the URM and the RM building. Table 7 presents the values of E_{in} and E_{hys} at resistance peak ($\delta_{V,max}$) and at maximum displacement (δ_{max}). The dissipative capacity of the RM building was significantly larger than that of the URM one ($E_{hys, RM}$ was 8.4 times higher at maximum displacement). This is because the cracks in the strengthened building spread widely across the walls, whereas in plain masonry, the cracks appeared only in a limited number of mortar joints. The high redistribution of internal stresses in the coating thus resulted in increased strength and deformation capacities.

and after the peak load condition, ξ_{hys} almost coincided in the two cycles. Considering the initial cycles, the URM and RM specimens exhibited an initial hysteretic damping of about 8 % and 9 %, respectively, and maintained almost constant values till the attainment of the peak load. Then, ξ_{hys} tended to increase and, at the end of the test, reached about 12 % for both buildings. These values are comparable to those previously adopted by Gattesco and Boem [46], who considered ξ_{hys} of about 10 % for the ultimate limit state, both in the case of URM and RM buildings. Similar values were also obtained by Magenes [47] and Javed [48] for URM masonry.
