# The moisture issue affecting the historical buildings in the Po valley: A case study approach

Elisabetta Rosina\*, Megi Zala, Antonio Ammendola

Department of Architecture, Built Environment and Construction Engineering, Polytechnic University of Milan, Italy

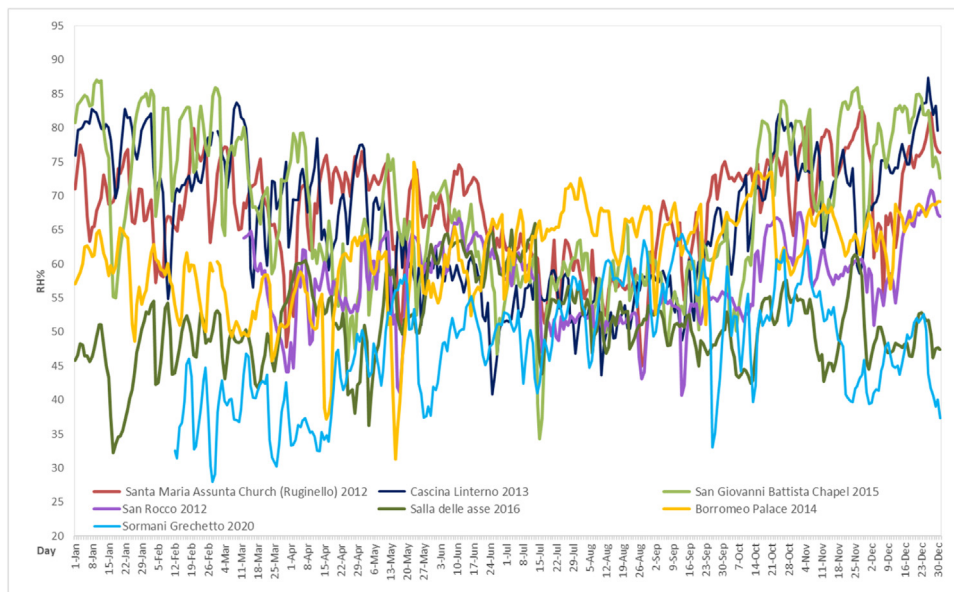
Fig. 3. The annual graph representing the daily relative humidity on the indoor environment for the case studies.

The microclimate was monitored using data loggers. Figs. 2-3 represent the annual daily average of T °C and RH%.
