# Assessing the structural behaviour of square hollow glass columns subjected to combined compressive and impact loads via full-scale experiments

Roman Kalamar<sup>a</sup>, Chiara Bedon<sup>b,\*</sup>, Martina Eliášová<sup>a</sup>

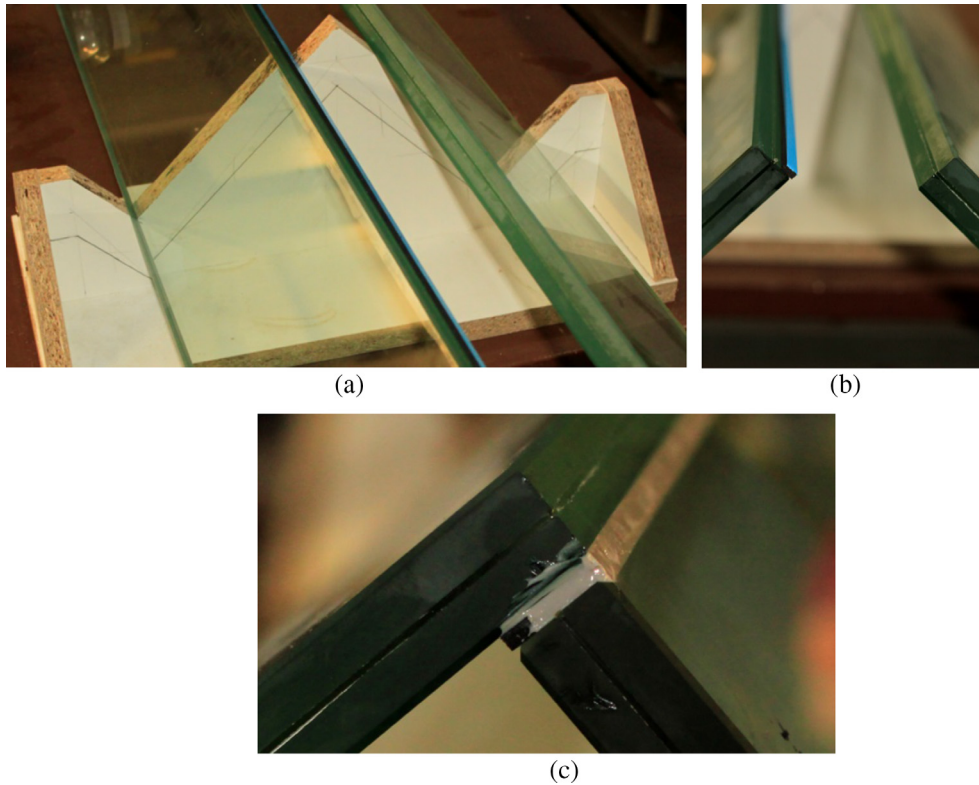
**Fig. 2.** Assembly of full-scale glass columns. (a) wooden forms acting as temporary supports and (b) detail of the distance tape, with (c) detail of an adhesive joint.

The correct position of the glass panels was verified by using a spirit level and eventually balanced by means of additional wooden wedges, in order to ensure a regular thickness for the adhesive joints to be realized along the specimens full length. To this end, special joint tapes – 6 mm in width and 3 mm in thickness, with double-sided adhesive surfaces – provided by the adhesive supplier were also used (Fig. 2(b)). The 3 mm thick gap provided by the tape was hence filled with the SIKAFast® 5215 – NT [29] structural adhesive (Fig. 2(c)).

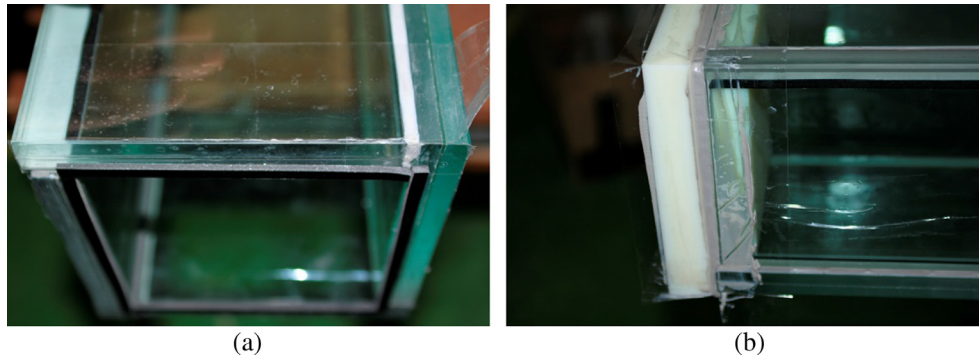
**Fig. 3.** Assembly of the columns end supports. (a) Distance tapes fixed at the top and bottom edges of the glass panes, with (b) detail of a plastic pad glued together with the glass components.

Once assembled the two half-columns together, at a final stage of the assembly phase, the end supports of each column were properly fabricated. The plastic pads adhesively connected to the columns ends were first prepared. As in the case of the panels' vertical edges, additional gap tapes were adhesively connected on the top/bottom faces of each specimen, see Fig. 3(a). A 3 mm glue joint was hence again realized, in order to provide the structural interaction between the glass panes and the end restraints (Fig. 3b).

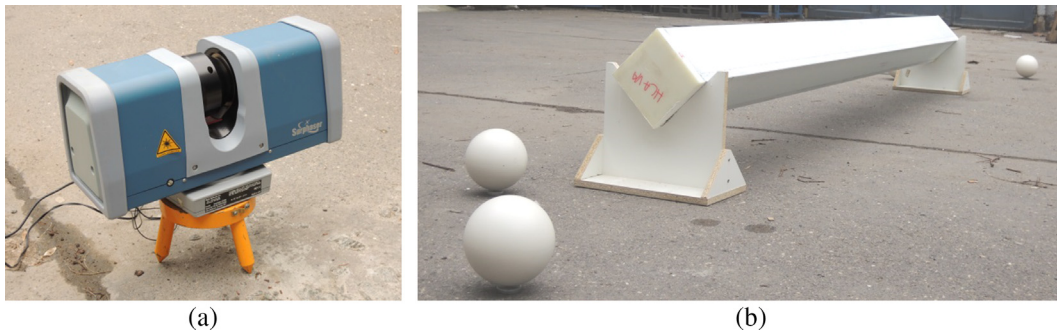
**Fig. 4.** Optical scanning measurements. (a) Optical component of the scanner and (b) overview of the white painted S01 specimen.

was chosen, for this purpose. For the determination of global imperfections of the assembled glass pillars, a Surphaser 25HSX panoramic scanner was used, see Fig. 4(a). Since the working mechanism of measurement of the panoramic scanner consists in sending a laser signal and capturing its reflection from the scanned object – due to transparency of the assembled glass specimens – the S01 column was painted with white colour (Fig. 4(b)). The result of scan mapping is a system of cross-sections able to accurately reproduce the overall three-dimensional surface of the column, see Fig. 5(a).

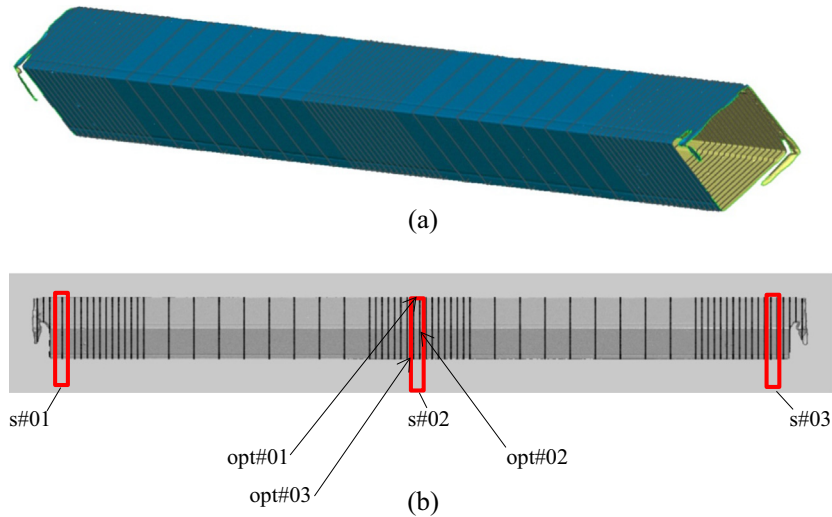
**Fig. 5.** Results of the optical scanning measurements. (a) 3D view of the full specimen scanning, with individual cross-sections (axonometry) and (b) side view of the specimen, with s#01, s#02 and s#03 selected cross-sections (s#01 = base of the column; s#03 = top).

For the comparative evaluation of the so measured data, three representative cross-sections were chosen in the column, namely two cross-sections close to the column ends (s#01 and s#03 in Fig. 5(b)) and to its mid-span cross-section (s#02), see Fig. 5(b).

While optical measurements were carried out for a multitude of sections distributed along the full specimen, see Fig. 5(a), the relative displacements of the s#02 and s#03 cross-sections only were critically compared with respect to the s#01 reference one, and considered (due to their position along the column length) well representative of any possible global imperfection.

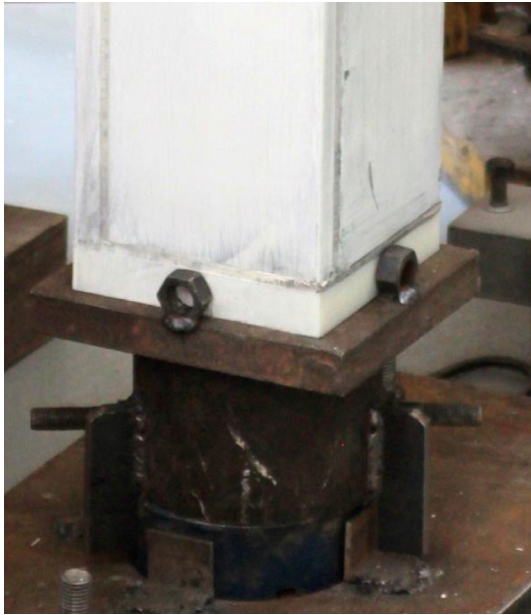
**Fig. 7.** Experimental setup for impact tests, detail of the actual end restraint for the full-scale specimens (base restraint).

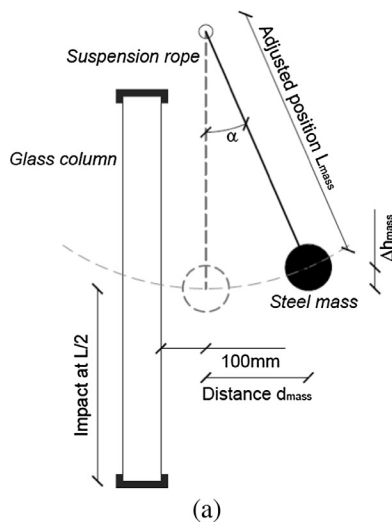
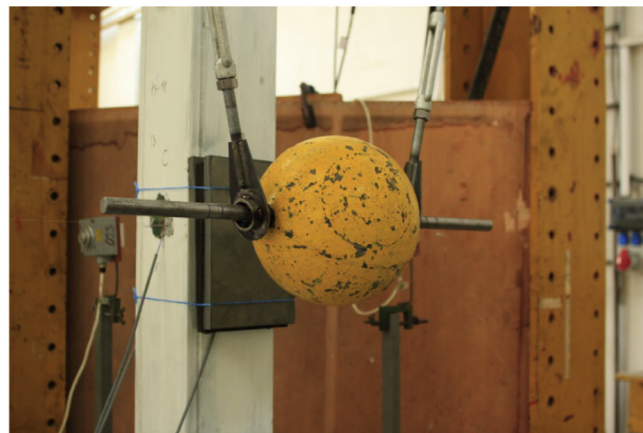
**Fig. 8.** Full-scale impact tests. (a) Overall impact loading scheme (lateral view) and (b) detail of a typical experiment, with evidence of the impact region.

was finally interposed between the glass specimens and the steel sphere (see detail of Fig. 8(b)), for some of the impact loads only. In the case of the S01 specimen, the protection pad was always accounted, while in the case of the S02 specimen the protection pad was used for some hits only and then removed for the last sequence of hits.

typical specimen was placed in a MTS device and subjected to linearly increasing compressive loads. Four tests were carried out with several speed values for the imposed compressive loads, i.e. with an imposed strain rate set respectively equal to 1 mm/min, 5 mm/min, 10 mm/min and 20 mm/min. As in the case of the full-scale impact tests, the experimental program was carried out in non-controlled temperature and humidity laboratory conditions. The compressive force was transmitted to the pad by interposing a steel round plate (with actual diameter 35.1 mm and thickness 10.0 mm) between the specimen and the load actuator. This small steel plate, see Fig. 10(a), was chosen since well representative of the contact region between the steel sphere and the rubber pad during the typical full-scale test (see Figs. 8 and 10(b)).

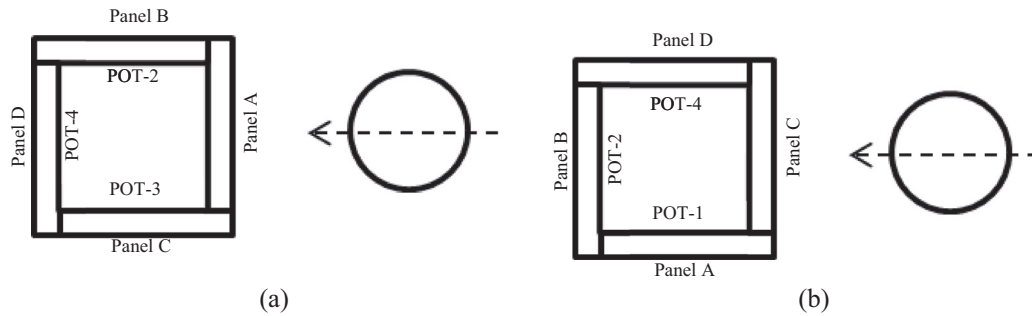
Fig. 9. Labelling of glass panes with respect to the impact mass, (a) S01 and (b) S02 specimens (transversal cross-section).

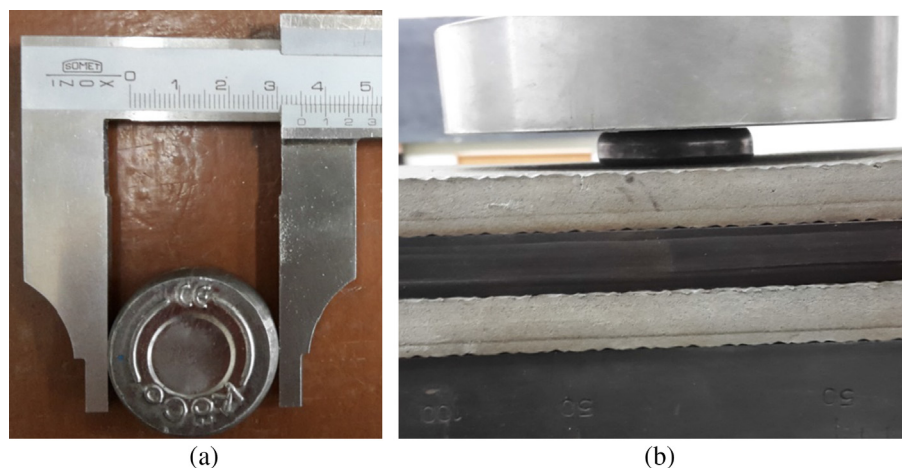
Fig. 10. Small scale experiments on the rubber pads. (a) Detail of the steel round plate representative of the contact region with the impact sphere and (b) typical compressive test on the rubber pads (lateral view).

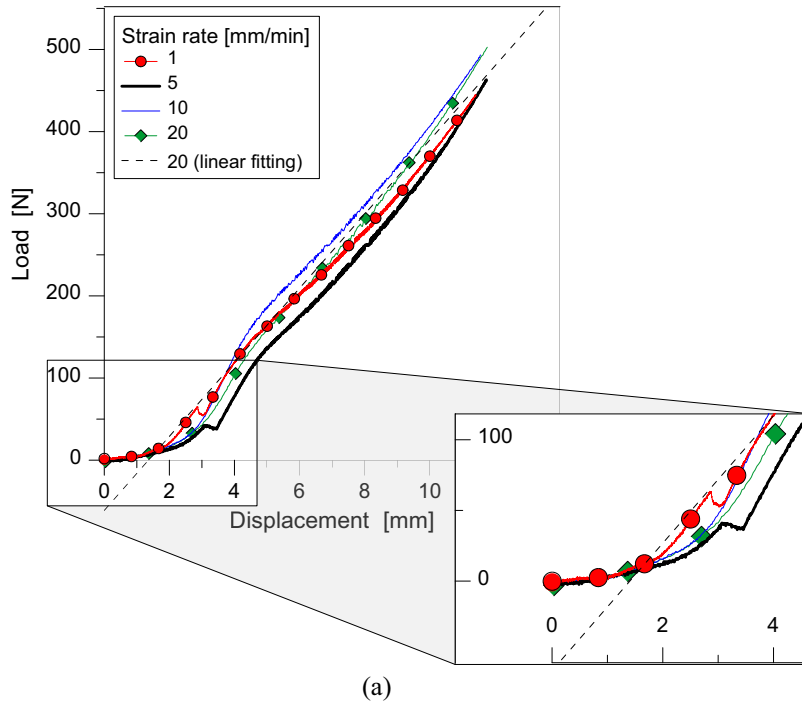
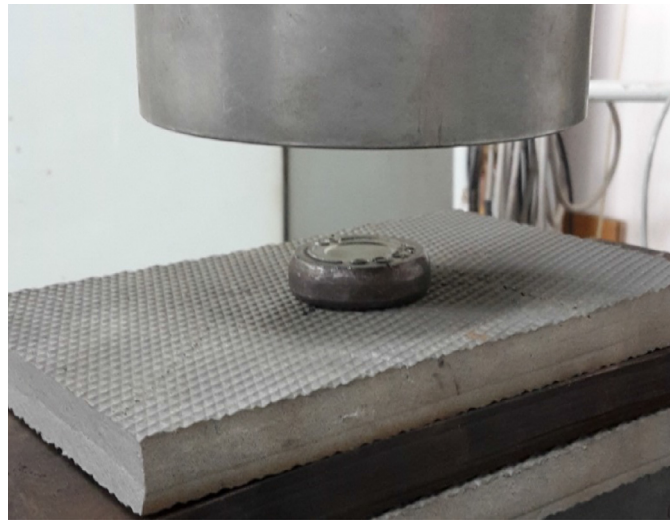
**Fig. 11.** Compressive tests carried out on the rubber pad. (a) Comparative load-displacement results, as obtained by changing the strain rate and (b) example of surface adjustment during the first loading phase, as observed for the experiment with 1 mm/min rate.

interface between the test samples and the steel plate. From Fig. 11(a), it can be noticed, for example, that as far as a maximum deformation in the order of  $\approx 3$  mm is attained, a sort of relaxation effect in the applied force can be noticed. This phenomenon was experimentally observed only in the case of tests characterized by minimum imposed strain rate values, i.e. 1 mm/min and 5 mm/min. The top surface of the pad in direct connection with the steel plate, in this regard, was characterized by a grid, which locally deformed during the first loading phase only (see Fig. 11 (b)).

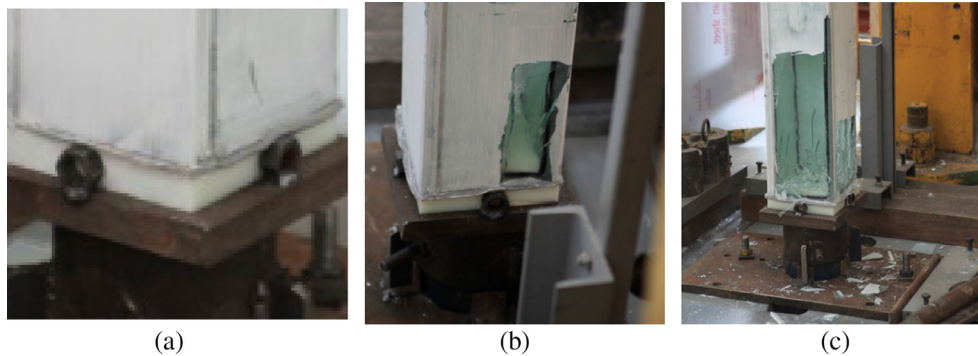
Fig. 13. Progressive damage and collapse of the S01 specimen. (a) Detail of the adhesive layer, (b) first cracks at the column base and (c) delamination of the paint from the panels surface, with evidence of cracks at the column base.

The first cracks in glass were observed at the base of the column, panel A, for a compressive load  $N_{f,1} = 630$  kN, see Fig. 13(b). The final collapse of the column occurred at  $N_{f,max} = 780$  kN, which

In terms of damage propagation up to collapse, premature and marked splitting deformations in the base adhesive, see Fig. 13(a). The first cracks at the base of the column panel were then clearly visible, thanks also to the progressive delamination of the painting from the specimen surface (Fig. 13(b)). The further increasing opening of cracks was thus easily monitored by simple visual check of the specimen, up to collapse (see for example Fig. 13(c)).

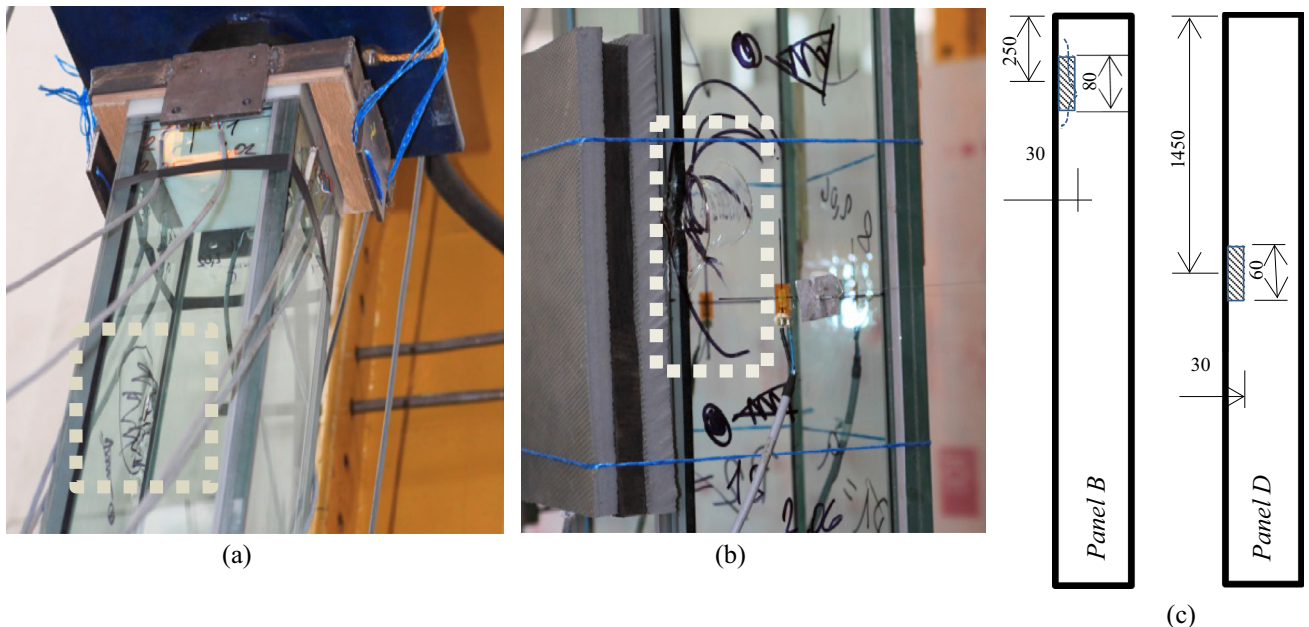
Fig. 14. Preliminary damage of the S02 specimen. (a) top cross-section (DAM02), (b) mid-span cross-section (DAM01), with (c) schematic representation of damage locations (dimensions given in millimetres).

Fig. 14 provides an overview of the so assigned damage locations. A steel hammer was used to hit the laminated panes, aiming to crack and remove the external glass layer only.

The first damage location (DAM01) was detected in the middle cross-section of the column (i.e. at a vertical distance of 1450 mm from the column top end), close to the lateral edge of panel D (see also Fig. 8(b) for labelling of glass panes). Cracks interested the outer layer only of the laminated glass panel, spanning over a region of approximate dimensions 60 × 30 mm. The second damage location (DAM02) was detected at the top of the column, close to the vertical edge of panel B, and interested also in this case the outer glass layer only of the laminated pane. A region of approximate dimensions 30 × 80 mm, at a vertical distance of 250 mm from the top end was measured.

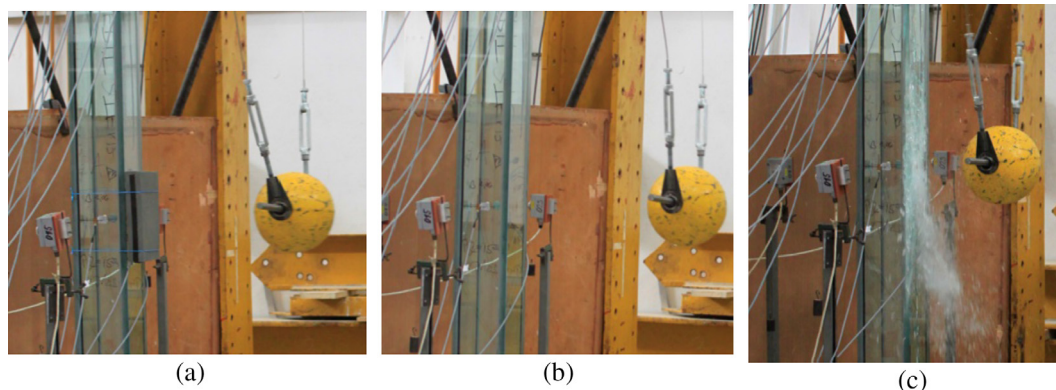
**Fig. 16.** Impact test on the S02 specimen. (a) Soft-body hits (with the rubber protection pad); (b) hard-body hits (rubber pad removed) and (c) corresponding damaged configuration for the column (2E loading configuration, with 1700 mm the release distance).

A further sequence of impact loads was then carried out, by removing the rubber pad (Fig. 16(b)). Compared to the previous soft-body impacts, this latter series was considered representative of accidental hard-body impacts on the specimen. Again, the release distance for the steel sphere spanned from 750 mm to 1700 mm (see Table 3). None of the first shocks caused apparent macro-cracks in the glass panes, with exception of the last hit released from the maximum distance (1700 mm, loading configuration 2E), see Fig. 16(c).

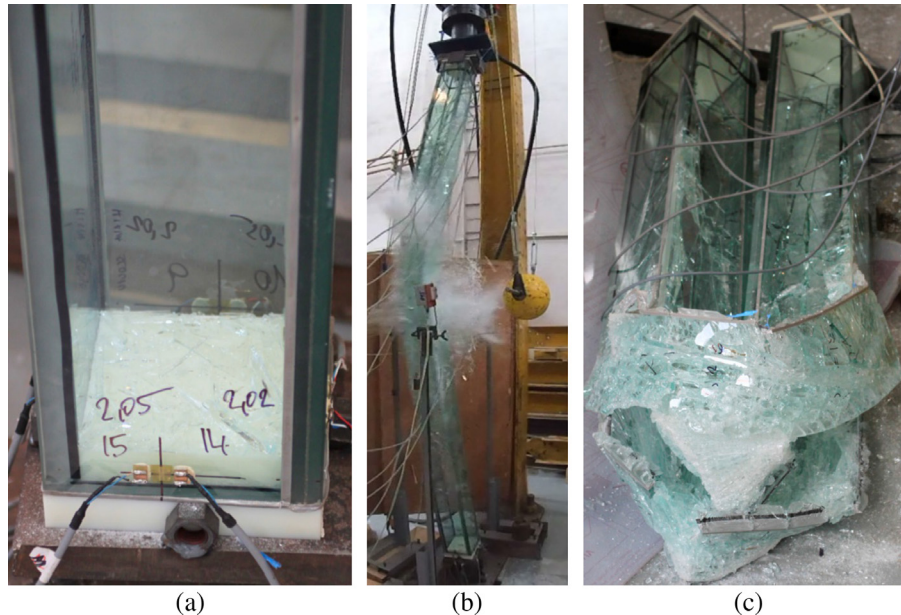
**Fig. 17.** Progressive damage of the S02 specimen close to collapse. (a) Detail of the adhesive joint at the base of the column, (b) instant of collapse and (c) S02 specimen at the conclusion of the experiment.

specimen, this effect was mainly justified by the presence of initial damage and asymmetry in the S02 column. In terms of fracture and collapse behaviour, the last sub-step of the experiment was characterized by damage both in the glass panels as well as in part of the adhesive joints. This latter effect can be noticed from Fig. 17(a), where the adhesive joint connecting the glass pillar (base section) and the plastic pad is pushed out of its original position. Differing from the S01 specimen, glass cracking initiated and progressively propagated from the centre of panel C directly exposed to impact (Fig. 16(a)). The collapse mechanism of the column was in any case associated to a typically sudden and abrupt phenomenon, with total loss of stability and null residual resistance for the specimen (Fig. 17(c)).
