# Experimental tests for the assessment of residual strength of r.c. structures after fire – Case study

A fire in a ham factory in San Daniele del Friuli caused serious damage to the prefabricated reinforced concrete (r.c.) roof panels and smaller damages to beams, columns and walls. In this paper the data captured during preliminary inspection of the building structure are described. To determine the residual strength of steel reinforcements and concrete of r.c. structural elements, a test program with laboratory and in situ tests is presented. The program includes test methods that are able to catch the variability of concrete degradation with distance from the heated surface. Test results are presented and their acceptability in relation to Italian Code is discussed. It is found that the amount of transversal and longitudinal reinforcements strongly influences the deterioration of the concrete due to fire and, consequently, the strength of structural elements. On the basis of tests results, a discussion on the advantages and limitations of the adopted test methods useful for the designers is performed. To restore the load-bearing capacity of the structure, repairs of columns an

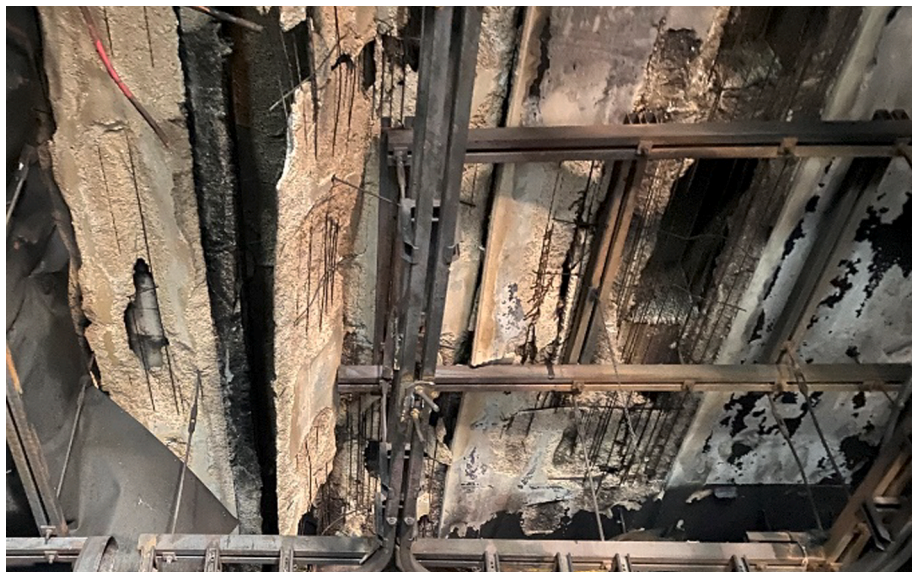
During the inspection at the construction site, it was observed that the most damaged area was the receiving zone, where the greatest volume of fire load was stored. In particular, the most severely damaged elements of the load-bearing structure appeared to be the prefabricated r.c. panels of the roof over the receiving zone. Large portions of concrete had fallen off, laying bare the reinforcements along the whole surface of the roof (Fig. 2). Moreover, the adhesion between reinforcements and concrete was visibly impaired. The panel depth affected by concrete spalling often exceeded the cover, and, in some parts, spalling depth was equal to the panel thickness. Reinforcement buckling occurred as well.

Fig. 2. Damage caused by fire in the prefabricated panels of the roof over the receiving zone.

- (5) Replacement of the roof panels with panels with the same load-bearing capacity, and restoration of the steel reinforcements.
- (6) Filling of the holes in the central beams with anti-shrinkage grout.

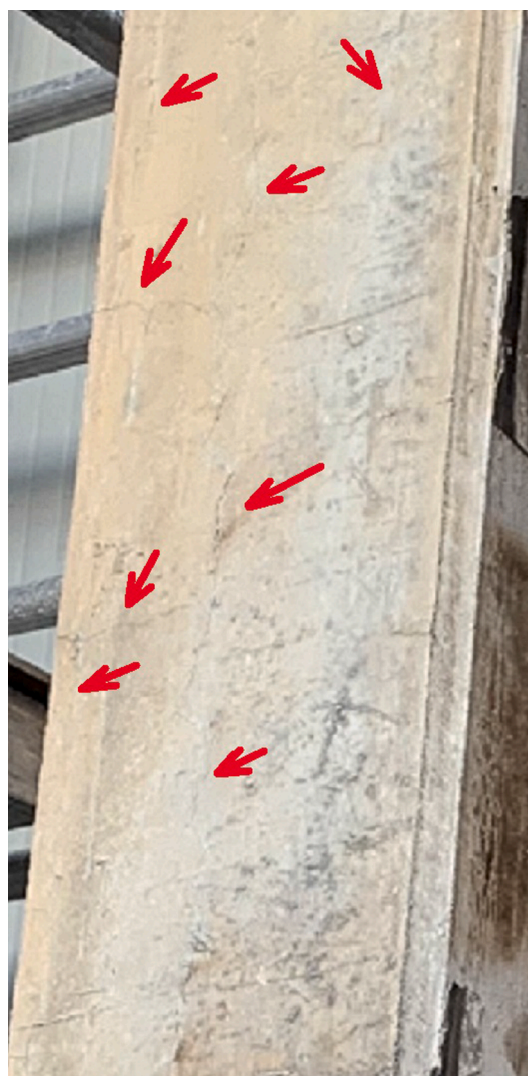
By visual inspection, splitting cracks around the reinforcement and internal cracks parallel to the fire-exposed surfaces were ascertained. Moreover, in column cross-sections, the chromatic change of concrete

Fig. 3. Splitting cracks around reinforcements in a column in the receiving area.

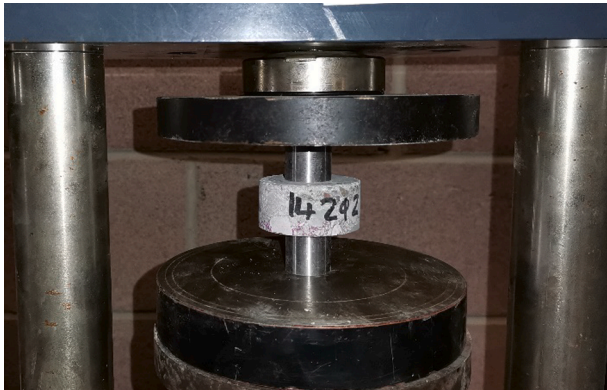
For r.c. structures not affected by fire, cores compression strength is mainly determined by the concrete located in the middle third of the specimen height, since this zone is weaker than the outer thirds, which are confined from the steel plates transmitting the test load. By contrast, for structures damaged by fire, the deterioration of concrete in the outer layers exposed to fire can lead to a reduction in concrete strength that exceeds the expected increase in strength in these layers due to confining action of the steel plates transmitting the load. Thus, test results coincide with the lower strength of the concrete located in the middle third and the concrete in the damaged outer layers. Moreover, tests on cores do not account for the variability of concrete strength degradation along the specimen height as a function of the temperature range to which the concrete has been subjected. Therefore, failure stress of cores extracted from fire-damaged structures and subjected to compression are difficult to interpret. For these reasons, an equivalent compression strength of concrete was obtained from concrete flat discs, as suggested by [8]. More precisely, discs 2.5 cm thick were obtained by slicing core samples perpendicularly to the longitudinal axis. Of the 2 discs derived from each cylinder, a punching test was carried out on the disc nearest the surface exposed to fire. In this test, compression is applied to disc cores by means of two cylindrical pins of diameter 2.5 cm, at a rate of 0.4 MPa/sec. In order to reduce significantly effects due to friction between the cylindrical pins and the disc, the interface was lubricated with stearic acid. The test setup is shown in Fig. 7.

Fig. 7. Punching test setup on concrete disc.

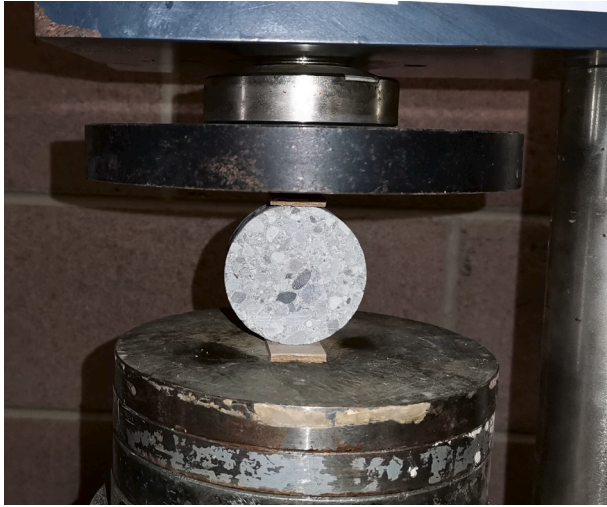
Differently from [3], where discs 1.5 cm thick are considered, indirect tensile tests are carried out on discs with thickness 2.5 cm.

The discs were obtained from cylinder specimens, adjacent to the discs used for punching tests, at a depth of 2.5–5 cm. One disc for each cylinder was subjected to the indirect tensile test. Discs subjected to

Fig. 9. Indirect tensile test on concrete disc.

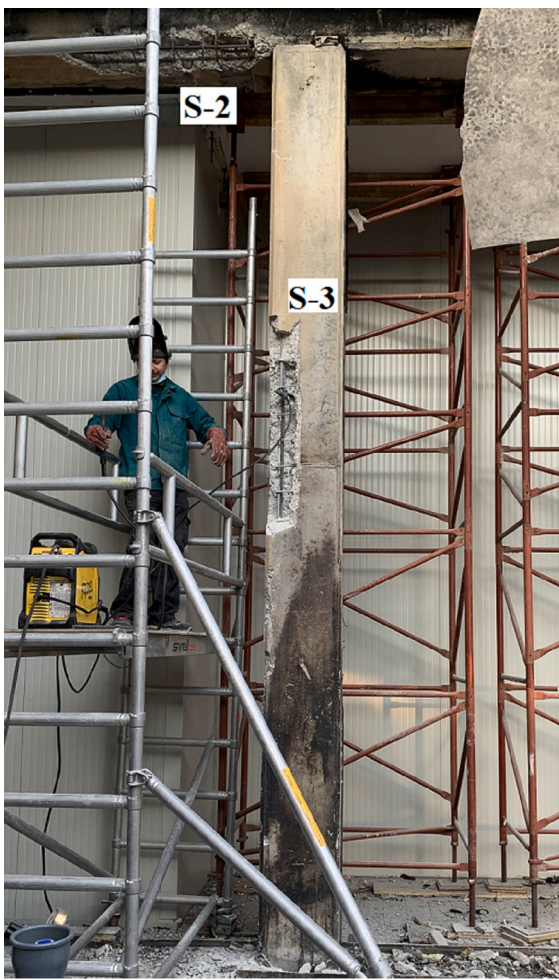
Four reinforcement samples were taken from the most damaged members in the receiving area, investigating all structural member typologies (i.e. beams, columns and walls). Samples about 70 cm long were obtained by cutting, by means of grinder, steel bars of structural elements, bared from the concrete cover. Then, testing samples of length 53 cm were derived for axial tensile test. Locations of steel sampling points are marked with the label S (Steel) in Fig. 5. In Fig. 10 the positions of samples S-2 and S-3 are shown. The diameters and test results of samples, i.e. yield strength, f<sub>y</sub>, and ultimate strength and strain, f<sub>u</sub> and ε<sub>u</sub>, respectively, are reported in Table 6. Samples S-3 and S-4 after failure are visible in Fig. 11.

Fig. 10. Location of reinforcement samples S-2, in the beam, and S-3, in the column.

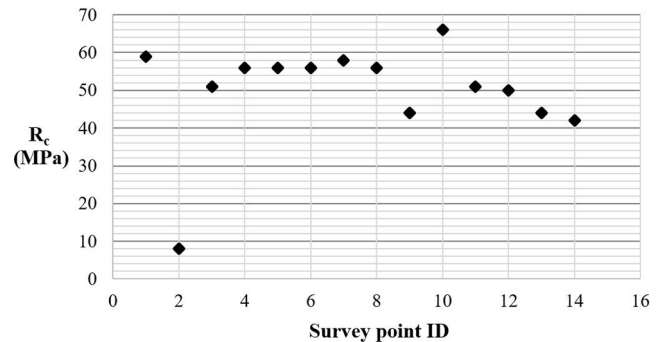
Concrete compressive strength based on rebound hammer measurements on structural elements made of concrete C25/30 are shown in Fig. 12. From Fig. 12 it can be seen that, for the most part, strength values range from 50 MPa to 60 MPa. This data set includes survey points both far away from and near the receiving area (Fig. 5), where the most severe damage was observed. Values of concrete cubic compressive strength lower than 50 MPa were obtained only in spots RH-30-2, 9, 13 and 14, for which  $R_c$  is equal to 8, 44, 44 and 42 MPa, respectively.

By comparing the strength values obtained from walls (44 and 42 MPa) with that obtained at the end of the adjacent beam of the frame (8 MPa), it can be derived that the presence of larger amount of reinforcement strongly reduces concrete compressive strength after fire. It follows that, for buildings in earthquake zones, the greatest fire damages

Fig. 12. Values of cube compressive strength of concrete based on rebound hammer measurements on structural elements (beams, columns and walls) made of concrete C25/30.

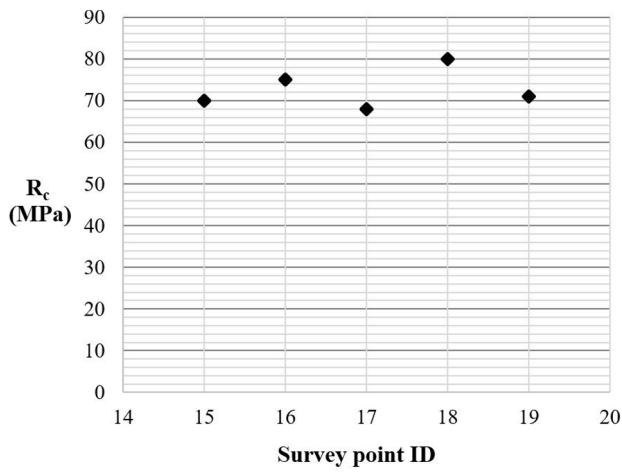
As regards prefabricated roof panels, made of concrete C35/45, values of compressive strength derived from rebound index are presented in Fig. 13. This figure shows that strength values range from 68 MPa to 80 MPa. Moreover, it can be seen that, as sample locations move away from the receiving area towards the delivery shed (survey points from RH-45-15 to RH-45-19), the compressive strengths neither increase nor decrease in a perceptible pattern, but change randomly. Thus, it can

Fig. 13. Values of cube compressive strength of concrete based on rebound hammer measurements on roof prefabricated panels made of concrete C35/45.

be presumed that the roof panels over the deboning area were not damaged by fire.
