Laboratory Ageing Thermal Cycles of MV Cable Joints: results of different diagnostic techniques

Abstract— The article reports the results of a multi-year experimentation in progress at the RSE laboratories and aimed at an in-depth diagnostic analysis of the causes of failure responsible for the out-of-services which affect MV cable joints of most of the urban network in the summer periods. To this aim an experimental set-up consisting of twelve cables equipped with different types of joints were connected together to form a ring in short-circuit. The ring was energized at rated voltage and current cycles were applied by means of external coils in order to reproduce the daily load variation typical of a MV cable network. Felts were wrapped around the cables to simulate the reduced thermal conductivity of the soil during summer periods. Continuous monitoring of the degradation of the joints was carried out by Partial Discharge (PD, on-line and off-line) measurements, together with Frequency Dielectric Spectroscopy (FDS) and Dissipation Factor (DF) - measurements. Results of the experimentation are presented and discussed.

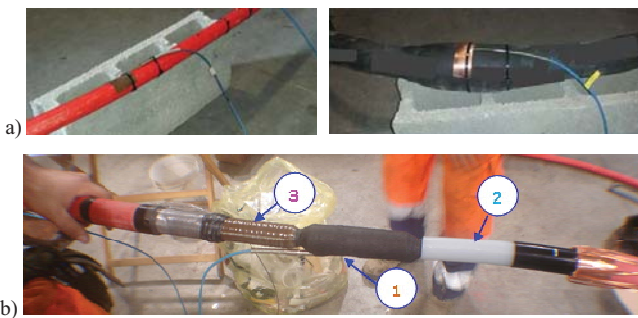
Figure 1 - View of the points of installation of the thermocouples outside the cable and the joints (mirror and main rings) a), and inside the joints (mirror ring) b).

Cycles of temperature from the ambient to the rated temperature, have been applied to induce accelerated ageing (and possibly defects) due to thermo-mechanical stresses, inducing current in the ring by means of heating toroidal transformers. The temperature was measured using thermocouples installed on the joint and cable surfaces, Figure 1a. A mirror-ring, composed by new XLPE and oil/paper cables, also equipped with new joints and with the same ratings, has been prepared. In this mirror-ring, the same current of the main ring was induced, but in the absence of the voltage supply. In the mirror-ring, temperature sensors were also installed on the joint and cable surfaces, but inside the joint Figure 1b, close to the conductor, to measure the radial temperature differences, thus allowing a more accurate estimation of the real temperature of the conductors of the main ring (and the effect of voltage in the ageing process).

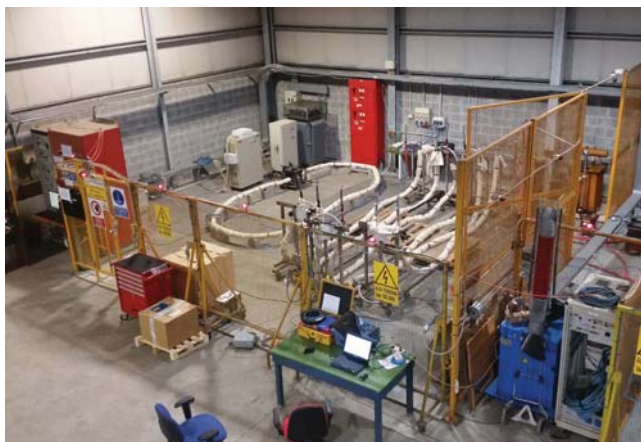
Figure 2 - Experimental set-up: view of the mirror ring and the part of the main ring with the six new joints (the other six from service are on the right part of the circuit and not visible in the picture).

Both rings were covered with felts to simulate the underground conditions during dry and hot periods, Figure 2. At this regard it should be noted that no humidity were simulated and that the six new joints were realized under the controlled laboratory environment (thus they should be free from assembling defects), in order to check if degradations were also possible under these conditions [12].

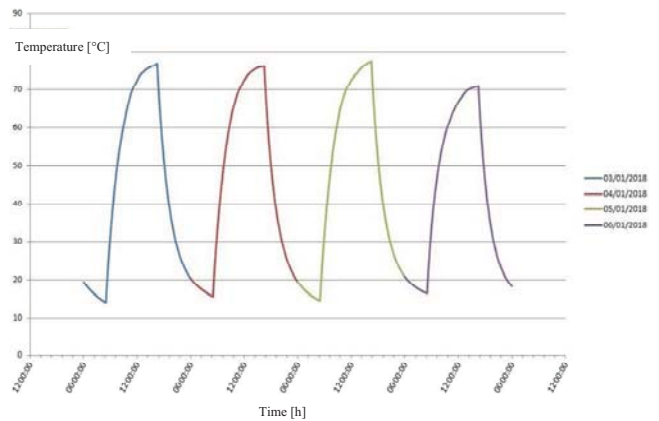
Figure 3 - View of four 24 hours cycles test.

Cycles of temperature of the duration of one day were applied to both cable rings (about 11 hours of heating and 13 hours cooling)

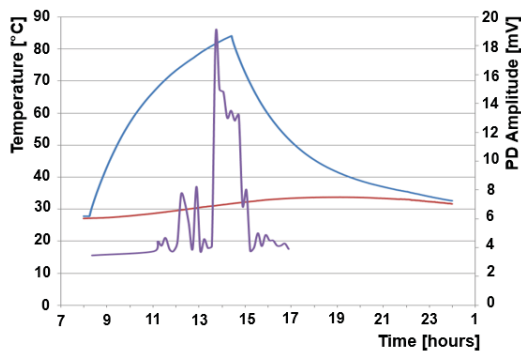
Figure 5 - Behaviour of room (red line) and conductor (blue line) temperature with the Vmax (purple line) recorded on Cable A during the 21th thermal cycle.

After 20 cycles, the first discharges appeared at 78°C on Cable A, then different PD patterns were recorded up to the maximum temperature of 84°C and during the cooling period Figure 5. The shape analysis of the PD patterns clearly addresses to the formation of a void whose typical pattern is clearly visible particularly in Figure 6A (82°C). This PD pattern was rapidly modified as the temperature increased Figure 6B, 84°C, as an indication of the recent formation of the defect.

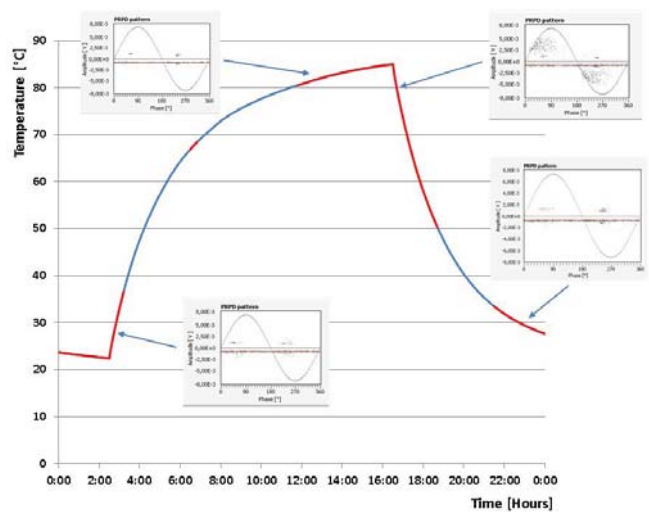
Figure 7 - Behaviour of conductor (blue line) temperature with the PD activity (purple line) recorded on Cable A during the 28th thermal cycle.

Always with an apparent random behaviour, bursts of pulses having higher PD, incepted and disappeared during the thermal cycles. Sometime these bursts incept during the cooling period and continued until a new heating period started. Figure 7 shows the profile of temperatures and the PD activities recorded during the 28th thermal cycle as an example.

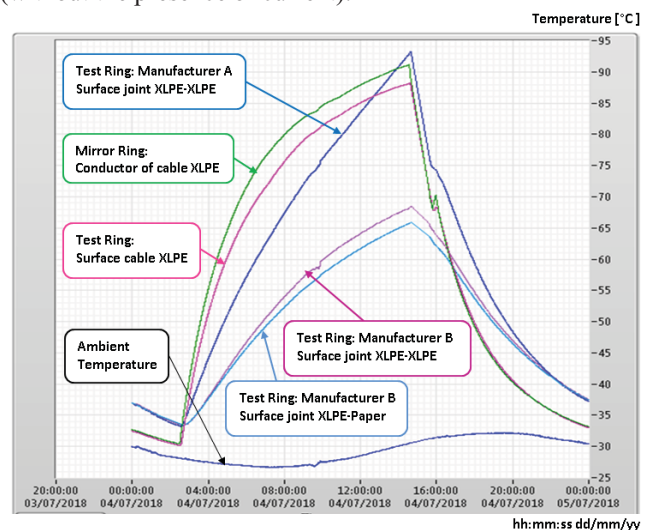
Figure 11 – Increase of the steepness of the temperature curve of XLPE homogenous joint A.

After about 280 cycles, significant variation were registered during the heating phase of XLPE homogenous joint A: the steepness of the curve increased thus reaching higher temperatures at the end of the heating period, Figure 11. Comparisons were also made between the same joint type in the test ring and in the mirror ring (without voltage), differences up to 15°C were observed in presence of the same current of 285A, thus confirming the importance of voltage losses to the temperature variation; in particular it was assessed that the phenomenon was increased in presence of temperature above about 55°C.

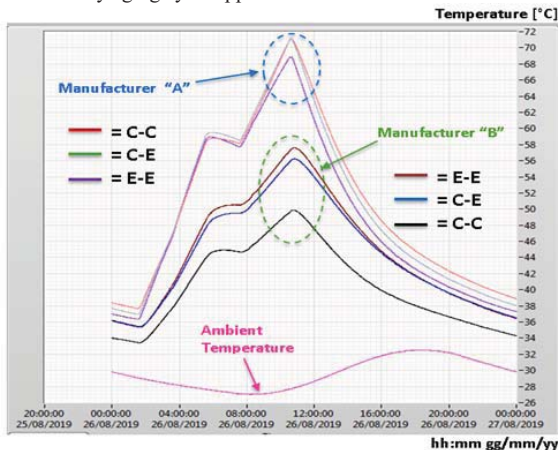
Figure 14 – Joints temperatures after more than 280 cycles

The deterioration phenomenon occurred mainly on the kits of manufacturer A and involved at first the homogeneous joints in extrusion, then the mixed ones and finally in the homogeneous joints with paper insulation (Figure 14).

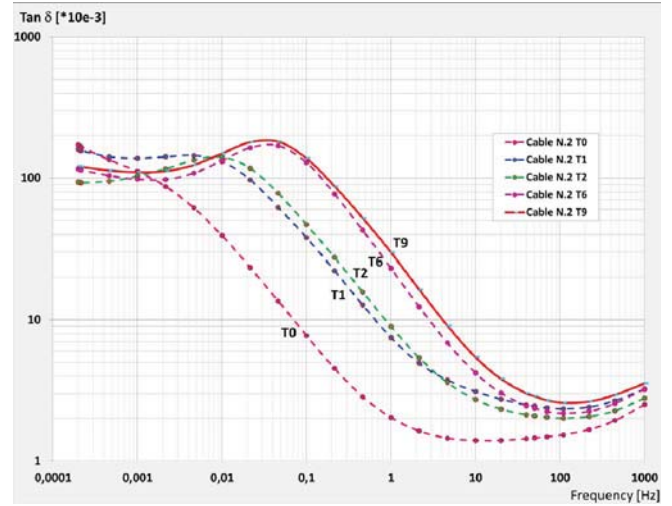
Figure 15 – FDS behaviour of the joint from 0 to 644 cycles .

This situation was also reflected by the FDS measurements carried out all along the period on all joints at ambient temperature. In particular with reference to one joint under examination an extracted of the curves is reported in Figure 15. Here it is evident that another important phenomenon occurred in addition to what occurred from T0 to T1. Then from T6 to T9 the behaviour of $\tan\delta$ with frequencies stabilized.

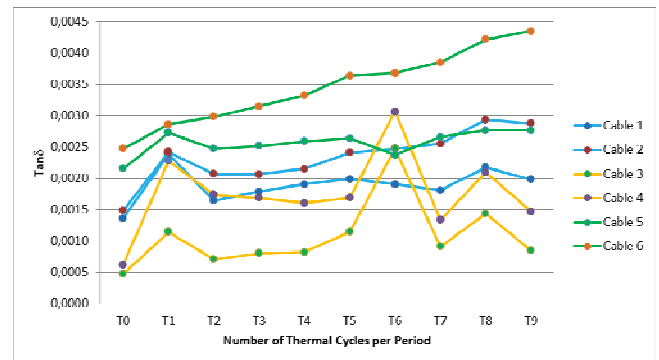
Figure 16 - $\tan\delta$ measurements at 50Hz for the six new joints.

On the contrary the only $\tan\delta$ measurements carried out at 50 Hz throughout the testing period at ambient temperature didn't show any particular variation for all the type and for both the manufacturers, Figure 16.
