An enquiry into the causes of an explosion accident occurred in a biogas plant

Marco Boscolo[1] | Luigi Bregant[1] | Stefano Miani[2] | Elio Padoano[1] | Marzio Piller[1]

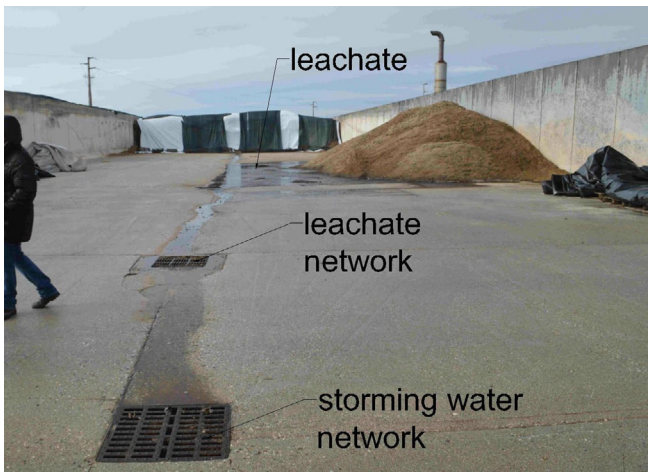
Another relevant aspect was the unusual leachate routing from the bunker silos. As shown in Figure 4, the manhole grates present a protrusion that prevent the catch basin from collecting the leachate waters, which can thus bypass the leachate tank and flow directly into the storm-water tank. The storm-water tank, along with a water-tight manhole, constitutes a hermetically sealed system, where anaerobic conditions are met and methane production can set.

FIGURE 4 Storm-water and leachate catch basins [Color figure can be viewed at wileyonlinelibrary.com]

As for point (ii), the formation of an explosive mixture in the technical rooms and electric transformer cabins should be avoided. To this aim, notwithstanding the somehow negligent operating behavior, it must be said that, according to the inherent safety operational approach,[9] the adoption of a grated manhole rather than a sealed one would have avoided the explosion. The grated manhole would have prevented the anaerobic biogas formation while allowing biogas dilution and dispersion in the atmosphere. It seems thus natural to conclude that a reconsideration of the security levels of all the underground electrical piping and their proper aeration is needed.
