Chemical and physical analysis of phaco handpiece tip surfaces before and after cataract surgery

Purpose: To evaluate the surface chemical composition and roughness of different phaco tips before and after their use during cataract surgery.

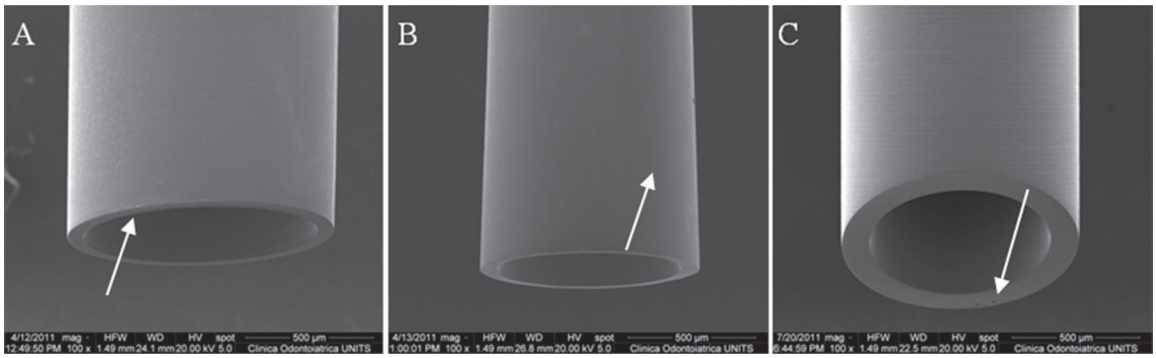
Figure 1. Scanning electron microscope images of new tips. *A*: Laminar Flow 19-gauge 15-degree straight tip. *B*: Turbosonics miniflared ABS tip 30-degree Kelman 0.9 mm tip. *C*: MICS tip. White arrows indicate the minimal production superficial irregularities.

The SEM images showed all new tips were of good quality. The surface was smooth, and the end of the phaco tip presented a sharp, squared cutting edge (Figure 1). Rare and minor production defects consisting of superficial scratches and material flaws were observed (Figure 1).

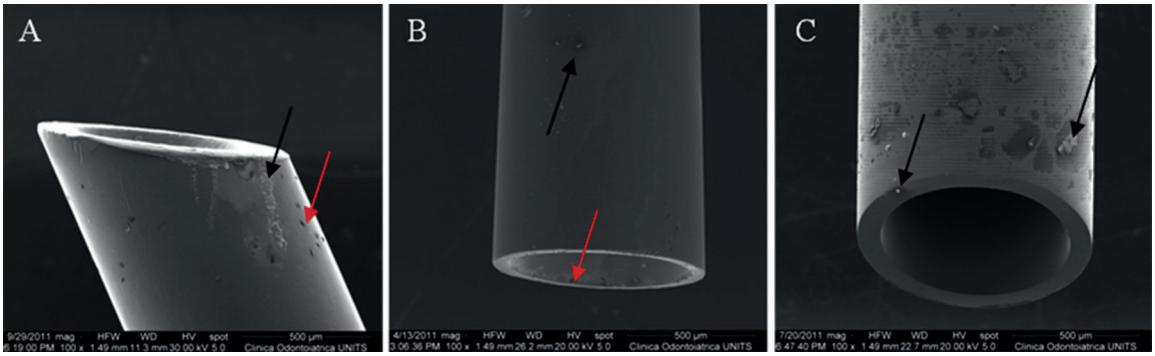
Figure 2. Scanning electron microscope images of tips after a single cataract procedure. *A*: Laminar Flow 20 gauge 30-degree curved tip. *B*: Turbosonics miniflared ABS tip 30-degree Kelman 0.9 mm tip. *C*: MICS tip. Black arrows indicate possible metallic debris and the red arrows, possible organic debris.

After cataract surgery, all tips showed superficial deterioration (Figure 2). Debris was found on the surface, mainly at the end of the tip. The nature of most of the debris appeared to be metallic, while others could have been organic in origin. The profile of the edge, previously squared, tended to be circumferentially rounded and irregular. The main area of alloy wear did not extend for more than 0.5 mm from the end of the tip. This region of deterioration was not homogeneous in shape, and the debris had collected in small clusters (Figure 2).

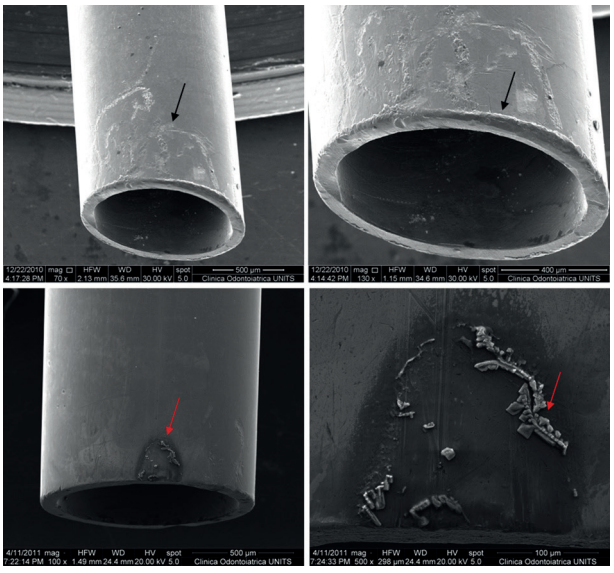
After 20 cataract cases, the decay in the quality of the tip was even more evident and the amount of superficial metallic rubble and irregularities was impressive (Figure 3).

Figure 3. Scanning electron microscope images of tips after 20 cataract cases (Laminar Flow 19-gauge 15-degree straight tip). Black arrows point to the irregular and rounded edge and surface scratches and the red arrows, to the superficial debris.

tip, this difference was statistically significant. The surface average roughness value after 20 surgeries (Laminar Flow 19-gauge 15-degree straight tip) was almost twice the value of the new samples.

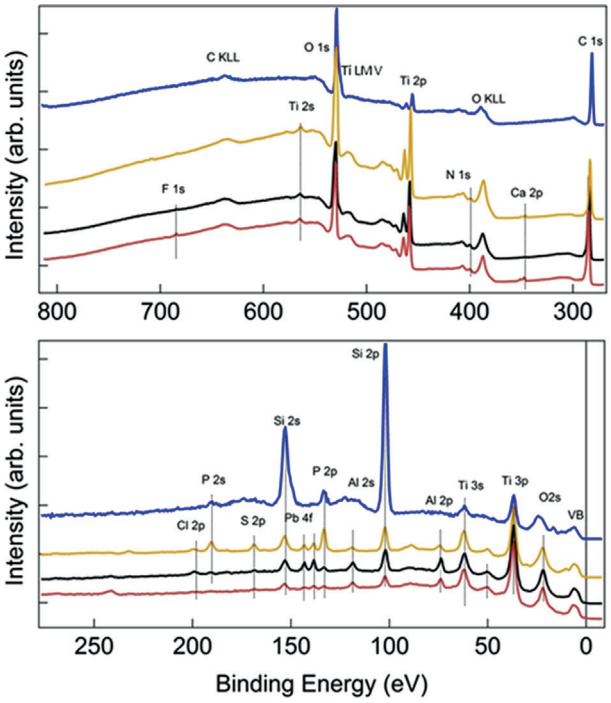
Figure 4 shows a sample comparison of the photoemission spectra recorded on the 2 Abbott Medical Optics tips, 1 Alcon tip, and 1 Bausch & Lomb tip. The surface chemical composition of the alloy between the 3 brands was similar, with minor differences, such as the presence of iron (Fe), Zn, sodium (Na), potassium (K), and calcium (Ca) in some tips and a relative amount of Al, Si, P, Pb, Cl, and F. This partially confirms the manufacturers' data regarding the construction materials used, which is a Ti–Al–vanadium (V) alloy.

Figure 4. Photoemission spectra measured using a photon energy of 900 eV on 4 new phaco tips. The red line represents the turbosonics mini-flared ABS tip 30-degree Kelman 0.9 mm tip; the black line, the Laminar Flow 19-gauge 15-degree straight tip; the yellow line, the Laminar Flow 20-gauge 30-degree curved tip; and the blue line, the MICS phaco tip. The elements that were identified in the spectrum are indicated. The numbers (eg, 1s, 2s, 3s, 2p) indicate the electron shell (identified by the principal quantum number; eg, 1, 2, 3) and the subshell (identified by s, p, d, f labels) within the atoms for each element. In these spectra, for the used photon energy (900 eV), the Ti LMV Auger peak superimposes to the V 2p core level region (Al = aluminum; arb. = arbitrary; C = carbon; Ca = calcium; Cl = chlorine; F = fluorine; N = nitrogen; O = oxygen; P = phosphorus; Pb = lead; S = sulfur; Si = silicon; Ti = titanium; VB = valence band).

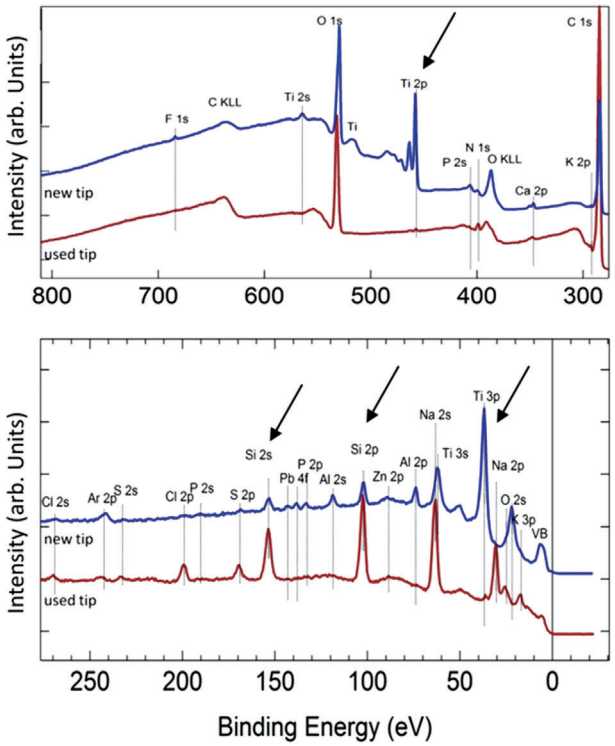
The main outcome was the increase in Na, Si, S, Cl, N, K, and C on the surface of the tip after surgery. As an example, Figure 5 shows a comparison between the photoemission spectra (collected at 900 eV) measured on 1 tip before use (new) and after use. The Ti peak is strongly reduced, while the Si and Na peaks show a significant increase. The tips after use appeared to be covered by a layer mainly composed of Na and Si.

Figure 5. Photoemission spectra, measured using a photon energy of 900 eV on a new and a used turbosonics mini-flared ABS tip 30-degree Kelman 0.9 mm. Note the difference in the Ti and Si peaks between the new tips and used tips (*black arrows*) (Al = aluminum; Ar = argon; arb. = arbitrary; C = carbon; Ca = calcium; Cl = chlorine; F = fluorine; K = potassium; N = nitrogen; Na = sodium; O = oxygen; P = phosphorus; Pb = lead; S = sulfur; Si = silicon; Ti = titanium; VB = valence band; Zn = zinc).

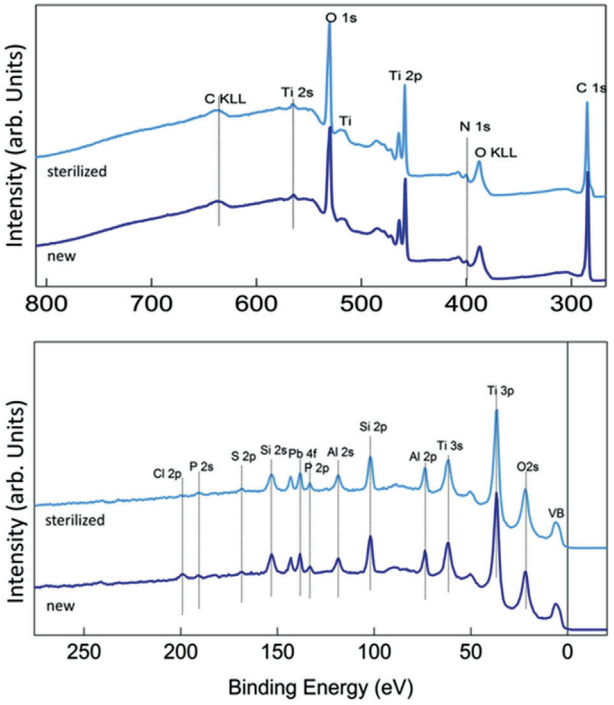
3 new phaco tips of each model were washed and sterilized as previously described for the used tips. The sterilization process did not increase the Si concentration on the surface of the new tips (Figure 6).

Figure 6. Photoemission spectra measured using a photon energy of 900 eV on a new phaco tip and a resterilized new phaco tip. No changes in the chemical composition or in the relative intensity of the peaks occurred (Al = aluminum; arb. = arbitrary; C = carbon; Cl = chlorine; N = nitrogen; O = oxygen; P = phosphorus; Pb = lead; S = sulfur; Si = silicon; Ti = titanium; VB = valence band).

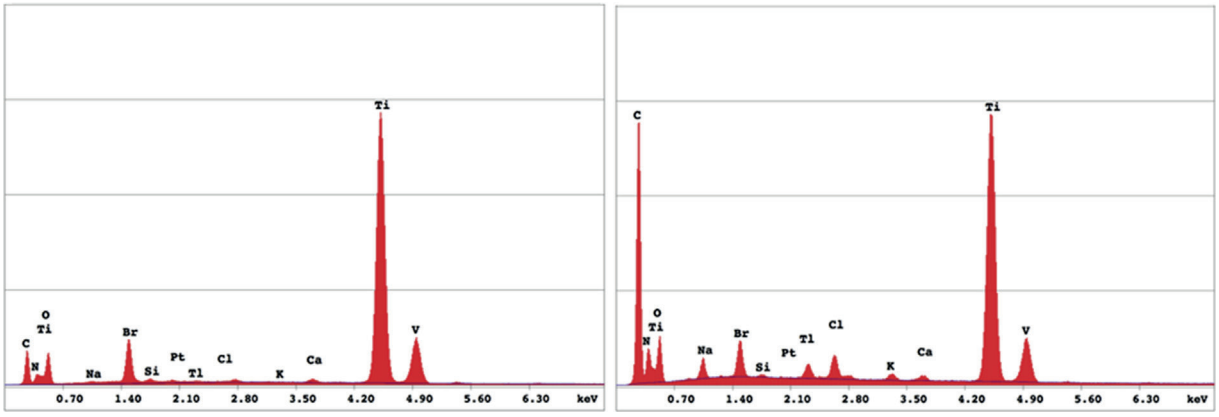
Energy Dispersive X-Ray Spectroscopy Energy dispersive x-ray spectroscopy showed that all the tips were made of a Ti alloy. The principal element detected was Ti followed by V and bromine, both in new tips and used tips. Minor elements, such as Na, K, Cl, C, and Ca were detectable, especially on used tips (Figure 7).

The debris on used phaco tips contained a high level of C, while on new phaco tips the presence of C was almost absent (Figure 7). Moreover the presence of C was low even on used tips when the analysis focused on the tip in an area free of debris. (Scanning electron microscopy images were used to guide the EDS analysis.)

Figure 7. Example of EDS analysis of a new (*left*) and a used (*right*) phaco tip (turbosonics miniflared ABS tip 30-degree Kelman 0.9 mm). Analysis of the debris showed a high peak of C, which was almost completely absent on the bare shaft of the tip (Br = bromine; C = carbon; Ca = calcium; Cl = chlorine; K = potassium; kev = kilo electron volt; N = nitrogen; Na = sodium; O = oxygen; Pt = platinum; Si = silicon; Ti = titanium; Tl = thallium; V = vanadium).

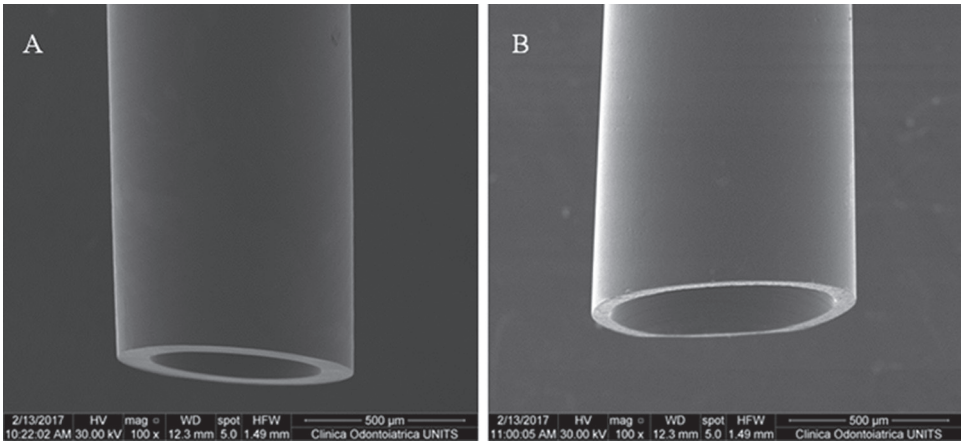
and the EDS analysis did not detect a C peak on their surface (Figure 8 and Figure 9, respectively). These data strongly suggest that the origin of the debris was related to biological material contamination after use.

Figure 8. Scanning electron microscope images of new resterilized tips. *A*: Laminar Flow 20-gauge 30-degree curved tip. *B*: Turbosonics miniflared ABS tip 30-degree Kelman 0.9 mm. No debris was visible on the tip surfaces.

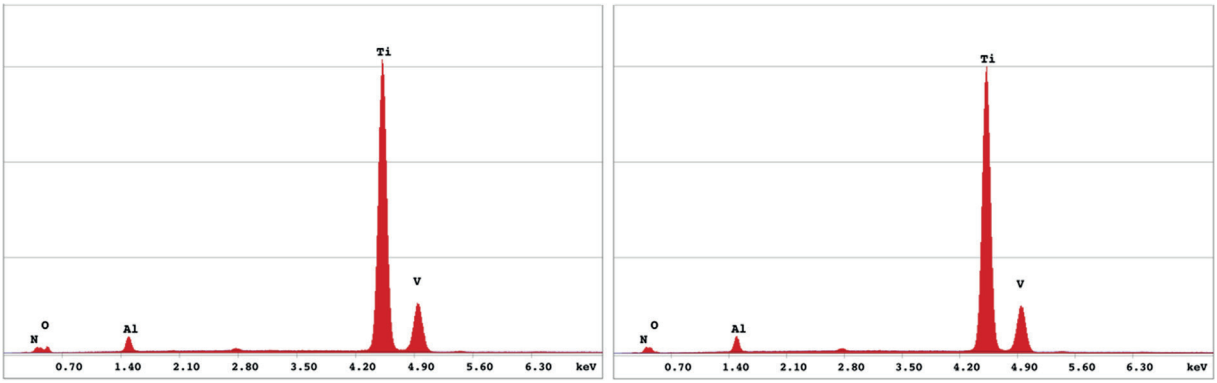
Figure 9. Example of EDS analysis of a new resterilized tip. *Left*: Laminar Flow 20-gauge 30-degree curved tip. *Right*: Turbosonics miniflared ABS tip 30-degree Kelman 0.9 mm. No carbon peak was detected (Al = aluminum; kev = kilo electron volt; N = nitrogen; O = oxygen; Ti = titanium; V = vanadium).
