Failure of fluorocarbon copolymer pipes subjected to mechanical strain in an alkaline environment

A failure analysis was carried out on leaking fluorocarbon-based copolymer pipes used in a cleaning and disinfection plant. Pipes conveyed a solution of sodium hydroxide and showed leaking after two months of service. Leaks originated from reddish-colored cuts located on the bending curves of the external surface of the pipes. Experimental findings and literature review pointed out that a combined effect of chemical degradation and mechanical strain (similar to stress corrosion cracking) triggered the failure. This type of degradation developed in high pH hydroxide solution due to dehydrofluorination of the exposed surface, starting material embrittlement and formation of crazes and microcracks. An applied mechanical deformation accelerated the crack opening and the solvent diffusion, up to the consequent pipe leaking and failure.

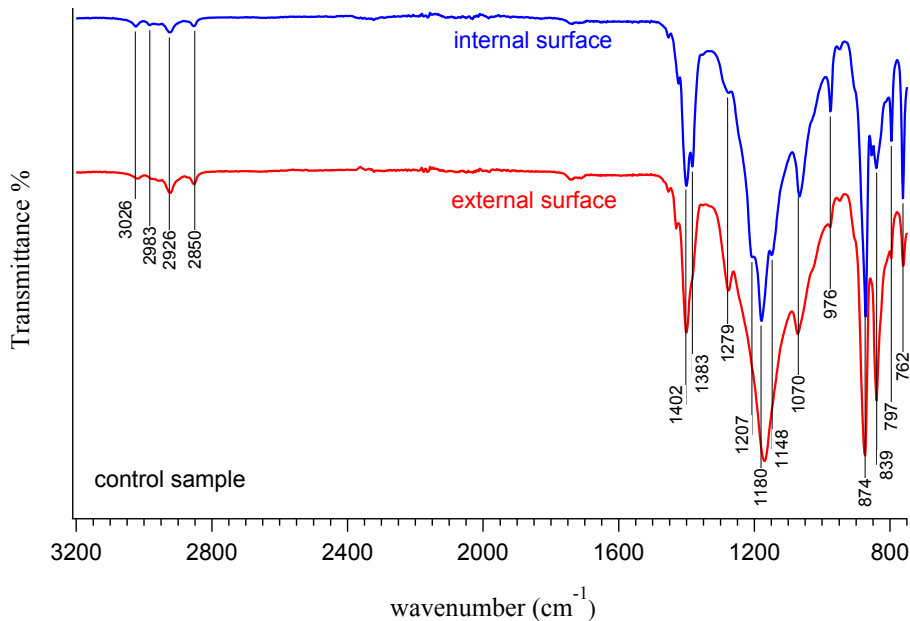
FTIR spectra of the control sample [internal and external surfaces] are shown in Fig. 10. The typical vibrational bands related to functional groups found in fluorocarbon polymers can be identified. The bands from 3026 to 2850 cm^{-1} are attributed to CH and CH_2 stretch; bands from 1402 to 1383 cm^{-1} to CH_2 bending; 1279 to 1067 cm^{-1} to CF_2 stretch; 976 to 797 cm^{-1} to CH_2 rocking and 762–613 cm^{-1} to CF_2 bending [5,6,20,21]. Bands related to α -phase PVDF [1383, 1207, 1148, 976, 797 and 762 cm^{-1}] are more intense on the spectrum acquired from the internal surface, while bands related to β phase [1279 and 839 cm^{-1}] are more pronounced on the one acquired from the external surface. This heterogeneous crystalline structure can be ascribed to the different cooling rates of internal and external pipe surfaces after the extrusion process. The formation of different crystalline structures in PVDF and its copolymers, as well as their IR spectral properties, are widely reported in the literature [4,21–23].

Fig. 10. FTIR spectra of internal (blue curve) and external (red curve) surfaces of control samples. (For interpretation of the references to color in this figure legend, the reader is referred to the web version of this article.)
