Vibration Analysis and Characterization of Damaged Structural Glass Elements

An original experimental program was carried out in August 2021. For the present study, the attention was focused on two original panels (from the set of 39 elements) that are currently part of the Crypt of Excavations suspension path (Fig. 13.4a).

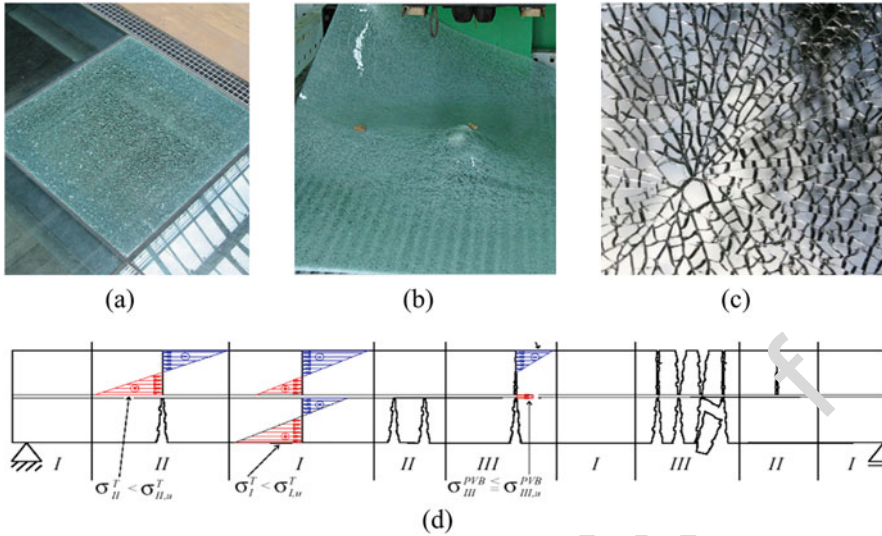
Fig. 13.1 Post-breakage performance of laminated glass (LG) members: (a–c) examples and (d) schematic representation of progressive fracture mechanisms in a double LG section, with evidence of stress distribution

29 Several aspects are however implicitly involved in the definition of key mechanical
 30 parameters that govern the complex post-breakage response of LG members
 31 (Fig. 13.1d), like the fragmentation of glass, the fragment size, the interlayer type,
 32 etc. [3].

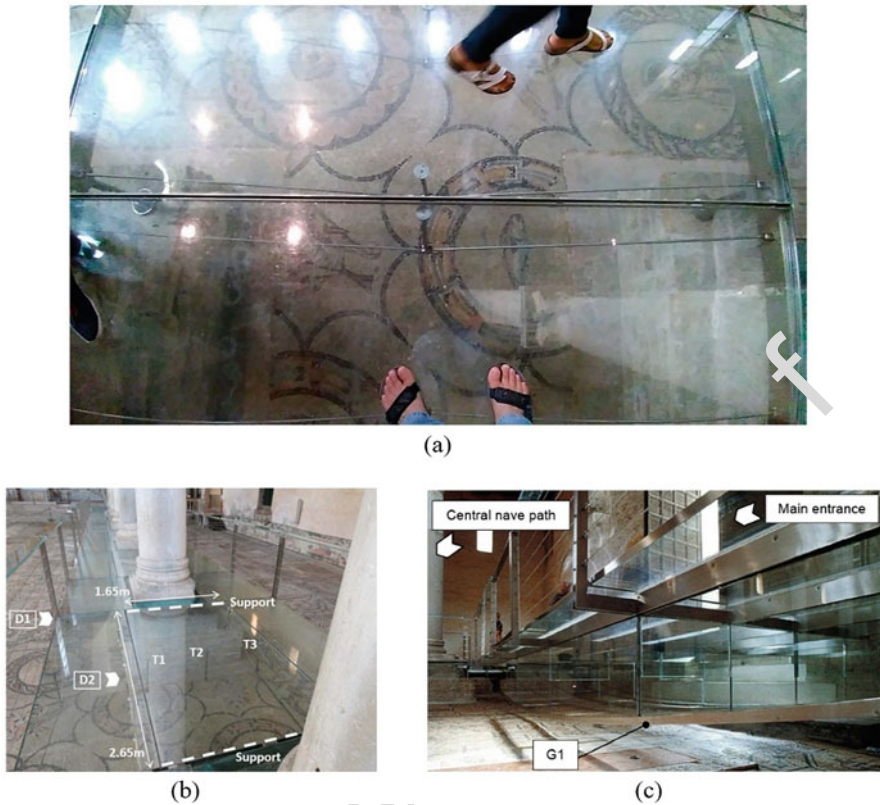
Recent studies on the vibrational parameters and assessment of glass pedestrian 78 systems can be found in [13, 14], where a case-study system has been investigated 79 with the support of Operational Modal Analysis techniques, FE numerical models, 80 and analytical models of literature that have been properly adapted to the explored 81 in-service walkway of Fig. 13.2. 82

Fig. 13.2 Vibration analysis of an existing in-service glass walkway: (a) visual inspection and (b–c) details of the structural system. (Figures reproduced from [9] under the terms and conditions of the Creative Commons Attribution (CC BY) license)

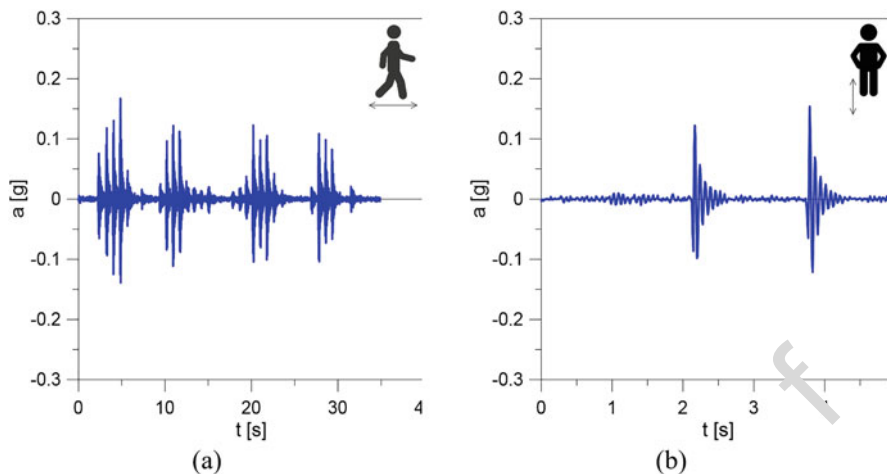
120 In this context, the experimental measurements were collected for two LGU and
 121 LGF modules in Figs. 13.4 and 13.5. A single occupant was involved for measure-
 122 ments ($M = 80$ kg). Out-put-only tests data were collected under the effects of linear
 123 walks and in-place jumps (Fig. 13.6).

Fig. 13.6 Example of vertical acceleration records under (a) linear walking path or (b) on-site jump of single occupant (detail)
