Performance of photovoltaic panels with different inclinations under uniform thermal loading

Integrating photovoltaic (PV) panels with different tilt angles in building envelopes or roofs is widely employed for environmental sustainability. However, little is known about the influence of different tilt angles on the thermal failure of the photovoltaic façades or roofs in fire conditions. A total of 15 four-edge shielded PV panels ($300 \times 300 \times 4.7 \text{ mm}^3$), with five different inclinations of 0° , 15° , 30° , 45° and 60° , were heated to fail using a uniform radiant panel. Measurements were taken to track glass thermal breakage, surface temperatures, incident heat flux and failure characteristics. The glass fracture and pyrolysis of the internal thermoplastic materials were observed under thermal radiation. The average breakage time of glass in PV panels showed an increasing trend with increasing inclination of the PV panels. Moreover, when the PV panels were tilted beyond 30° , the time to failure increased more significantly. The maximum temperature difference and heat flux that the PV panels can withstand were primarily measured within the range of $61\text{--}8

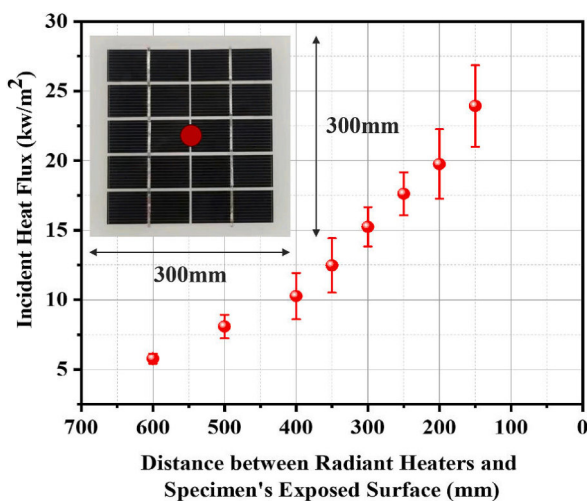
Fig. 3. The incident radiant heat flux calibration curve.

The radiant panel comprised four high-performance methane gas-fired radiant heaters ($300 \times 300 \text{ mm}^2$ each), forming a $600 \text{ mm} \times 600 \text{ mm}^2$ radiant heat source. During preliminary tests, a water-cooled heat flux gauge was employed to measure the incident radiant heat flux of the exposed surface of the specimen. The calibration graph in Fig. 3 illustrates the incident radiant heat flux between radiant panel and specimen's exposed surface. The error bars indicate the deviation of heat flux from 3 repeated calibration tests. The PV panel was positioned in parallel with the radiative panel with a distance of 25 cm, which was demonstrated to be suitable for inducing cracking through pre-testing.

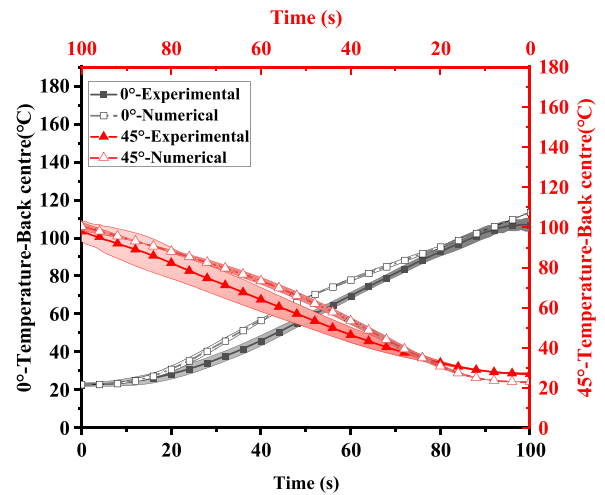
Fig. 11. Comparison of the central temperature of TPT between experimental and numerical conditions in Cases 1 and 4.

first 100 s of the experiments were selected for numerical simulation, due to the first breakage of glass in PV panels occurring during this period. The experimental temperatures measured by TC 9 (center of back surface) and the predicted temperatures in Cases 1 and 4 are shown in Fig. 11: the experimental and simulated mean values are represented by solid and dashed lines, respectively, with the corresponding standard errors indicated by shaded areas. Compared with the experimental results, the average error for all the cases was 13.5 % in the thermal model of the PV panels, indicating that the thermal model was capable of predicting the PV panel temperature under fire conditions. However, it should be mentioned that the numerical results are slightly higher than experiments, which may be caused by the gas bubbles of EVA and expansion of the TPT (Fig. 7(b) and (c)), resulting in the temperature of the internal layers not being transferred to the back sheet, which has not been taken into account in the thermal model.

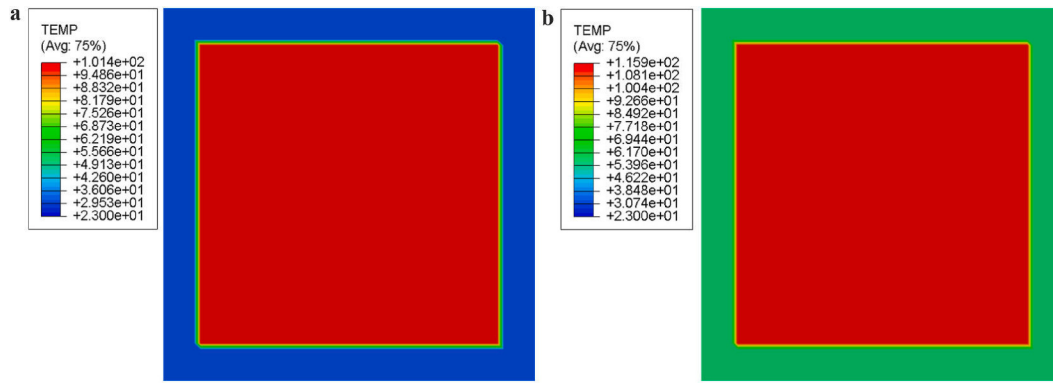
Fig. 12. The temperature field (°C) of the exposed PV panel glass surface at the time of breakage: Test 2 (Case 1, left) and Test 3 (Case 4, right).

The temperature distributions of the exposed PV panel glass surface at breakage times (29 s and 68 s in Test 2, Case 1 and Test 3, Case 4) are illustrated in Fig. 12. It can be observed that, at the moment of breakage, the temperature fields in numerical model are similar: the temperatures of the exposed areas are much higher than covered areas, and the temperature differences between the exposed and shaded regions,

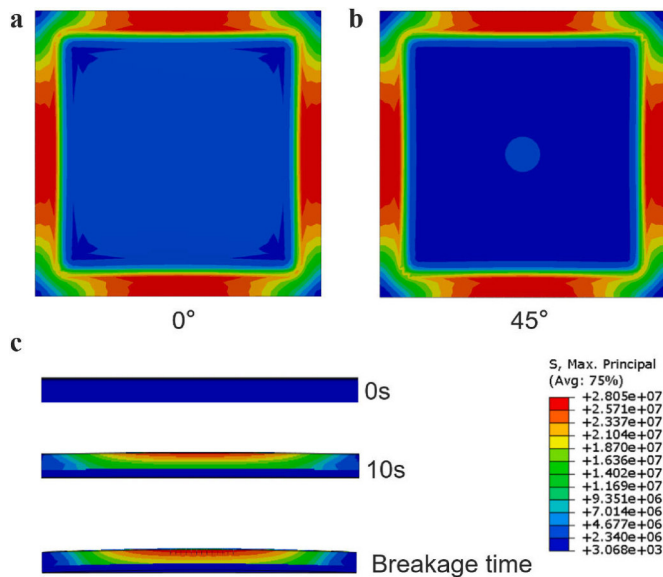
Fig. 13. (a)–(b) The planar direction stress fields at the final calculated step just before the crack occurrence in Test 3 of Case 1 and Test 3 of Case 4; (c) Stress variance at different times in Test 2 of Case 2.

The stress fields of PV panels in Test 3 of Case 1 and Test 3 of Case 4, as well as the stress variation over time in Test 2 of Case 2, are shown in Fig. 13 at the final calculated step before crack initiation. For PV panels with various inclinations, the maximum principal stresses were observed at the high-temperature gradient edge, which agrees with experimental results. It can be found that in Fig. 13(c) that the tensile stress increased on the exposed side as the heating progressed, particularly at the regions where cracks were most likely to initiate.

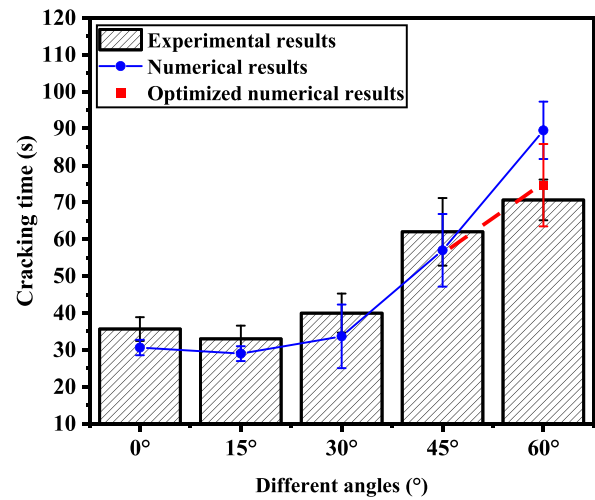
Fig. 14. Comparison of the first failure time of PV panels between experimental, numerical and modified numerical results.

As depicted in Table 5 and Fig. 14, the average first failure times of the PV panel models were 31, 29, 34 and 57 s from 0° to 45°, respectively, with an average error less than 15 %. However, the relatively large errors in Case 5, where the calculated time prominently exceeds experimental result should be noted. This was caused by the assumption of uniform thermal loading: at 60° condition, the PV panel was significantly more unevenly heated due to the excessive PV panel inclinations,

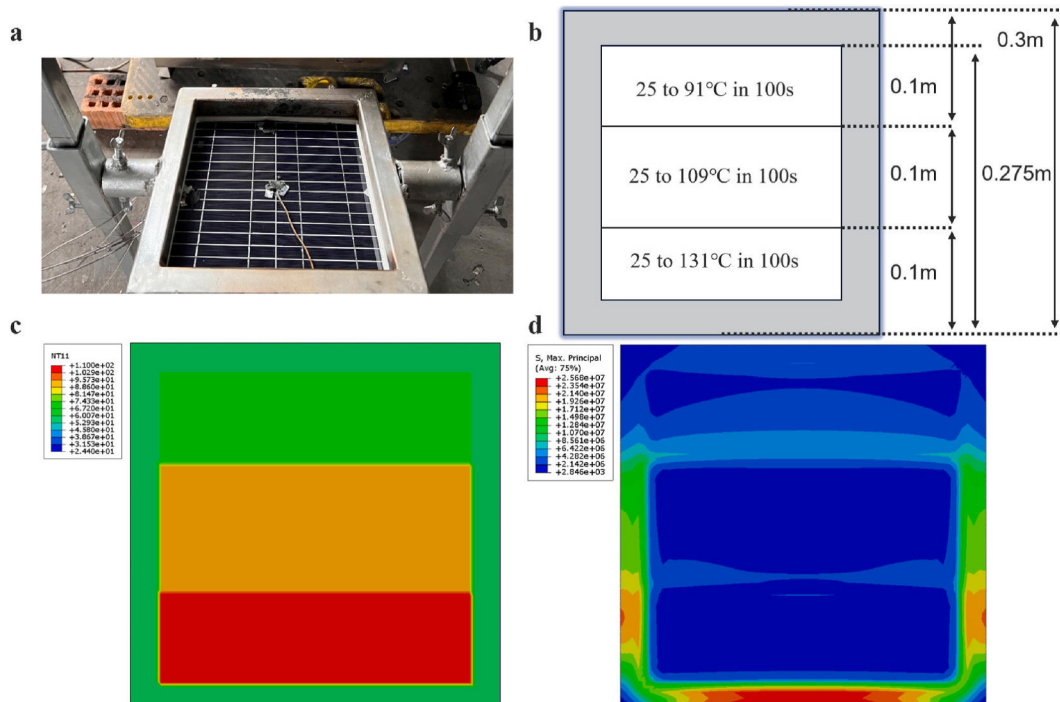
Fig. 15. (a) PV panel in Case 5; (b) A simple assumption of a three-layer rising temperature; (c) Temperature distribution and (d) Maximum principal stress distribution in glazing in PV panels before crack initiation.

Moreover, TC 6, obstructed by the frame (Fig. 15(a)), yields temperatures lower than actual values, hence leading to a significant discrepancy in failure time during the simulation. Therefore, in this section, the above temperature errors were corrected using an assumption of a three-layer rising temperature. A square PV pane of $0.0047 \times 0.3 \times 0.3 \text{ m}^3$, the same as the experiments, was used in the optimized simulation. It can be found that in Fig. 15(b), the edge of the pane is covered by a frame with a width of 0.025 m. The central section of the PV panel was further divided into three regions with different heating rates. Taking Test 2 of Case 5 as an example, the panel was heated for 100 s, and the final temperatures in the upper, middle, and lower sections were 91°C , 109°C , and 131°C (assumed temperature by linear calculation), respectively. Fig (c) and (d) show the calculated temperature fields and maximum principal stress, respectively. It can be found that the temperature of the lower part is significantly higher than the other two parts; therefore, the maximum principal stress reaches its maximum value in the center part of the lower edge. Fig. 14 show the optimized numerical results, it can be seen that under this assumption, the simulated failure times are 83 s, 62 s, and 79 s, respectively, with an average error of 5.3 % from the experiment, proving a very good validity of the model.

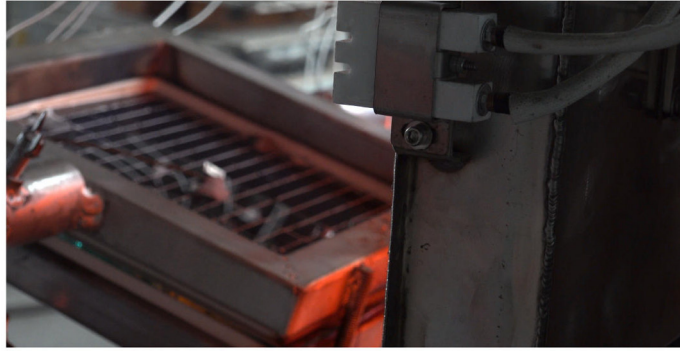
(a) PV panel at 75° condition.

Fig. 16. (a) PV panel at 75° condition. (b) Maximum principal stress distribution in glazing in PV panels at the time of crack initiation.

In addition, as depicted in Fig. 16(a), the PV panel was tilted at an angle of 75° and heated using a radiant panel at the same condition in a pre-test. We found that the failure time was 68 s, and the average failure time of PV panels at 60° was 71s. The difference in failure time between the two was not significant, with the average error smaller than 5 %. Furthermore, based on the simple assumption of a three-layer rising temperature used in the 60° condition, the central portion of the PV panel was divided into three regions in which the heating rates were different. The temperature is assumed to be a linear distribution and the final temperatures in the upper, middle, and lower regions were 81°C , 119°C , and 141°C . As seen in Fig. (b), the result showed that the first failure time of the PV panel at 75° condition was 76 s, which is not significantly different from the average first failure time at 60° .
