Large-scale experimental study of thermal performance of building-integrated photovoltaic façade in an enclosure fire

Chengming Xiao^a, Rui Zhou^a, Dezhi Ran^a, Fengqi Wang^a, Haonan Chen^a, Chiara Bedon^b, Jinhua Sun^a, Yu Wang^{a,*}

^a State Key Laboratory of Fire Science, University of Science and Technology of China, Hefei, 230026, PR China

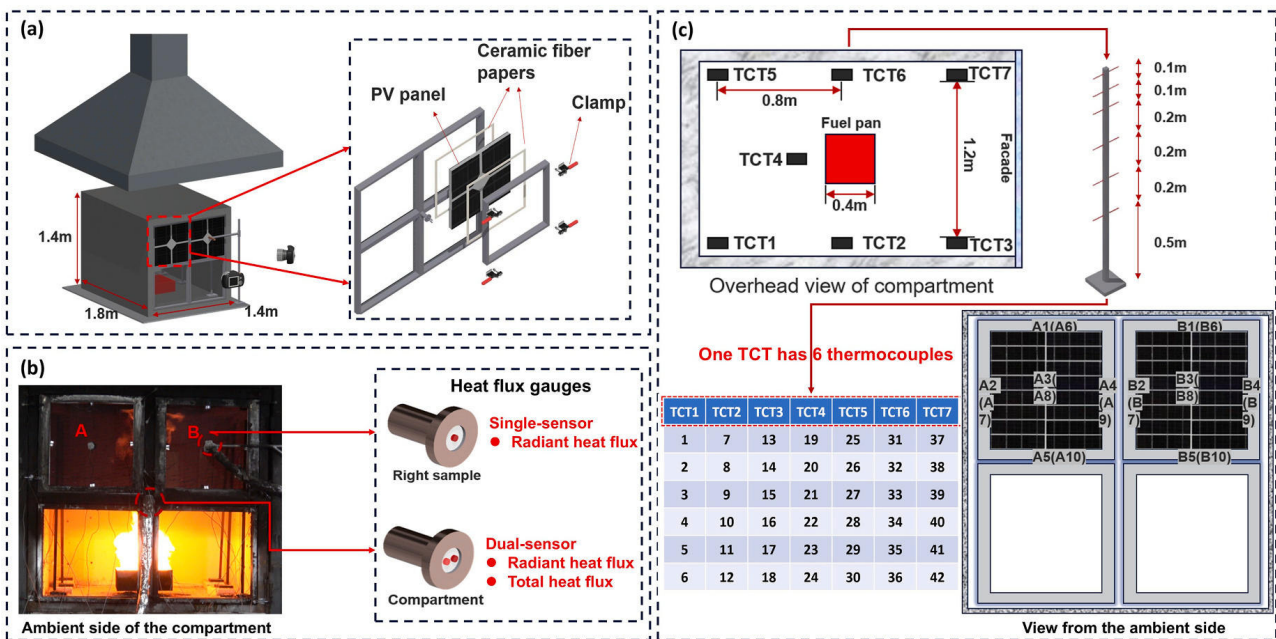
Fig. 2. (a) Experimental setup; (b) Layout of heat flux gauges; (c) Layout of thermocouples in the compartment and PV panels at fire-exposed and ambient sides.

As shown in Fig. 2, an experimental compartment with dimensions of 1400 (length) × 1400 (height) × 1800 (width) mm³ was built to resemble the fire conditions in BIPV façade. It was constructed from stainless steel and internally lined with 80 mm-thick ceramic fiber boards to reach insulation. A stainless-steel frame was installed on the open side of the compartment, with a small opening reserved at its center for mounting the heat flux gauge. Two PV panels, named Panels A (left) and B (right), each with a size of 600 mm × 600 mm, would be fixed on the frame by the clamps to form a PV façade. The frame covered the outer 30 mm edge of the test sample, creating a central heated area of 540 × 540 mm². In addition, 10-mm-thick ceramic fiber papers were covered with the edges of the sample and secured into the frame, which could reduce the influence of heat conduction and may as well prevent localized stresses of uneven pressure from the metal frame. Two openings (each with dimensions of 600 mm × 600 mm) were located at the lower part of the compartment to allow natural ventilation. Each set of experiments was conducted twice.

The measurement systems included the sheet and sheathed thermocouples (TCs), heat flux (HF) gauge, mass loss balance, digital camera and data acquisition. As illustrated in Fig. 2, there are 42 thermocouples in the compartment and 20 thermocouples on both sides of the PV panels. Seven thermocouple trees (named TCT 1–TCT 7), each equipped with six 1 mm diameter K-type thermocouples, were placed in the compartment to measure gas temperature, as shown in the overhead view of the compartment. In addition, sheet thermocouples were set at the four-sided shielding area and the geometric center of the front and back surfaces of the PV panel, to measure the surface temperature through high heat-conducting sheets, which were composed of a highly conductive aluminum alloy. With dimensions of 20 × 10 mm², the thermocouples increased contact areas between the temperature-sensing elements and the detected objects. The measurement of thermocouples ranges from 0 to 1200 °C, which is adequate for conducting these tests. For the

purpose of analysis, bracketed numbers represent the thermocouples attached to the sides exposed to fire, whereas un-bracketed numbers indicate the thermocouples situated on the ambient sides. Two Schmidt–Boelter heat flux gauges were installed. A dual-sensor gauge was located at the center of the compartment frame to measure both the total and radiant heat flux of the compartment, whereas a single-sensor gauge was mounted on a bracket 55 mm away from the surface of the right sample to measure the radiant heat flux received by the façade. All the thermocouples and flux gauges were connected to a high-precision data acquisition instrument through armored cables, with a sampling frequency of 1 Hz. A fuel pan with dimensions of 400 mm (length) \times 400 mm (width) \times 150 mm (height) was placed in the center of the compartment floor. To ensure the repeatability of the fire source, 6 L of n-heptane were measured using two measuring jugs for each test. Above the burning compartment, a smoke-collecting hood with dimensions of 6000 mm \times 6000 mm was located, and the heat release rate (*HRR*) could be calculated using the oxygen consumption method. Furthermore, two digital cameras were positioned at the front and side of the compartment to record the fire behavior and development.

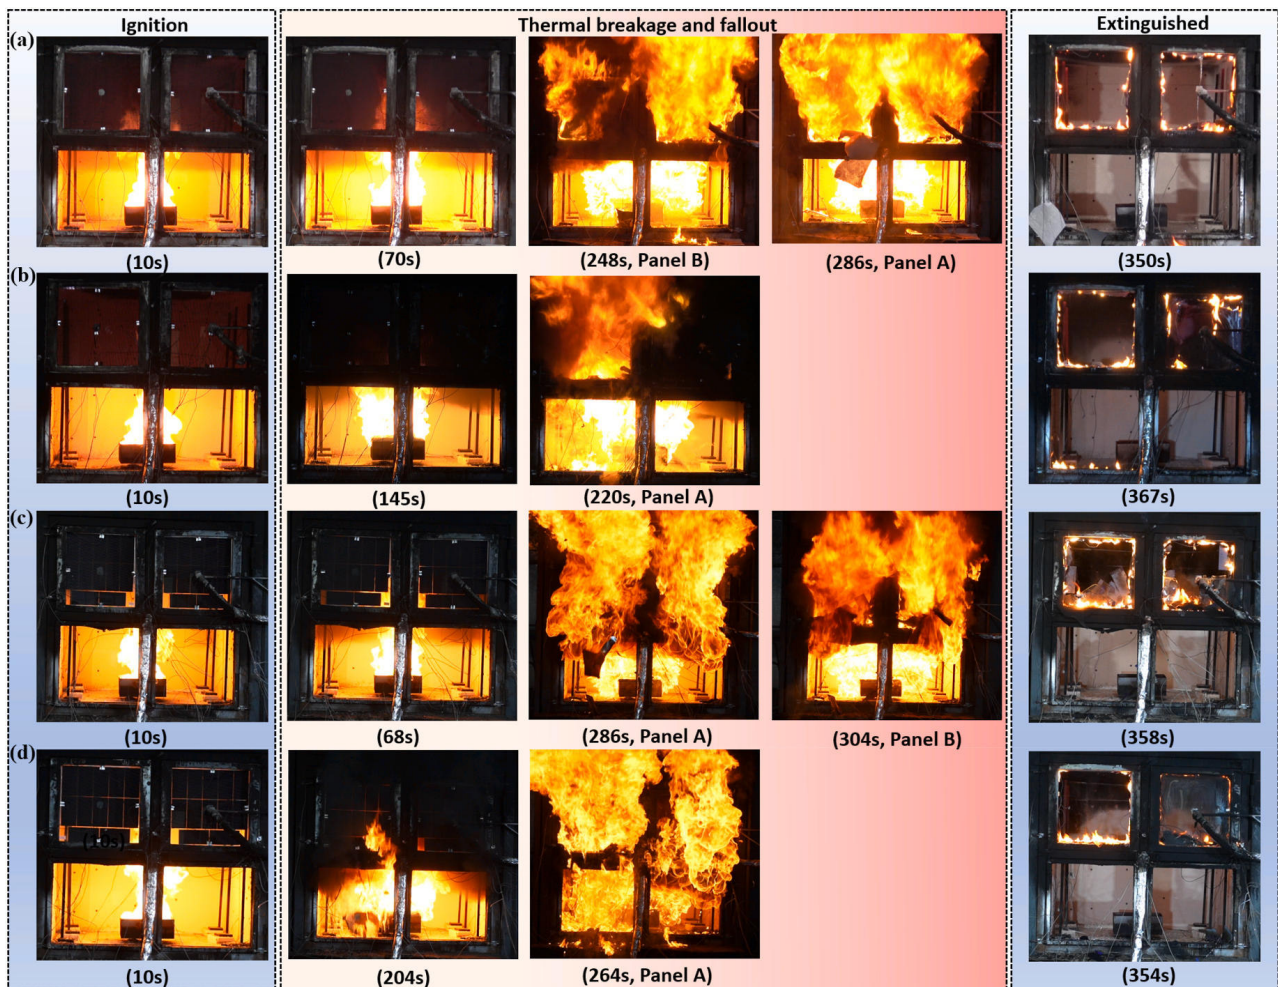
Fig. 5. Fire behavior of double-glazed PV modules. (a) Test 2 (Case 1); (b) Test 2 (Case 2); (c) Test 2 (Case 3); (d) Test 2 (Case 4).

Fig. 5 shows the experimental phenomena for different cases. The time to first breakage, as well as the moments when panels A and B fell out to form openings, are listed. In some cases, the specimens did not fall out to form openings; therefore, some images are blank (e.g., in Test 2 (Case 4), only the inner pane of panel B detached). It should be noted that the time ($t = 0$ s) was defined as the moment of fuel ignition, and the ignition-stage photographs were taken at $t = 10$ s to avoid camera obstruction during manual ignition. Additionally, the extinction time refers to the moment when the flame disappears. For BIPV façade fires, the fire performance is significantly more complex than that of traditional glass façade fires, as it involves not only the melting and combustion of internal combustible materials but also the breakage and fallout of glass. In the above six PV panel cases, almost all panels broke, and burning laminated layers and glass debris fell to the ground below the façade and continued burning throughout the test (as seen in Fig. 6(a)). The risk of falling panels and debris is not acceptable as they can easily ignite combustibles inside the building façade, posing a greater risk of fire. Furthermore, the falling parts could also pose a significant safety risk to occupants during egress by obstructing evacuation paths, causing injuries, or creating conditions that hinder timely and safe evacuation. Even after the heptane fire had burnt out, the combustible layers in the PV panels continued to burn, as shown in the final images of each PV panel case. In addition, there were significant differences in the cracking and fallout behavior of PV panels with annealed glass or tempered glass structures, as well as differences in the order of melting of internal combustible materials.

Taking the typical Case 1 as an example, the breakage of the inner glass was first observed, followed by the melting, flowing, and emitting gases of the PVB interlayer. As cracks continuously propagated and eventually intersected to form glass islands, as well as the adhesive effect of the interlayer PVB failed, portions of the inner glass fell out, as shown in Fig. 6(b). It is noteworthy that the location of crack initiation in the outside glass was nearly the same as the inner glass due to the close bonding. Furthermore, it was observed that the interlayer began to sustain burning and some of them along with PV panel fragments started dripping onto the ground during the test. In the later stage of the experiment, the right broken outer glass and most of the bonded inner glass within the PV panels fell out as a whole, forming new ventilation openings. However, the left PV module did not immediately fall out as a whole but instead

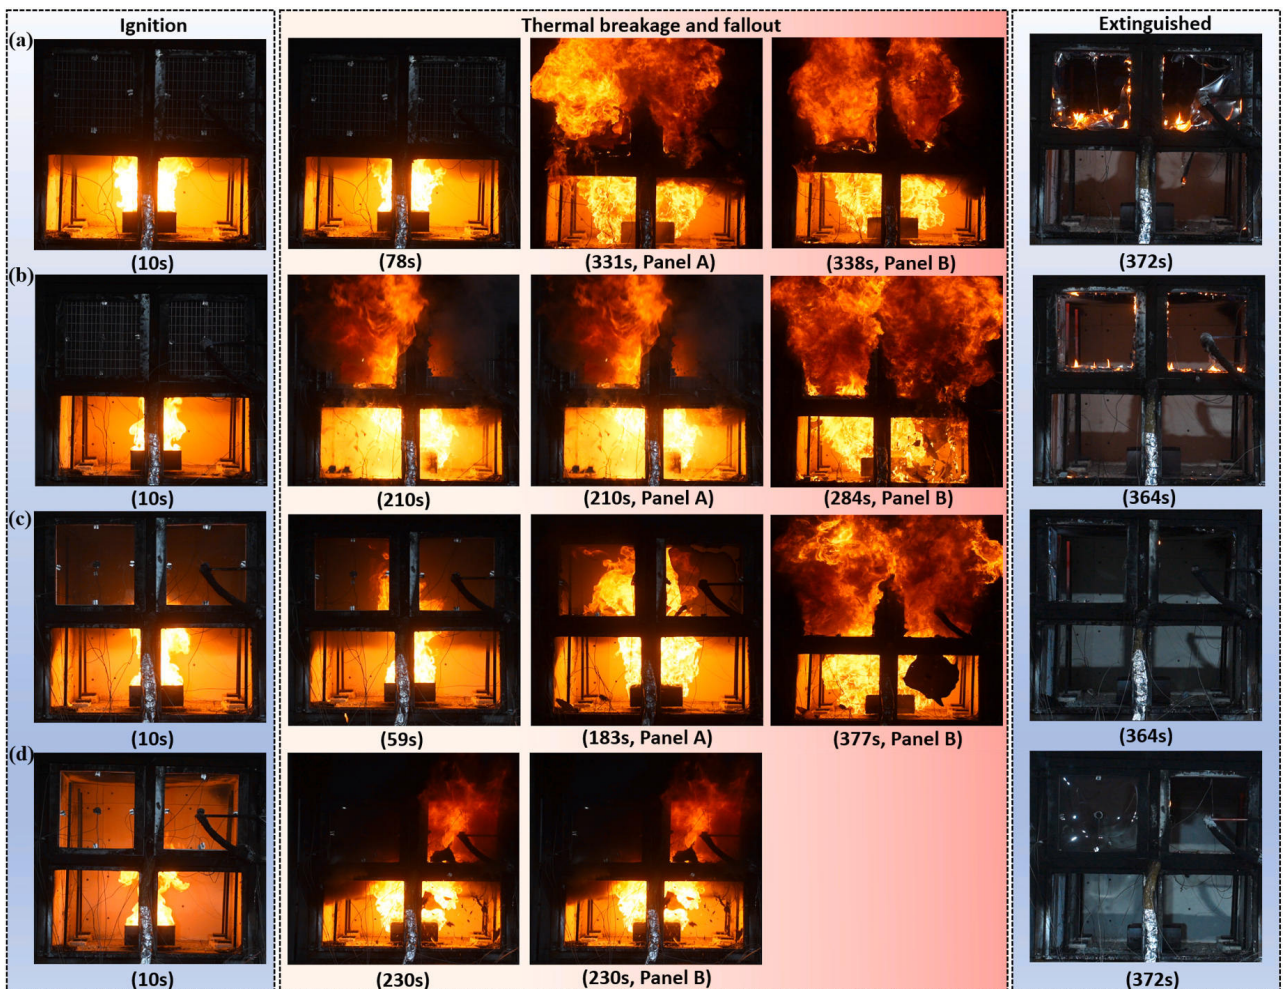
Fig. 7. Fire behavior of single-glass PV modules. (a) Test 1 (Case 5); (b) Test 2 (Case 6); (c) Test 1 (Case 7); (d) Test 1 (Case 8).

Compared with double-glazed PV modules, single-glass PV modules are encapsulated by the combustible TPT backsheets. Unlike double-glazed modules, where the rear cover glass effectively attenuates heat transfer, single-glass modules expose the combustible backsheets directly to the flame, resulting in accelerated pyrolysis of the material. In the case of single-layer annealed glass PV panels, the observations were consistent with previous bench-scale experiments [30]. It was observed that the glass fractured and the pyrolysis of EVA film and TPT backsheet occurred. As the test continued, cracks continuously propagated and eventually intersected, leading to island. However, unlike the single-layer annealed glass in Case 7, even after crack islands had formed, the single-glass crystalline silicon PV panel did not fall out immediately after breakage. This difference was primarily attributed to the composite structural characteristics of the PV module. The front glass layer was firmly bonded with the EVA interlayer and TPT backsheet through the lamination process. When the glass fractured under elevated temperatures, the broken fragments were not instantaneously unsupported but were retained by the adhesion of the EVA and the confinement imposed by the backsheet, thereby remaining attached to the panel surface. Meanwhile, the EVA was gradually softened and partially combusted under fire conditions, exerting a tensile effect on the glass fragments, which caused them to assume a suspended or stretched state, resembling a softening phenomenon, as shown in Fig. 7(a). Eventually, as the fire intensified, the fragments progressively fell out, which ultimately resulted in the formation of new openings. While in the case of single-layer tempered glass PV panels, melting and dripping of the backsheet material were first observed, followed by the fallout of the tempered glass. Unlike single-layer annealed glass PV panels, the pre-stress of tempered glass caused overall breakage immediately. It is noteworthy that in Case 7 with single-layer annealed glass (Fig. 7(c)), the initial fracture was accompanied by the fallout of a small portion of glass fragments, which was attributed to the absence of adhesive interlayer restraint. In contrast, the fracture and fallout characteristics in Case 8 were observed to be consistent with those of single-layer tempered PV panels.

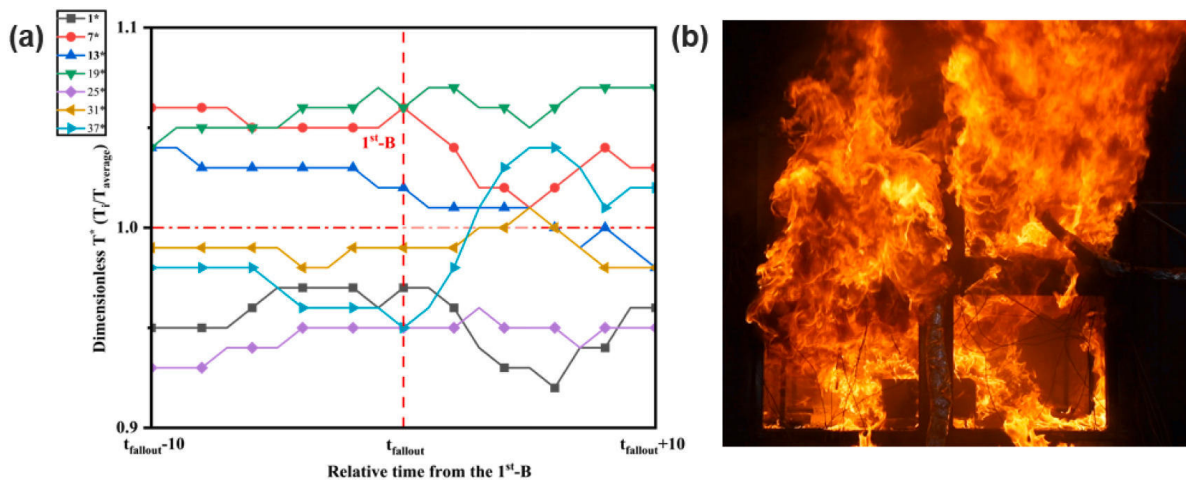
Fig. 11. Dimensionless temperature during the first fallout. (a) Test 1 (Case 4); (b) The Moment of fallout of Case 4.

The dimensionless temperature during the first fallout is shown in Fig. 11. Taking Test 1 (Case 4) as an example, the dimensionless temperature at all regions remained relatively stable before the first fallout. Specifically, the dimensionless temperature located at the rear of the compartment, far from the fire source (e.g., TC_{13}^* , TC_{25}^*), was significantly lower than 1, indicating that these regions have relatively low heat distribution. After the right-side sample B fell out, a strong positive response was observed at the measurement point TC_{37}^* (near the opening), where its value increased 9.4% compared to the moment of fallout. In contrast, the measurement point TC_{13}^* , which was located with respect to TC_{37}^* , showed an entirely opposite trend: it remained around 0.97 before the fallout of sample B, then rapidly dropped after the fallout, even reaching 0.92. This indicated that the fallout of sample B caused a sudden change in the compartment pressure, and the flame quickly deflected toward the newly created opening, causing this region to experience a brief thermal shock. As fresh air continued to enter through the opening, the cooling effect intensified, leading to the dimensionless temperature fluctuations. The spatial temperature distribution changed significantly within just a few seconds after the fallout, highlighting the strong impact of façade fallout on compartment thermal conditions and fire dynamics.

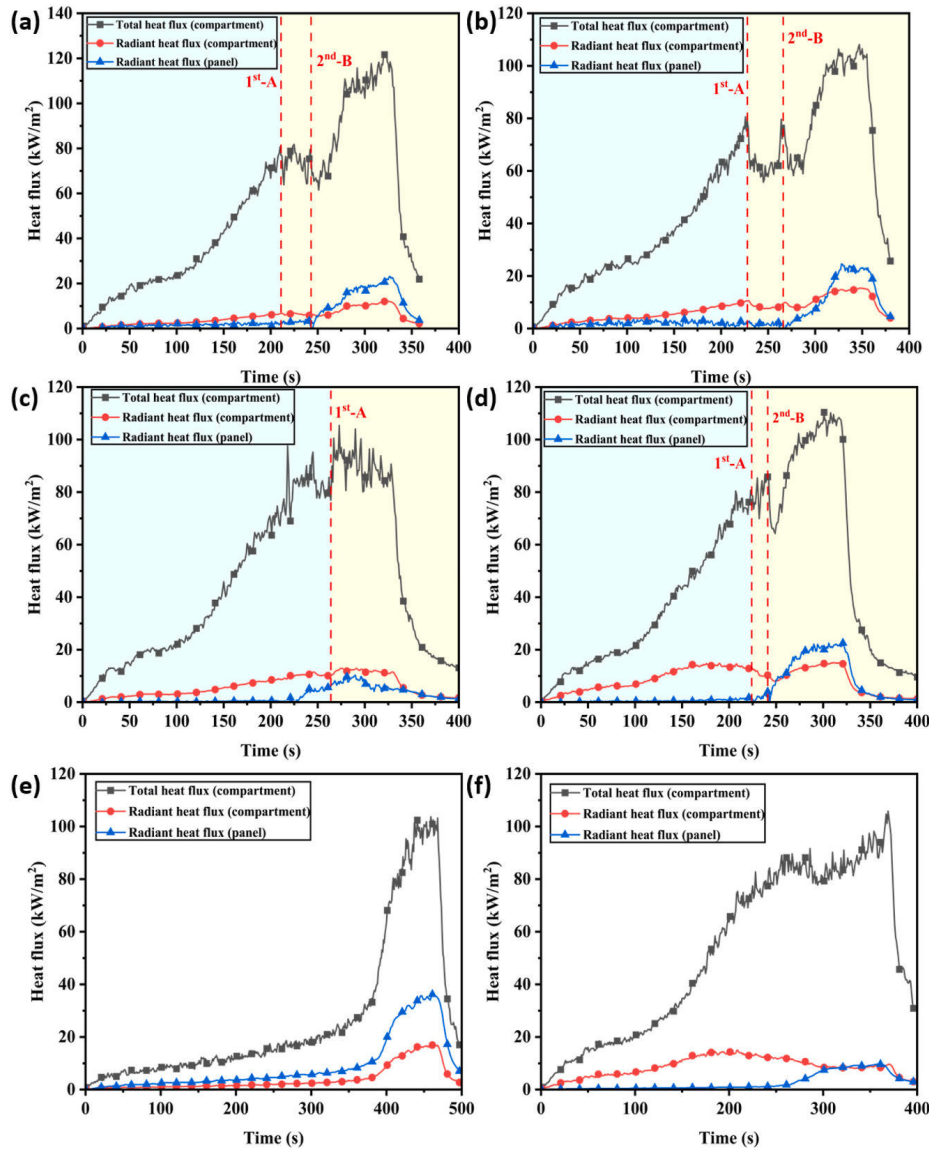
Fig. 12. The measured heat fluxes of the compartment and the panel. (a) Test 1 (Case 1); (b) Test 1 (Case 2); (c) Test 2 (Case 4); (d) Test 1 (Case 6); (e) Control 1; (f) Control 2.

Fig. 12 shows the time-varying heat flux on the fire-exposed area of the façade in different cases. In these experiments, the total/radiant heat flux at the fireside of the compartment, as well as the radiant heat flux at the ambient side of the panel surface, was measured. In all experimental cases, the total heat flux gradually increased with fire growth, but significant fluctuations and subsequent rises were observed once PV panel fallout occurred, indicating that the newly formed opening strongly promoted fire development. The measured heat flux on the panel surface originated from two sources. One is the radiation transmitted through the right-side PV panel before its fallout, which is related to the transmittance of the tested sample. It is noteworthy that in crystalline silicon PV panels (Fig. 12(c) and (d)), the measured heat flux was relatively low due to the shielding effect of the solar cells. A similar phenomenon was also observed in Control 2 (Fig. 12(f)). The other source is the upward entrainment of flame spillover through the lower

opening. In Case 4 shown in Fig. 12(c), the right PV panel remained intact, and the measured heat flux increased with the intensification of the bottom flame ejection. In contrast, in other experimental cases, once the right PV panel broke, the heat flux rose rapidly and became the dominant contribution.

As shown in Fig. 12, the maximum total heat flux among all cases was 120 kW/m², and the critical total heat flux for PV panel fallout ranged from 70 kW/m² to 90 kW/m². Compared with the total heat flux, the contribution of radiative heat flux is relatively small, accounting for only about 8%. Therefore, the radiation plays a limited role in the breakage and fallout of PV panels in a compartment fire. Further comparison with the control groups reveals that in Control 1 (without PV panels), the façade opening remained fully open and the total heat flux increased relatively smoothly, whereas in Control 2 (with the fire-resistant board), the façade was partially ventilated and the maximum total heat flux was limited to about 106 kW/m². To sum up, the fallout of PV façade not only determined the timing of new opening but also triggered secondary fire intensification, resulting in total heat flux exceeding that observed under both fully open and semi-open (no ventilation change) conditions.
