# Three-Dimensional Study of Polymer Composite Destruction in the Early Stages

**Keywords:** carbon fiber; CFR polymer; X-ray; computed tomography; fracture dynamics

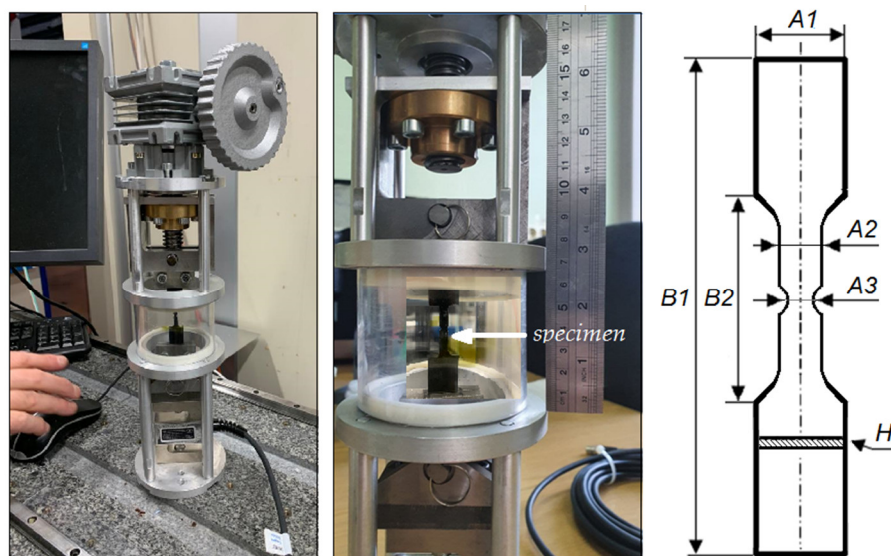
**Figure 1.** Photo of the tensile machine for in situ X-ray tomography study of samples under load (left). The setup and drawing of the CFRP sample (right).

The CFRP samples under investigation were made from carbon fiber/epoxy prepreg ACM 1208–C200UD (Aksa A38–3K/ACM 1208) manufactured by UMATEX, Moscow, Russia. The typical autoclave curing conditions for porosity-free laminates were a full vacuum of 1 bar and an autoclave pressure of 7 bar. All samples were selected from the same panel. The prepreg ply thickness was  $0.2 \pm 0.01$  mm, and the samples were made of 4 plies with the cross-ply orientation of fibers [0/90/90/0]. The nominal thickness ( $H$ ) of samples was  $0.82 \pm 0.01$  mm. They were cut using a diamond cutting tool in the shape presented in Figure 1 and Table 1.

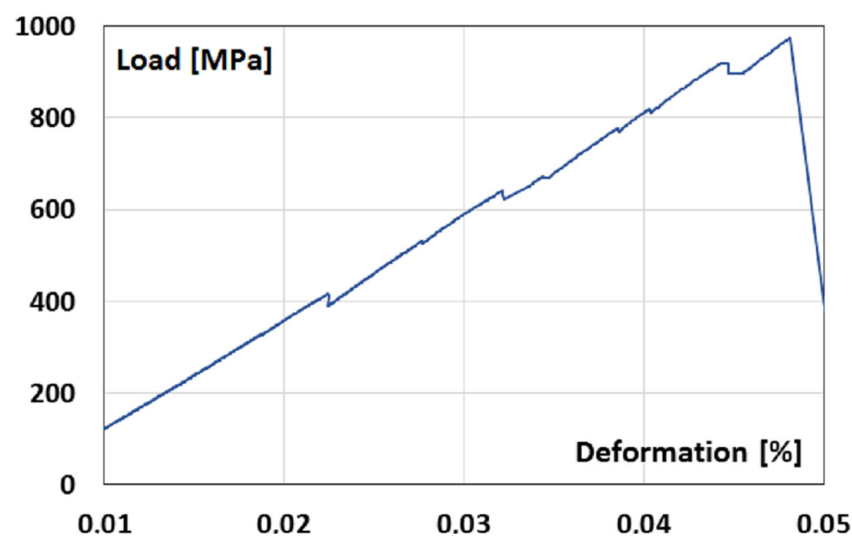
**Figure 2.** The load curve for the four-layer sample with the fiber orientation [0/90/90/0]. The fibers of the outer layers are oriented along a direction of external loading.

CFRP samples were stretched in steps from 38 to 865 MPa with a step of 190 MPa. The load curve in Figure 2 shows the process of brittle fracture with clear signs of load redistribution (notches on the curve). The average Young's modulus was measured to be  $E = P/\varepsilon = 18.5$  GPa in the range from 14.78 to 20.25 GPa.

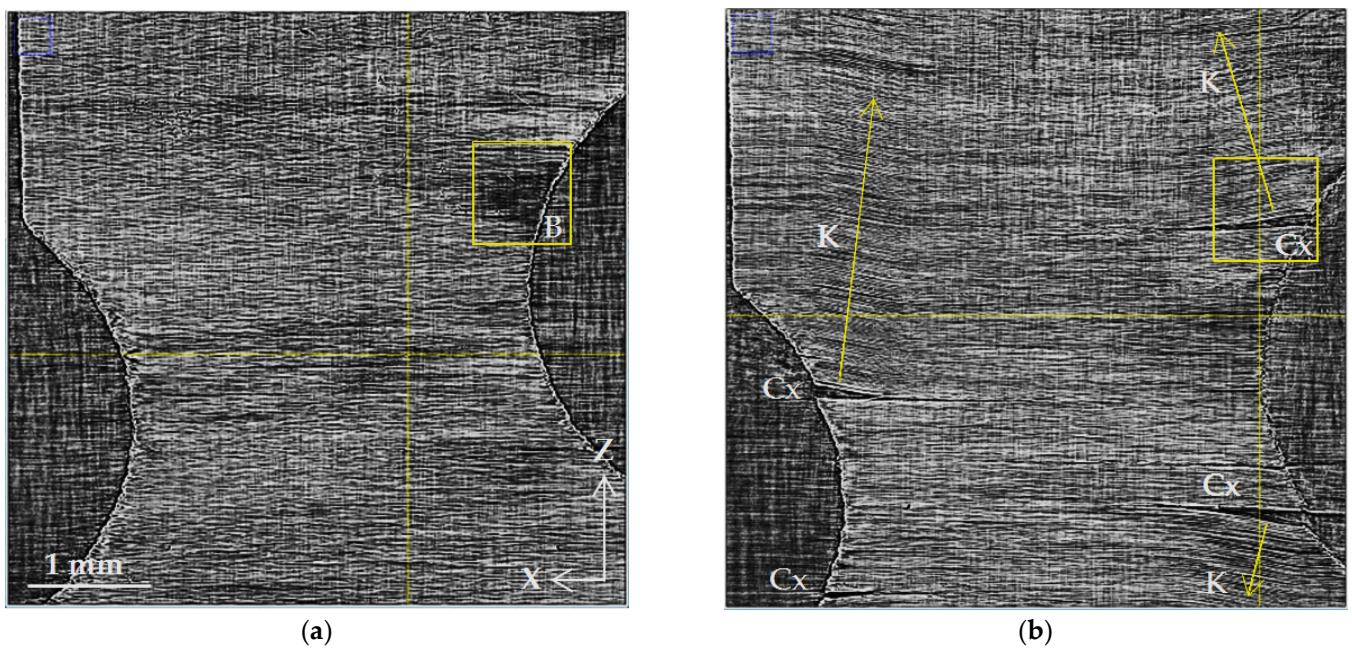
**Figure 5.** Microstructure of cross-ply CFR plastic at the interface of adjacent [90/90] layers: (a) initial state, 38 MPa; (b) loaded state, 865 MPa. B—binder pocket; Cx—crack spreading along the X-axis; K—kinking of fiber package.

Figure 5 shows the structure at the interface between the inner layers of  $[90^\circ]$  fibers packed perpendicular to the external load. Despite strong artifacts resulting from X-ray coherent scattering under the grazing irradiation of the fibers in these layers, the SR micro-CT image enables us to recognize the principal deformation and defects of the microstructure. The evolution of multiple Cx cracks formed by tensile forces can be observed clearly at the interface between the layers. The location of the cracks mostly coincides with visible damage at the previous layer boundary (Figure 4b). The observed cracks appear to propagate throughout the entire depth of the second layer with openings at both boundaries of this inner layer. In the image of the initial structure (Figure 5a), there is a small dark zone measuring  $0.5 \times 0.5 \text{ mm}^2$  (B) that corresponds to a local decrease in X-ray absorption and, consequently, to an excess of binder material of about  $10 \mu\text{m}$  thickness near this layer boundary. When stretched, new damages appear in this zone (Figure 5b) in addition to Cx cracks, and the images show fractures and other local deformation areas of fiber stacking (K).

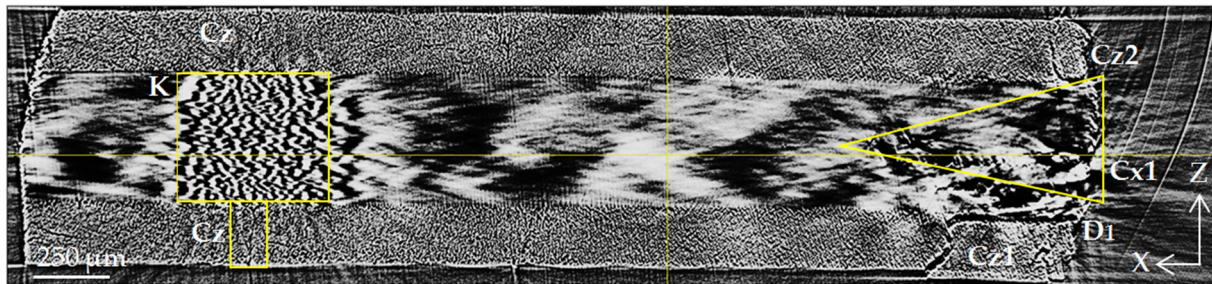
**Figure 8.** Transverse XY slice of the loaded CFRP sample (slice position is marked in Figures 6 and 7). D1 is interlayer delamination; Cx—transverse crack spreading along the X-axis ( $90^\circ$  fibers); Cz—vertical cracks along the Z-axis ( $0^\circ$  fibers); K—kinking of fibers.

Figure 8 shows an XY plane slice with four layers of fiber orientations  $[0/90/90/0]$  visible. One can see a strong delamination D1 at the interface of layers 3 and 4 on the right side of the image. Near the delamination, there is a wide Cz crack running along the fibers across the  $0^\circ$  layer. There is also a similar Cz crack in the upper  $0^\circ$  layer. Extensive cracking Cx1 occurs in the  $90^\circ$  layers and expands to a considerable depth. As was mentioned above, nonlinear X-ray scattering complicates the interpretation of the SR micro-CT results for  $90^\circ$  layers; nevertheless, some important conclusions can still be drawn. On the left edge of the image, longitudinal cracks (Cz) in  $0^\circ$  layers are visible, which is accompanied by the deformation of the regular packing of fibers in  $90^\circ$  layers, and small ripples (K) are observed.

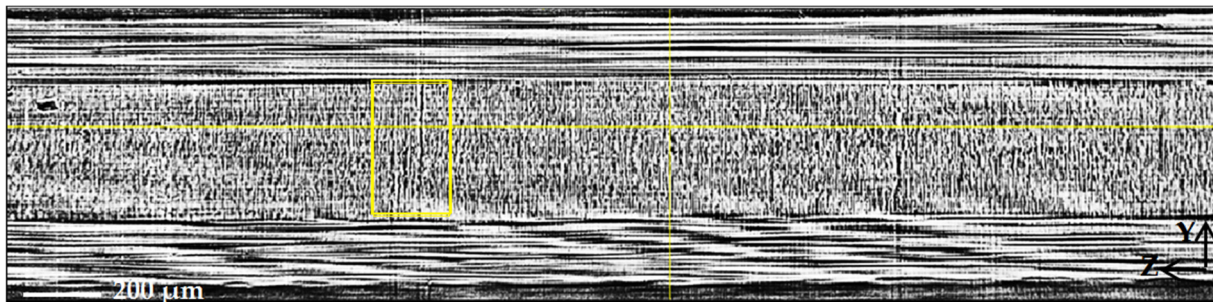
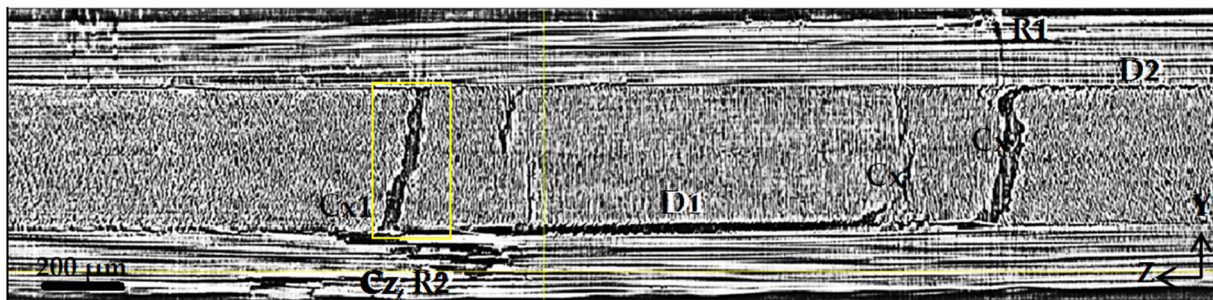
**Figure 9.** Transverse ZY1 slices (a) and ZY2 (b) marked in Figures 6 and 7. D1 and D2 indicate delamination at interfaces 3–4 and 1–2, respectively; Cx—transverse cracks spreading along the X-axis in  $90^\circ$  plies, Cx1—crack indicated in Figures 6 and 7; Cz—vertical cracks along the Z-axis in  $0^\circ$  plies; R1 and R2—rupture of fibers.

Planes ZY1 and ZY2 marked by lines in Figure 6 are presented in Figure 9.

the sample neck, demonstrates numerous thin longitudinal cracks (Cx) in the 90° layers. One of the cracks boxed in Figure 9a has been identified as the beginning of the large transverse crack Cx1 described in Figures 6–8. The analysis of the full set of SR micro-CT experimental data indicates the deep penetration of transverse cracks in the 90° layers of the sample. In particular, the Cx1 crack spreads for over 1.75 mm from the edge surface to the depth of the sample.

Figure 9b shows the ZY2 section near the right edge of the sample. Transverse cracks in 90° layers are visible as large damages, with the opening width being in the range from 50 to 100 µm. One can see that at a certain size and width of the opening, intralayer Cx cracks spread across the boundaries of the layers and induce extensive delamination (D1 and D2) at these boundaries. In addition, longitudinal Cz cracks in 0° layers grow and contribute to the development of delamination. This process is also accompanied by local fiber breaks, as can be seen in zones R1 and R2.

One of the natural results of tensile loading is the rupture of fibers. This is also observed in our X-ray images—elements designated by the letter R (Figure 7). With the moderate value of the applied load, only individual fiber breaks are visible in most images. However, in the YZ cross-section (Figure 9b) of the lower 0° layer, an extensive longitudinal crack (Cz) is observed, including the rupture of a significant part of the fibers passing through region R2.
