Article

Reliability of Field Experiments, Analytical Methods and Pedestrian's Perception Scales for the Vibration Serviceability Assessment of an In-Service Glass Walkway

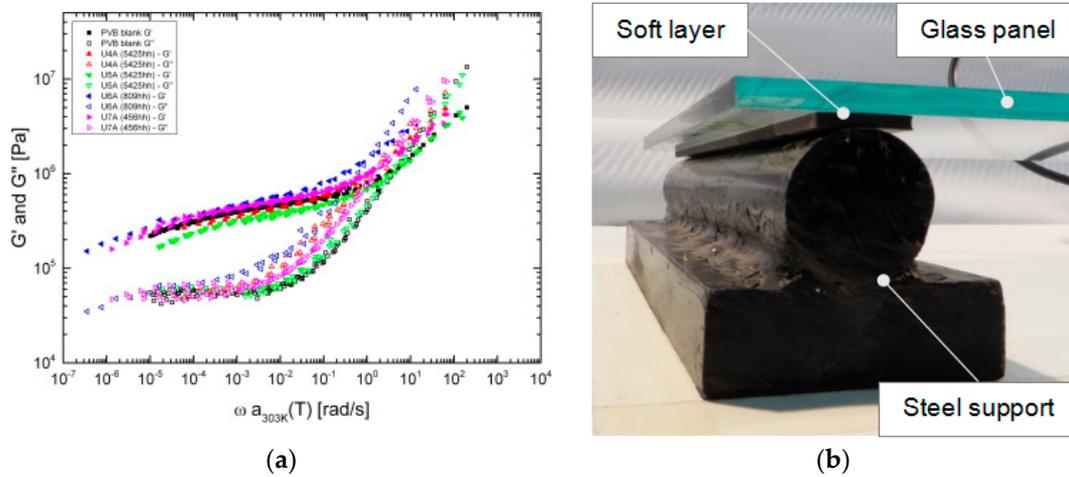
Figure 1. Dynamic performance of glass members: (a) Sensitivity of polyvinyl butyral (PVB®) stiffness to humidity/loading frequency (reproduced from [15] with permission from Elsevier, license n. 4585281507083, May 2019) and (b) flexible restraints (reproduced from [16] under CC BY 4.0 license).

the properties of the involved materials and bonding layers or the presence of mechanical and adhesive restraints that could manifest a time/temperature/humidity-varying flexibility (see Figure 1 and [15,16]). Even more attention is required for pedestrian glass structures that could be subjected to severe operational conditions, with pronounced human structure interaction (HSI) phenomena [17,18].

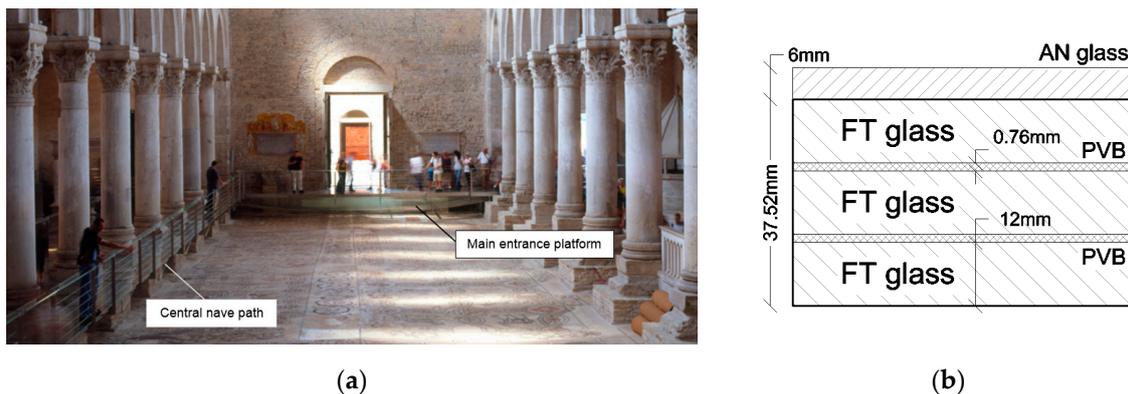
Figure 2. In-service pedestrian system object of analysis: (a) General/front view (photo by C. Bedon, courtesy of So.Co.Ba) and (b) nominal cross-section of the glass slab.

This paper focuses on the vibration serviceability assessment of an in-service glass walkway in Italy. The pedestrian structure (see Figure 2 and Section 3) was built in the early 2000, in the monumental building of the Basilica of Aquileia (UNESCO World Heritage Site). The original design of the indoor suspension system resulted in a sandwich laminated glass (LG) slab, composed of a triple fully tempered (FT) section and polyvinyl butyral (PVB®) bonding layers. A sacrificial annealed (AN) layer was placed on the top of each LG panel, to obtain an LG + AN resisting section. A series of steel tendons and frame members were then used to support the glass plates, for up to ≈140 square meters of transparent walking surface.

The selected LG + AN panel of Figure 6 was realized in the form of a sandwich thickness with 42 mm of glass (see also the detail of Figure 2b), with 4.37 square meters of pedestrian surface and a total glass mass $M_{glass} = 460$ kg. The primary goal of the original design was to ensure the slab—based on a global beam-like bending behavior—appropriate structural performances under live loads.

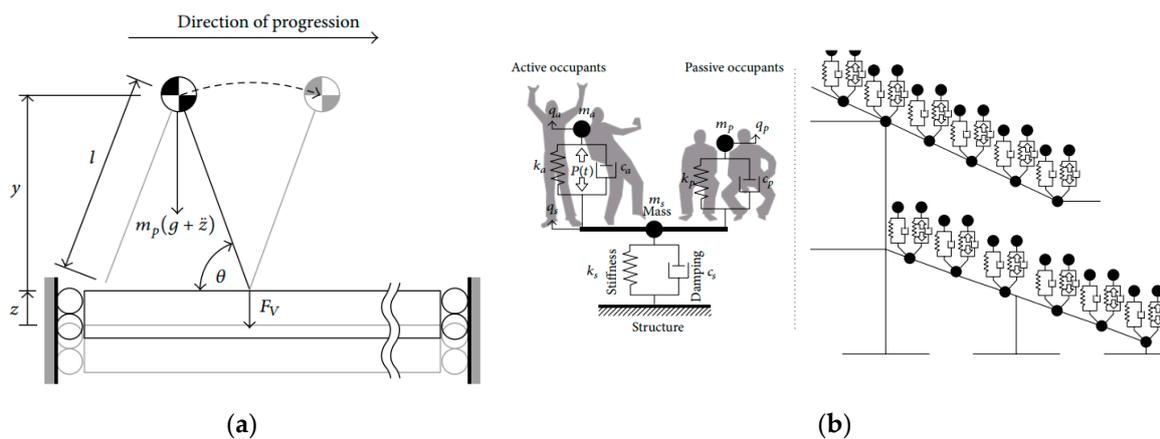
Figure 4. Mathematical models for human-structure interaction (HSI) calculations of pedestrian structures: (a) Inverted pendulum approach and (b) crowd effects on stadium structures. Figures reproduced from [18] under CC BY 4.0 license.

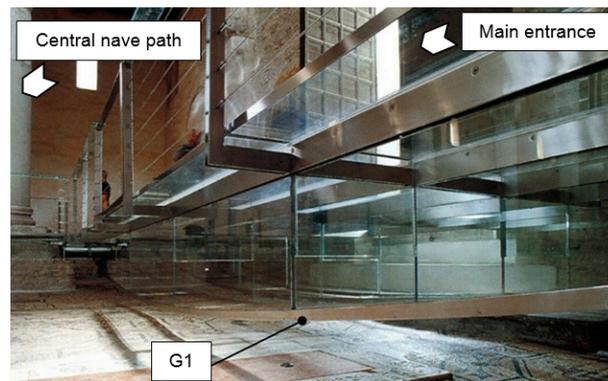
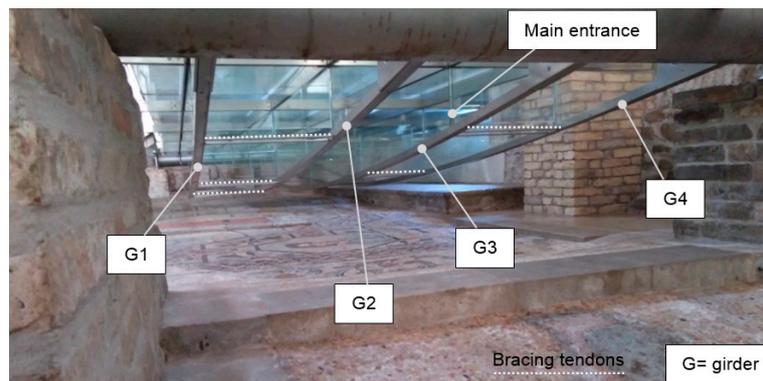
Figure 5. Main entrance suspension platform: (a) Front/bottom view and (b) detail bottom view, with evidence of longitudinal girders and tendons (photos by C. Bedon, courtesy of So.Co.Ba).

The main entrance platform consists in a simply supported slab, with a global beam-like bending behavior ensured by four longitudinal steel-glass girders (14.5 m their span), see Figure 5.

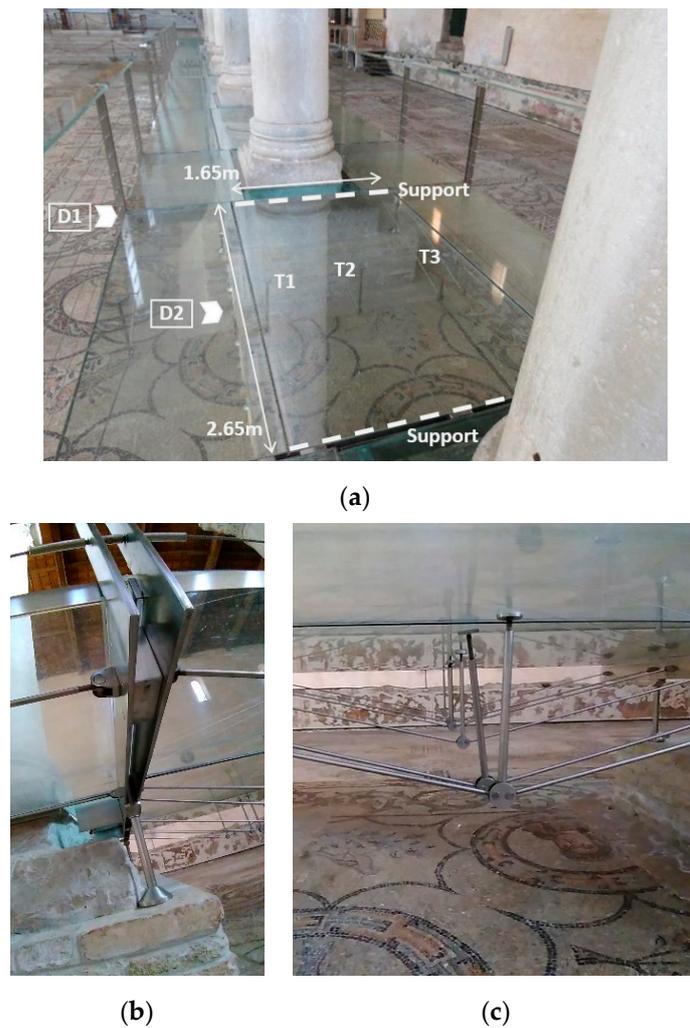
Figure 6. Reference two-side supported panel along the central nave path: (a) General view, with (b–c) D1 and D2 details (reproduced from [20] with permission from Elsevier, license n. 4585290441718, May 2019).

Special care is spent in this paper for the central nave path, see Figure 6, consisting of a series of independent LG + AN panels, with two-side linear supports along the short edges and variable span (comprised between 2.5 m and 2.65 m, depending on the actual distance of the columns). Three adjacent panels are used in the width of the path (Figure 6a). Among them, the central panel is considered, being characterized by a maximum width of 1.65 m, and by the presence of three steel tendon pairs (10 mm the diameter, with 0.75 m their distance) that are intended to act as mid-span unilateral supports for the glass slab (see for example the T1-to-T3 tendons in Figure 6a, or the lateral view of Figure 6c).

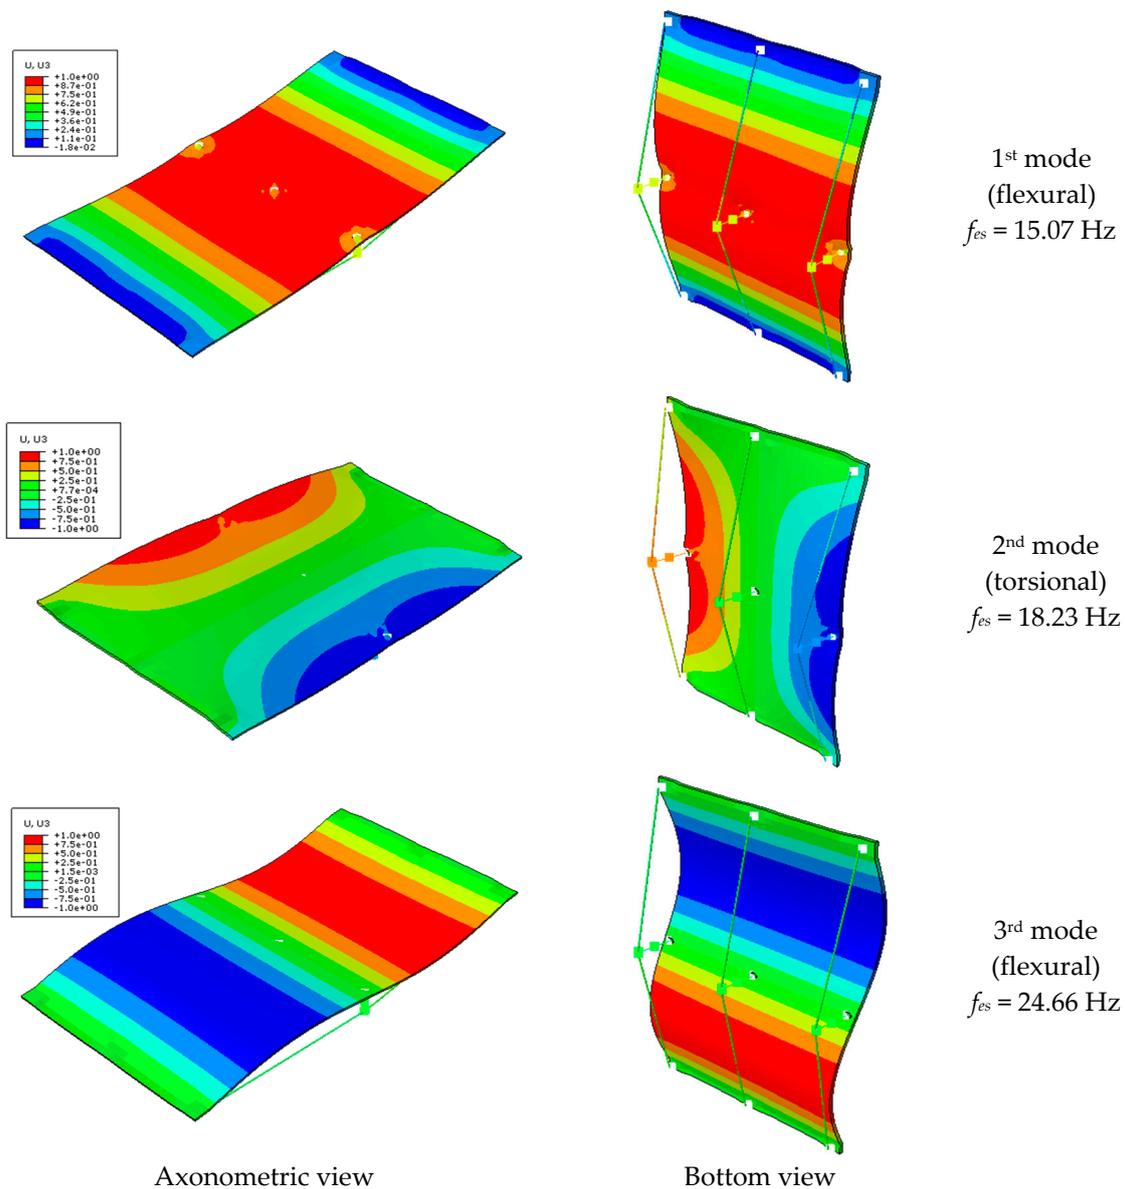
Figure 7. First vibration modes and frequencies of the empty structure (ABAQUS, axonometric and bottom view). Numerical study derived from the FE model presented in [20].

The acceleration measurements were performed using six micro electro-mechanical system (MEMS) triaxial accelerometers prototyped in [47]. Their position was aimed at properly capturing the fundamental mode of the system, based also on past studies (see [20] and Figure 7).

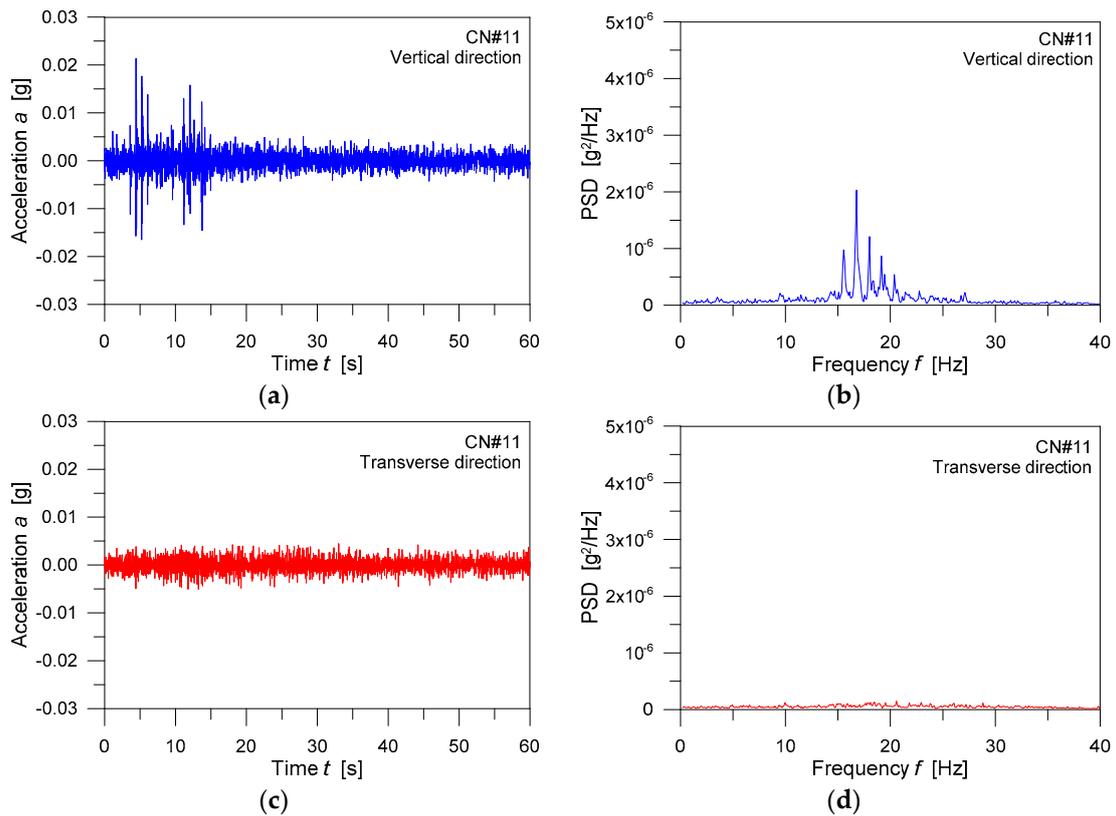
Figure 8. Examples of vibration measurements. (a,c) Acceleration-time history and (b,d) power spectral density functions under random walking traffic.

The acceleration data were recorded with a sampling frequency of 128 Hz, over a typical duration of 2 min. An example of accelerations and power spectral density functions is proposed in Figure 8, for the vertical and transverse directions. All the collected records were post-processed via the SMIT Toolsuite [48], based on the ERA-OKID-OO approach [49,50].

In doing so, the vertical accelerations were specifically investigated, being of primary interest for the examined system, with respect to mostly negligible longitudinal/transverse dynamic effects (i.e., Figure 8c,d).

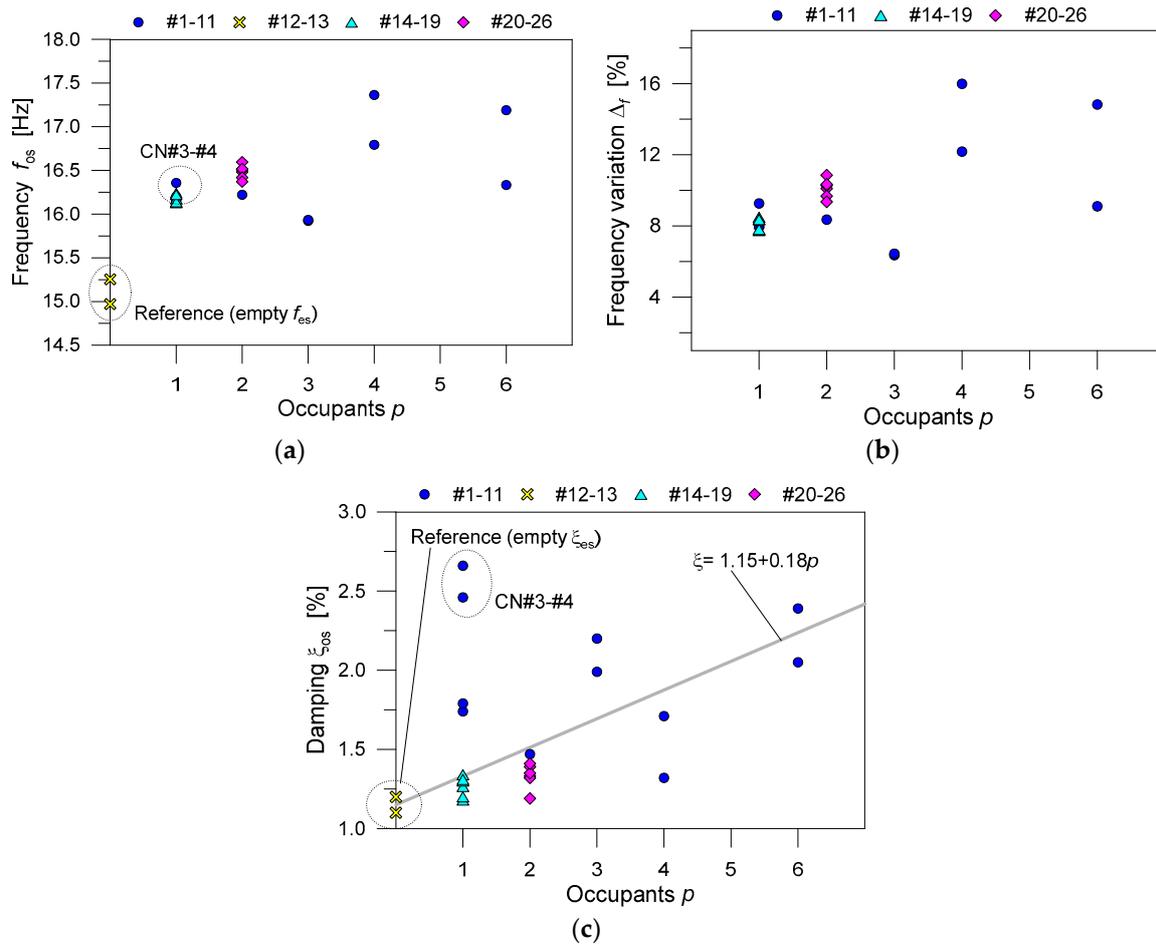
Figure 9. Variation of (a) frequency, (b) frequency scatter and (c) damping for the occupied system (average values).

According to Figure 9a,c, it is possible to notice that as far as the full set of measurements is considered for the LG + AN panel in bending, a general increase with p is generally observed for the fundamental frequency $f_{os} > f_{es}$ and modal damping $\xi_{os} > \xi_{es}$. In Figure 9b, frequency scatter values are also proposed as a function of p , where:

A maximum scatter in the order of $\Delta_f = +15\%$ was obtained ($p = 4$ and $p = 6$), compared to the empty structure. When $p > 0$, moreover, it can be perceived from Figure 9b that the f_{os} predictions are minimally affected by the ambient conditions herein investigated. For $p = 1$, even in the presence of a relatively wide range of imposed accelerations, Δ_f resulted in fact equal to $+8.08\%$ (P#1) and $+8.34\%$ (P#2) respectively, giving evidence of mostly negligible time/temperature/humidity effects, for the explored scenarios. This is in line also with the numerical findings reported in [20] for the empty structure, where it was shown that the vibration frequency can be highly sensitive to the stiffness of PVB foils (and hence to the global bending stiffness of the LG + AN section), but also other relevant aspects should be taken into account, like the loss of prestress in the bracing tendons, etc. The higher the ambient temperature (i.e., $P\#1 > P\#2$) and the lower the bending stiffness of the system, hence the lower the expected frequency f_{os} and the corresponding Δ_f .

According to Figure 9b, the added value of the experimental study reported herein is the role of time and humidity. More pronounced ageing phenomena ($P\#1 > P\#2$) and high temperature effects ($P\#1 > P\#2$) were observed to prevail on ambient humidity ($P\#2 > P\#1$). For $p > 1$ ($P\#1$ scenarios), a mean frequency increase up to $\Delta_f = +15\%$ was calculated. Given the same ambient conditions, such a result can be hence mostly justified by the combined number of standing/walking volunteers. This effect is also emphasized in Table 3, where the mean experimental Δ_f estimates (i.e., average results grouped by p) are not linearly proportional to p . Based on the dimensions of the panel ($1.65 \times 2.65 \text{ m}^2$), in this context, it can be reasonably expected a frequency increase up to $\Delta_f = +15\% - 20\%$ for the

In terms of damping, see Figure 9c and Table 3, the presence of standing/walking people increased up to two times the capacity of the empty structure ($\xi_{cs} = 1.15\%$). The presented damping estimates, however, include several movement features, and also in-place jumps characterized by impulsive accelerations. As far as more detailed calculations are not available, a simple (ξ_{os}, p) linear correlation could be taken into account for preliminary estimates and in-service monitoring considerations on the two-side supported system, see Figure 9c.

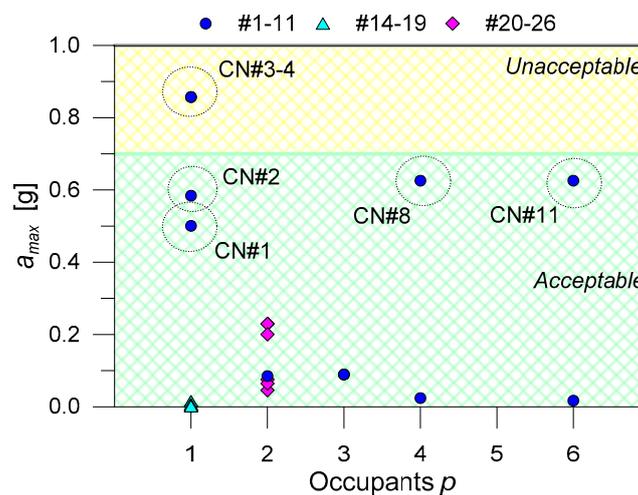
Figure 10. Vibration serviceability assessment of the examined system, based on EC0-A2 provisions. Experimental acceleration peaks (average values, vertical direction), as a function of the number of occupants.

For the case-study system, based on Equation (6), the limit acceleration peak $a_{max} = 0.7 \text{ m/s}^2$ can be hence taken into account ($f_v = f_{es} = 15.1 \text{ Hz}$), and no additional vibrational checks are required. As shown in Figure 10, the EC0-A2 provisions and the experimental estimates for the examined structure result in fact in mostly satisfied serviceability performances, for all the considered test scenarios (i.e., with “acceptable” acceleration peak for 24 configurations, over 26). The exception is represented by the CN#3 and #4 scenarios (in-place jump, $p = 1$), while few other configurations (four in total) are approaching the vibration acceptability limit. Two of them (CN#1 and #2) are still associated to an impulsive excitation ($p = 1$), while the CN#8 and CN#11 configurations have a relatively high occupation density (with normal walking activity).

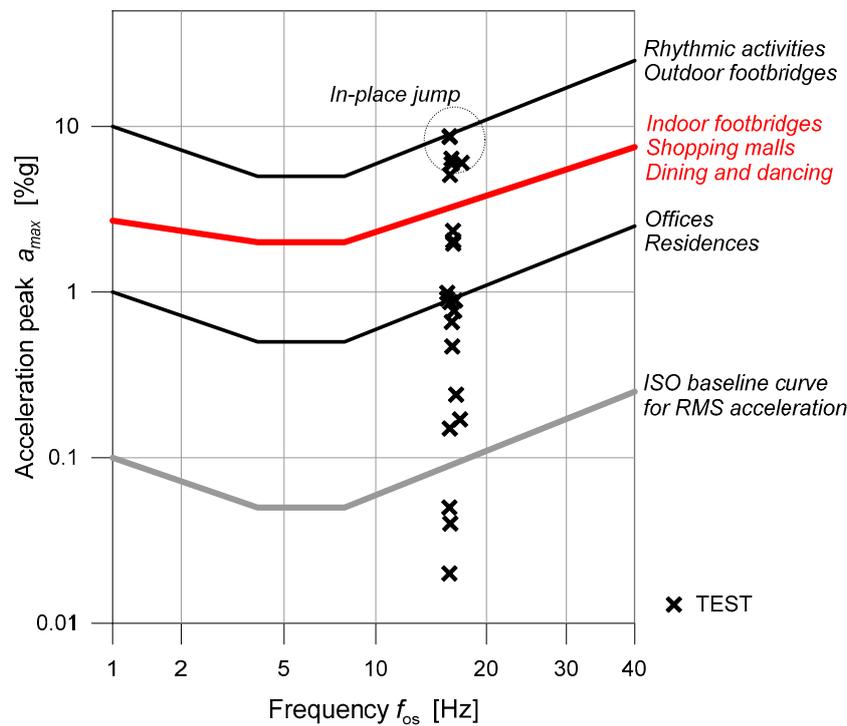
Figure 11. Vibration serviceability assessment of the examined system, based on ISO recommended limits. Experimental acceleration peaks (average values, vertical direction), as a function of the corresponding frequency.

When the ISO criterion is applied to the examined system, see Figure 11, it is possible to notice that most of the CN#*n* configurations could still satisfy the recommended comfort limits. For few of them only (five in total, with four associated to an in-place jump ($p = 1$)) the threshold performance for

“indoor footbridges” is exceeded. Three further conditions are approaching the limit peak, while the majority of them suggests a relatively good dynamic behavior of the structure.

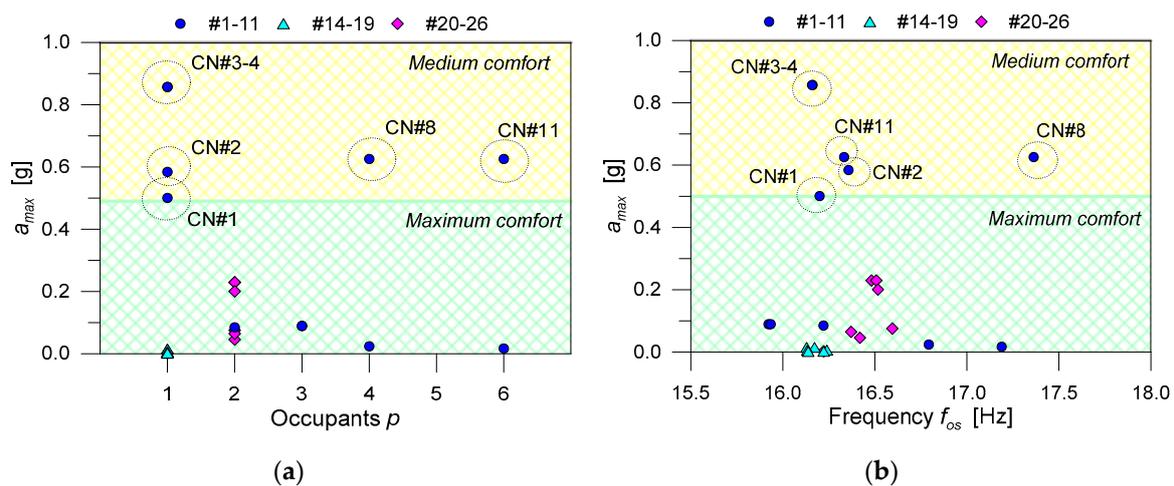
Figure 12. Vibration serviceability assessment of the examined system, based on the SÉTRA guideline document. Experimental acceleration peaks (average values, vertical direction), as a function of (a) number of occupants and (b) frequency.

In Figure 12, comparative results are proposed for the experimental acceleration peaks of the glass walkway, as a function of p and f_{os} . Differing from EC0-A2 and ISO provisions, it can be noticed that the majority of CN# n configurations are associated to “maximum” comfort, while six of them fall in the “medium” level. Again, the configurations with “medium” vibration performance are characterized by an in-place jump ($p = 1$), see Figure 12b. Few others, however, are related to high occupation density and normal walking conditions (CN#8 and #11).

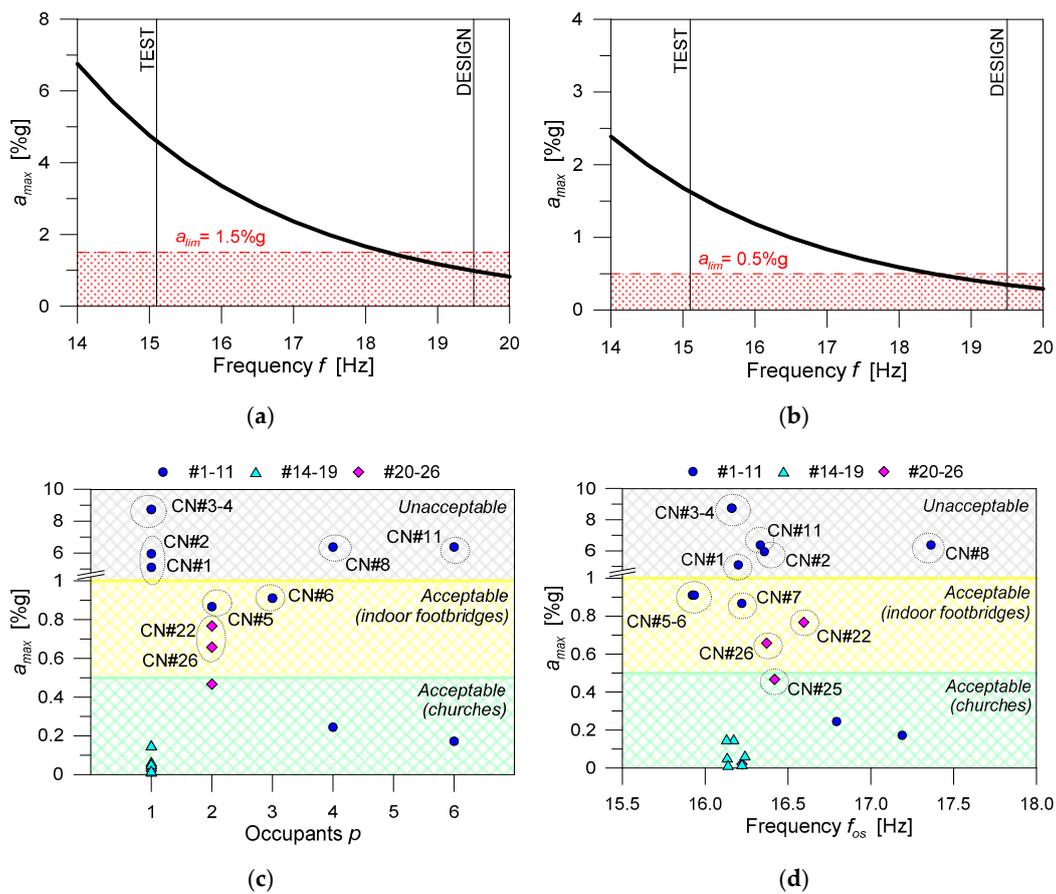
Figure 13. Vibration serviceability assessment of the examined system, based on the AISC technical guide. Expected acceleration peaks, based on Equation (10), for (a) indoor footbridges and (b) church systems, with (c,d) assessment of experimental acceleration peaks (average values, vertical direction), as a function of the number of occupants or frequency.

For the examined walkway, given $f = f_{es} = 15.1$ Hz and $W = M_{glass}$, it is possible to notice that the inequality of Equation (10) clearly results in unsatisfactory vibration performances, with a maximum acceleration up to $4.59\%g > 1.5\%g$ (“indoor footbridges”, that is ≈ 3.15 the exceedance ratio). Even considering that the pedestrian system is realized in a church, Equation (10) would provide unpleasant acceleration ratios ($1.62\%g > 0.5\%g$, ≈ 3.24 the exceedance ratio), see Figure 13a,b.

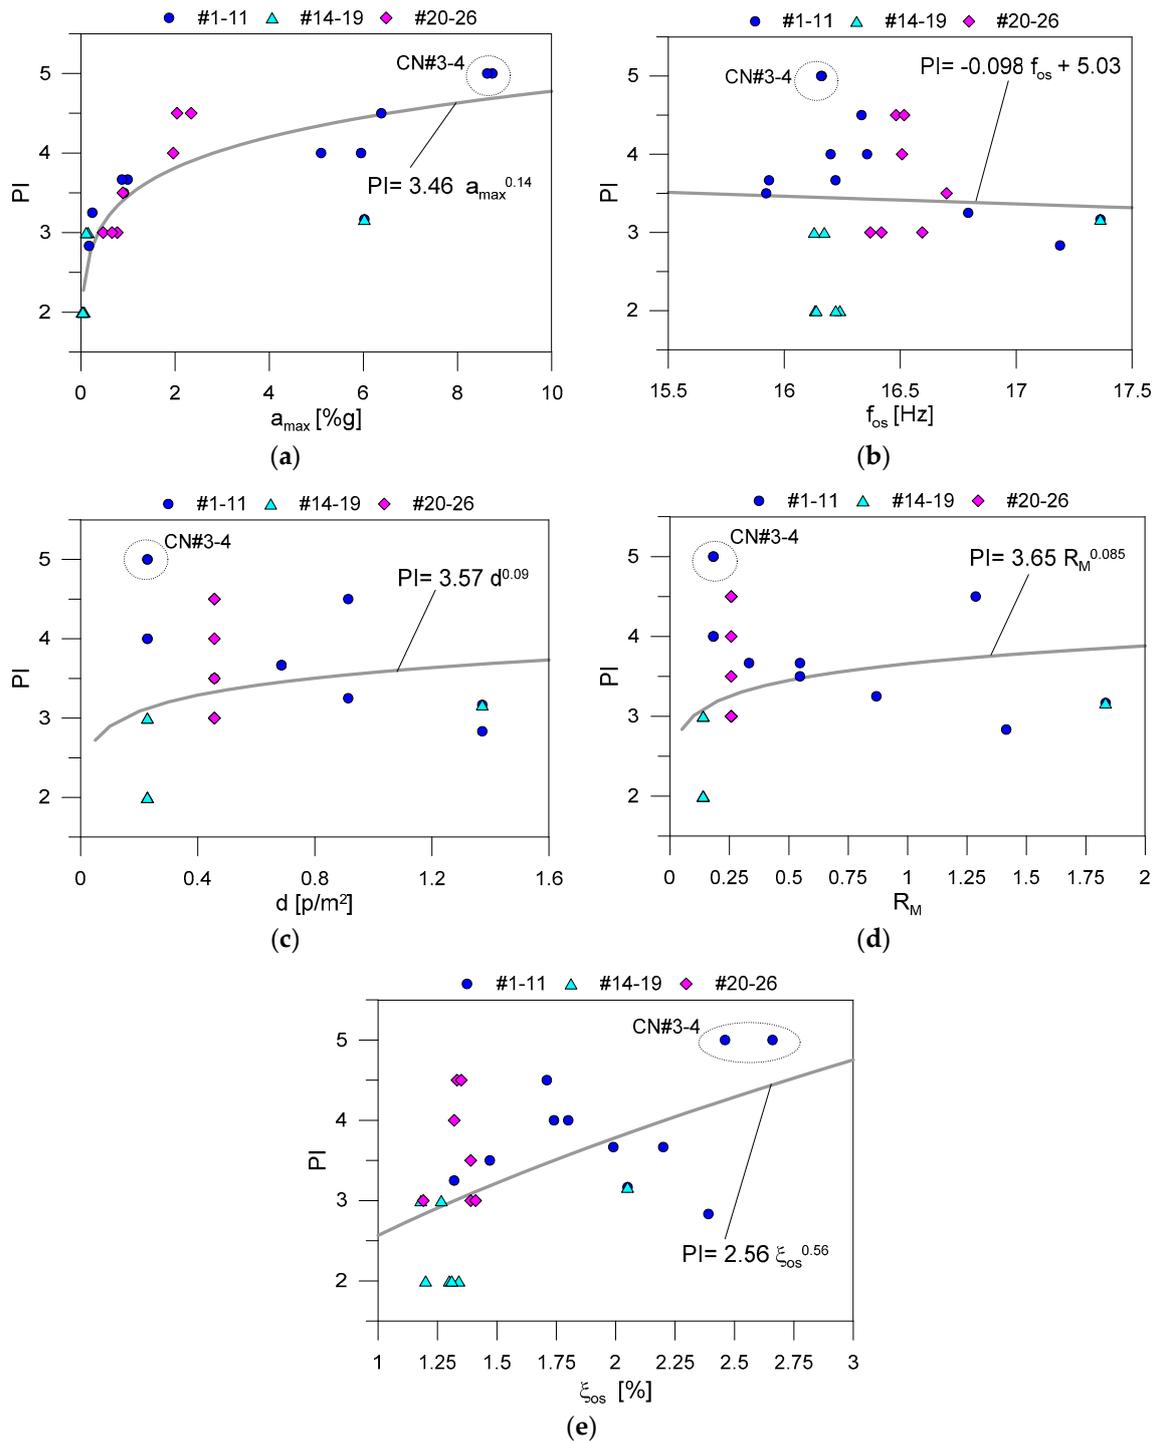
Figure 14. Perception Index (PI) values for the examined system, as a function of (a) acceleration peak a_{max} ; (b) frequency f_{os} ; (c) occupation density d ; (d) added mass ratio R_M ; (e) damping ξ_{os} .

In Table 5 and Figure 14, the obtained perception estimates are shown. It is important to notice that the number of occupants reflects the actual size of the examined walking surface. Given the class of use of the structure (monumental/religious building), in addition, the CN# n configurations can be considered well representative of the typical operational condition for the examined system.

In Figure 14a–d, PI values are reported as a function of the acceleration peak a_{max} (%g), frequency f_{os} , occupation density d , added mass ratio R_M and modal damping ξ_{os} . From the collected data, it is possible to notice that:

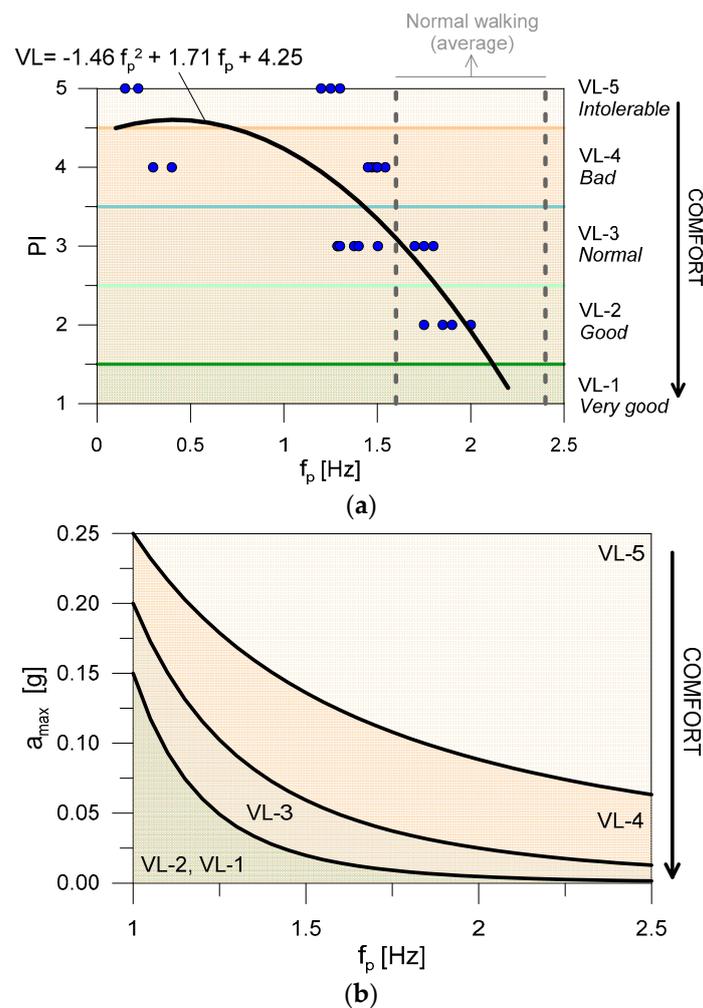
Figure 15. Analytical correlation between (a) experimental walking frequencies f_p and corresponding vibration comfort levels VL (vertical direction) for the examined system, and (b) definition of possible perception curves for graphical comfort assessment.

In Figure 15a, a possible analytical correlation of PI grades is hence proposed for the case-study system, as a function of the reference VL classes and walking frequencies f_p . There, the average f_p is derived—for each CN# n configuration—from the corresponding experimental records. The mean walking frequency for “normal” activity is also emphasized in the figure (dashed lines). The second-order fitting curve of the experimental PI data shows that under “normal” activities the structure can be still associated to “normal” or even “good” performances. The comfort level decreases,

The advantage of Figure 15a is hence that the comfort performance of the in-service structure can be assessed for a given walking frequency f_p , accounting also for the specific structural typology and destination. Otherwise, it does not consider other relevant movement features, like the imposed acceleration peak. It was in fact shown in [37] that $PI-a_{max}-f_p$ plots derived from experiments can offer a suitable tool for comfort estimates. A similar approach is hence proposed in Figure 15b, where fitting curves are obtained from the experimental data, including movement features (walking frequency, acceleration peak) and perception feelings from the volunteers. As shown, as far as a “normal” walking activity is taken into account, it is possible to notice that “good” or “normal” perception feelings of the volunteers are associated to relatively low acceleration peaks, up to a maximum of 0.07–0.08 g. When the walking frequency decreases and/or the acceleration peak increases, the perceived comfort rapidly
